# In-flight break-up, Stolp Acroduster II SA-750, VH-YEL

16 km north-east of Caboolture airfield, Queensland, on 18 August 2021

**ATSB Transport Safety Report**

AO-2021-032

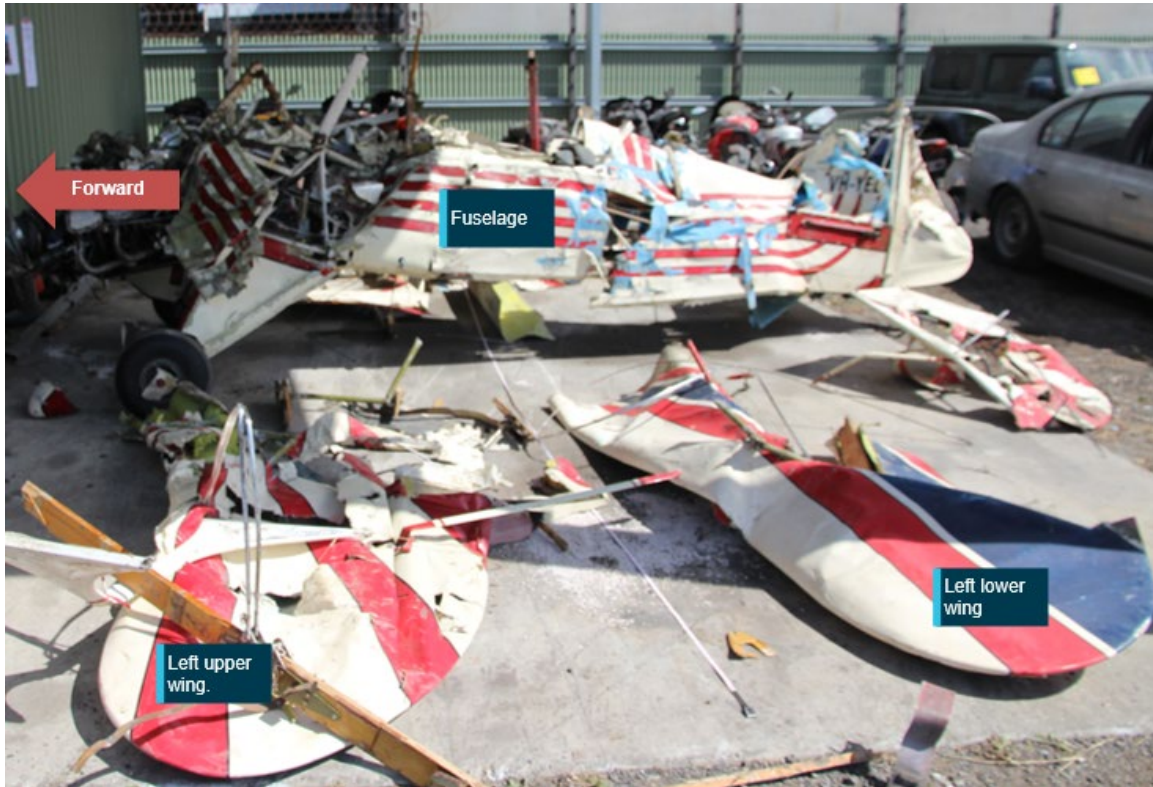
Figure 6: VH-YEL as recovered and partially reassembled

The main wreckage was recovered by barge at the changing of the tide and was transported to a secure storage facility for examination by the ATSB (Figure 6). Reconstruction of the sections of recovered aircraft identified that:

- the majority of the parts were accounted for with the exception of the right interplane strut
- the aircraft flight controls had no pre-impact defects
- the fuselage, wings, flying and landing wires had no pre-impact defects
- the forward cabane strut upper wing attachment point eye bolts to the centre-wing structure had fractured and displayed evidence of pre-existing fatigue cracking
- there was no evidence of propeller rotation at impact, however, the engine most likely stopped from fuel starvation during the in-flight break-up sequence.

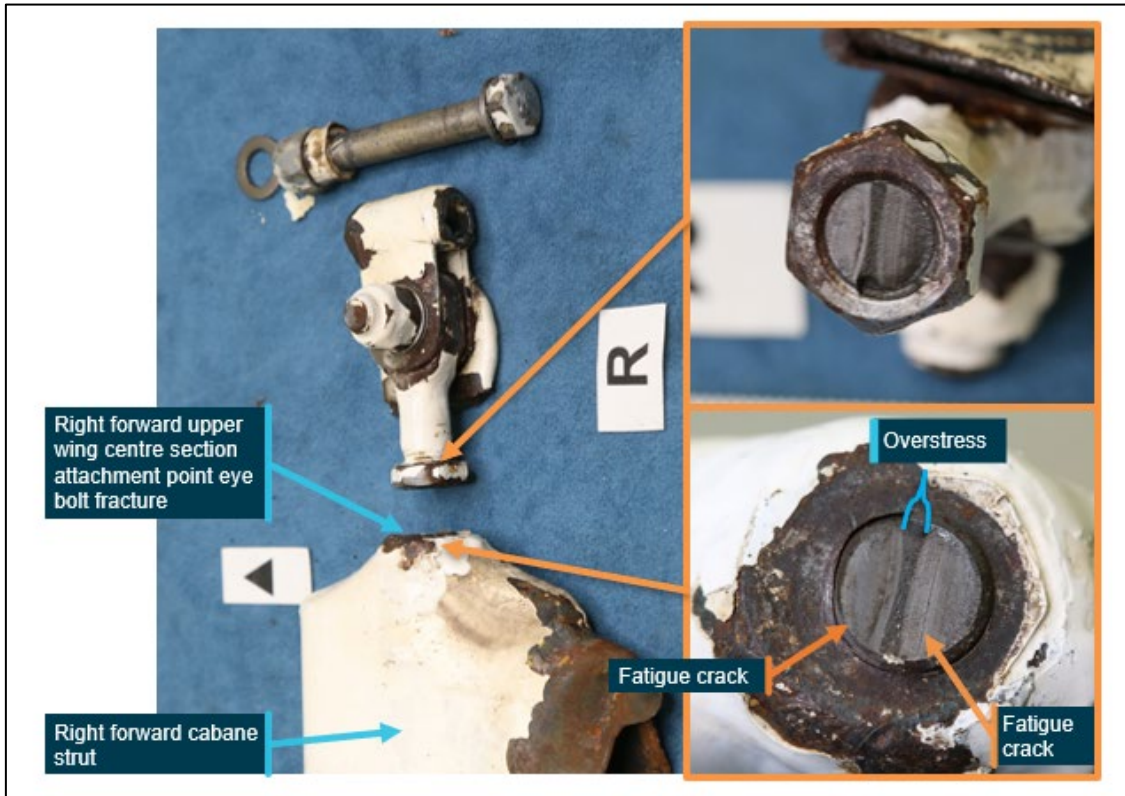
**Figure 7: Right eye bolt, cabane strut and fracture surface**

- There were uniaxial fatigue cracks in a fore/aft direction through 85% of the right eye bolt threaded cross section with the remaining material fractured in overload (Figure 7).

The location of the crack on the right forward cabane strut eye bolt was directly under the securing nut, making it impossible to identify the fatigue crack without disassembling the attachment point and removal of the eye bolt. The location of the crack on the left forward cabane strut was directly above the securing nut and would have been difficult to identify while it was forming in the threaded section without disassembly and removal of the eye bolt from the cabane strut.

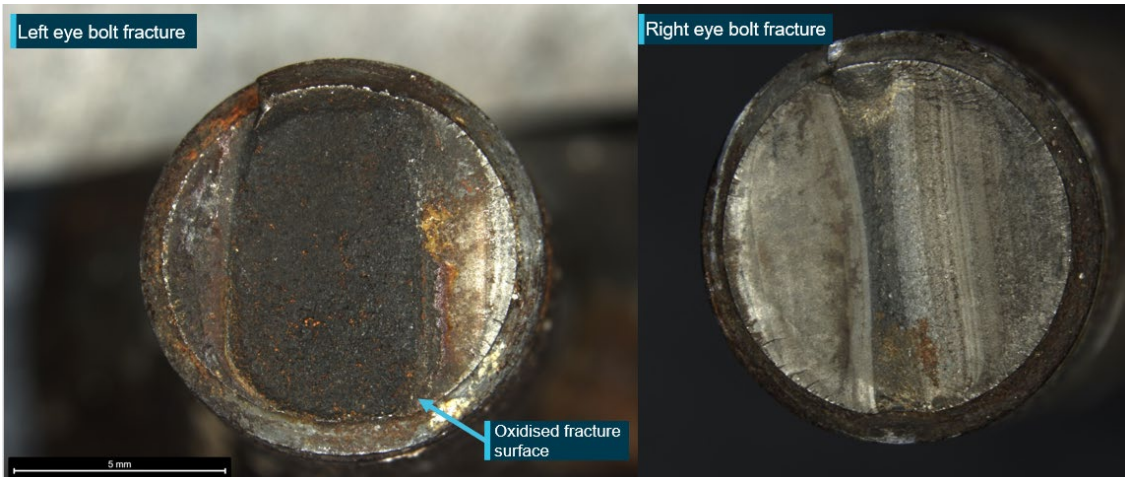
**Figure 8: Corrosion level differences between left and right eye bolt fracture surfaces**

- There were several areas of additional micro-cracking present in the threaded portion of the forward eye bolts.
- The left eye bolt fracture surfaces had significant corrosion when compared to the right eye bolt fracture surfaces. This indicated that the left eye bolt had completely fractured some time before the accident flight (Figure 8).

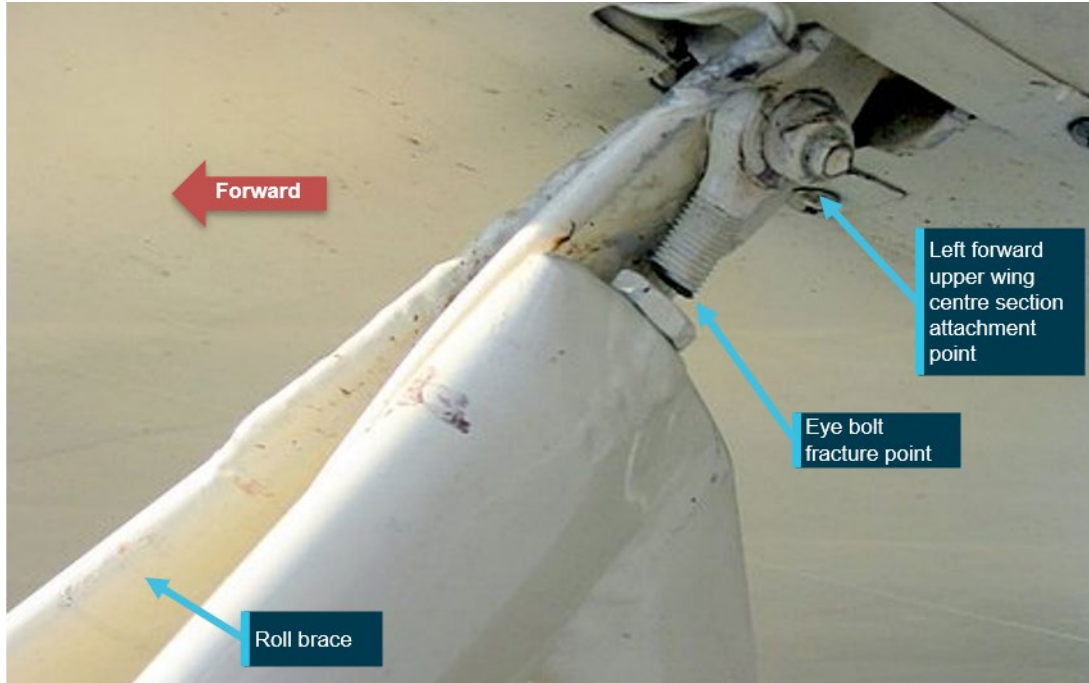
**Figure 9: Previous Acroduster SA-750 with fractured wing attachment eye bolt**

A subject matter expert familiar with the early design and development of the aircraft type indicated that there has been a history of cabane strut eye bolt cracking in the same area of the threaded section as occurred with VH-YEL. They provided the ATSB with an image taken 2 decades before this incident of an Acroduster SA-750 where a left forward upper wing cabane

strut eye bolt fractured completely through its threaded section. That fracture was in the same location as VH-YEL. The left roll brace was the only remaining structure providing support to that section of the wing (Figure 9). It could not be determined how long prior, or for how many hours the aircraft had flown with the failed eye bolt.

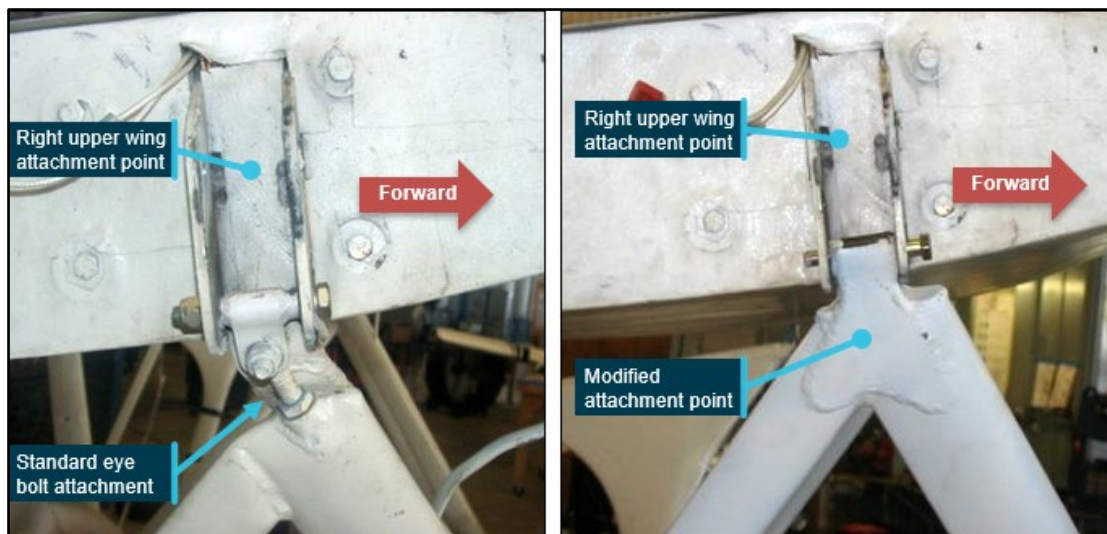
**Figure 10: Right-side upper wing centre section attachment point with a standard eye bolt attachment (left) and a modified attachment (right)**

The ATSB was further advised that some owners of Acroduster aircraft made modifications to the upper wing attachment points. The modification removed the eye bolts and replaced them with a welded structure, which attached directly to the upper wing attachment point, effectively strengthening the attachment points (Figure 10). The ATSB notes that the modification shown was not approved by the aircraft design owner and had been added by experimental amateur-built owners. Advice on such modifications should be sought from a suitably qualified aeronautical engineer on any design changes undertaken.

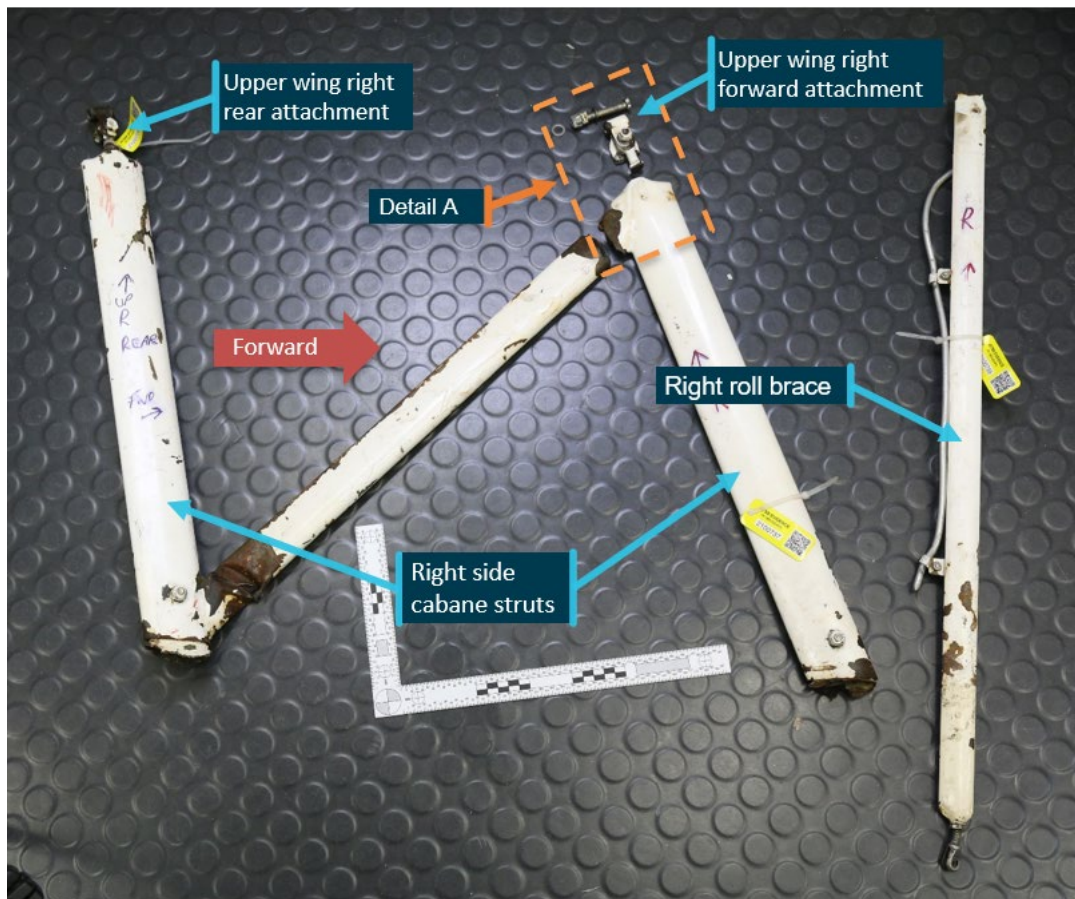
**Figure A1: Right cabane struts, roll brace and upper wing attachment points**

Figure A1 shows the right cabane struts and roll brace. The area notated as Detail A (also see Figure A2) shows the fractured upper wing attachment point.

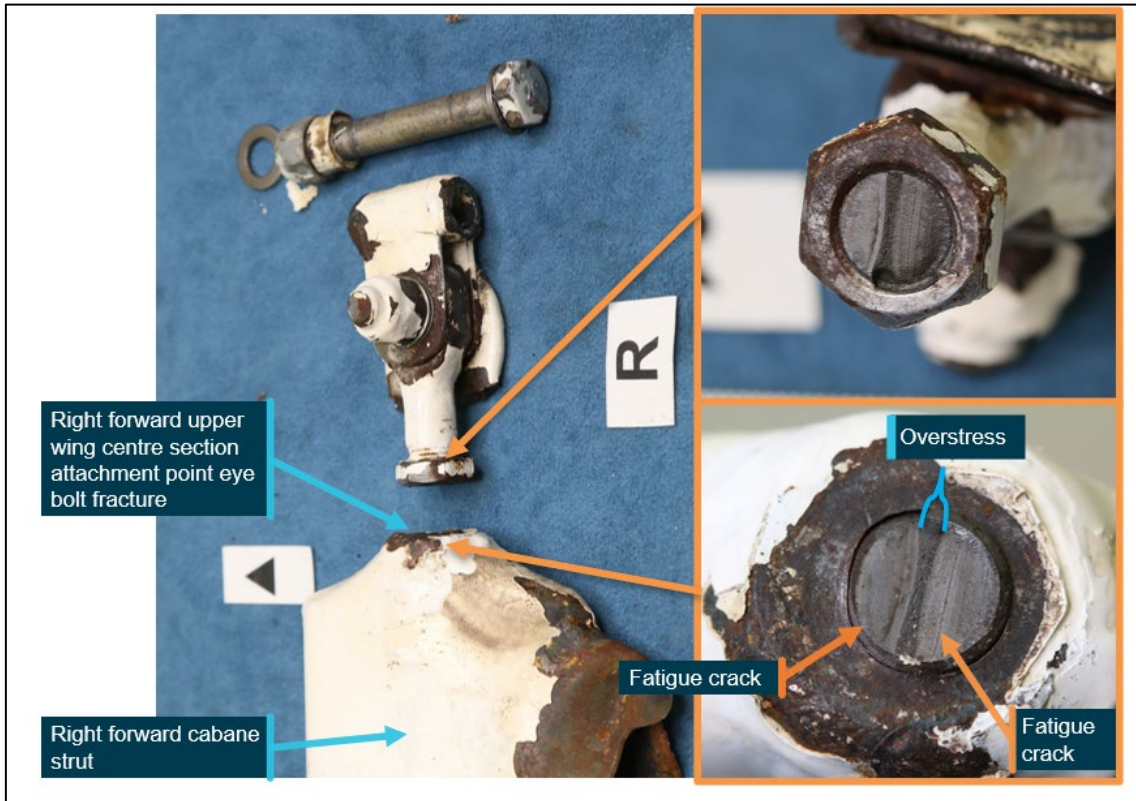
**Figure A2: Right cabane strut forward upper wing attachment eye bolt showing evidence of significant fatigue cracking through the threaded portion (Detail A from Figure A1)**

The fatigue cracking had extended through approximately 85% of the right eye bolt and about 35% of the left eye bolt cross-section prior to ductile overstress fracture. (Figure A2 and A3).

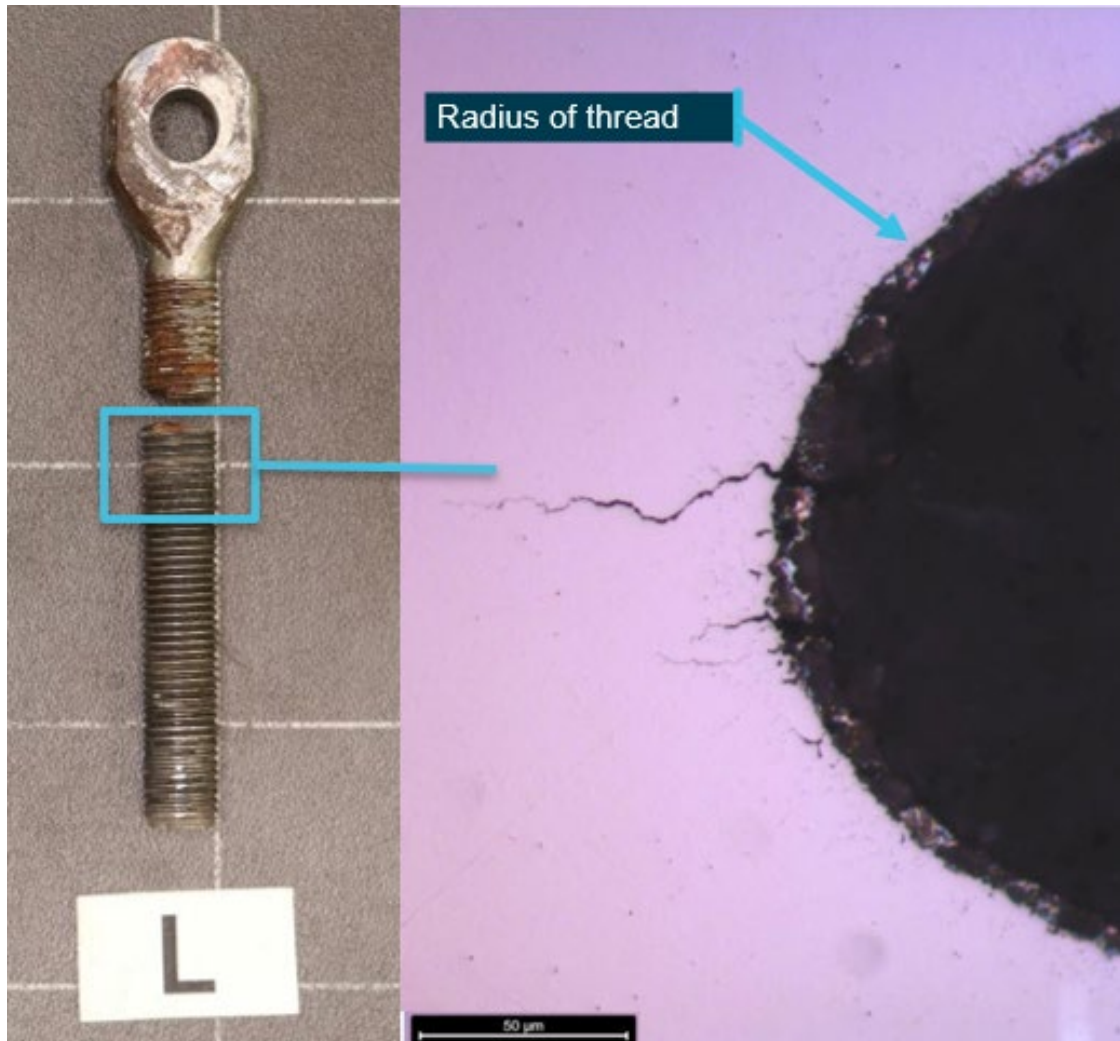
**Figure A4: The fractured left eye bolt and a corresponding metallurgical cross-section that shows additional microcracking had developed within the threads of the bolt shank**

The scanning electron microscope examination also identified the presence of additional microcracking in the thread root region of each bolt that extended further along the shank. The extent of cracking was later confirmed by metallurgical sectioning of the left eye bolt whereby numerous smaller penetrating cracks had developed along the bolt shank threads (Figure A4).

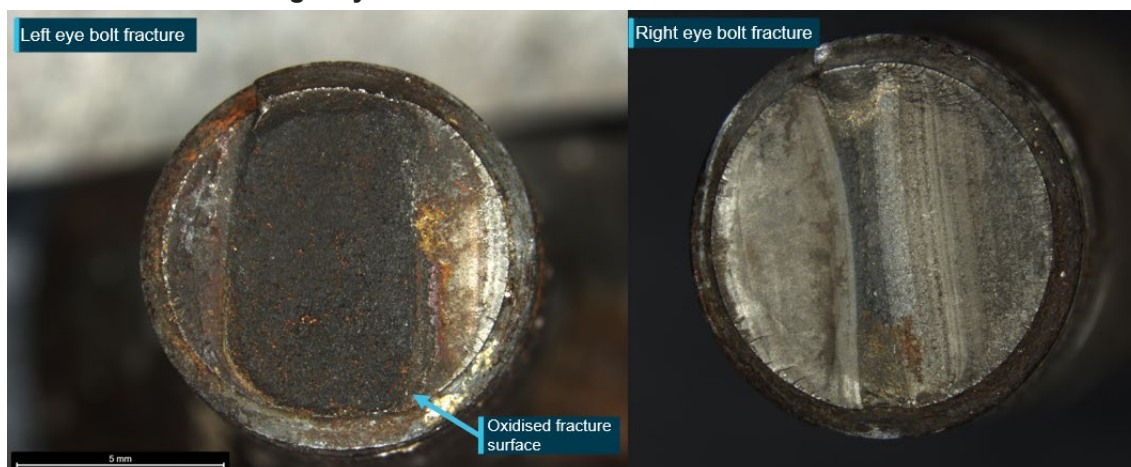
**Figure A5: Eye bolt fracture surfaces showing the difference in the level of corrosion between the left and right eye bolt**

An optical comparison between the fracture surfaces of the left and right eye bolts identified notable differences between each bolt. The left eye bolt had significantly more corrosion and associated oxidation of the majority of the fracture surface, when compared with right eye bolt (Figure A5). That physical difference provided evidence to identify that the left eye bolt had likely been the first to fracture, followed sometime later by fracture of the right eye bolt.

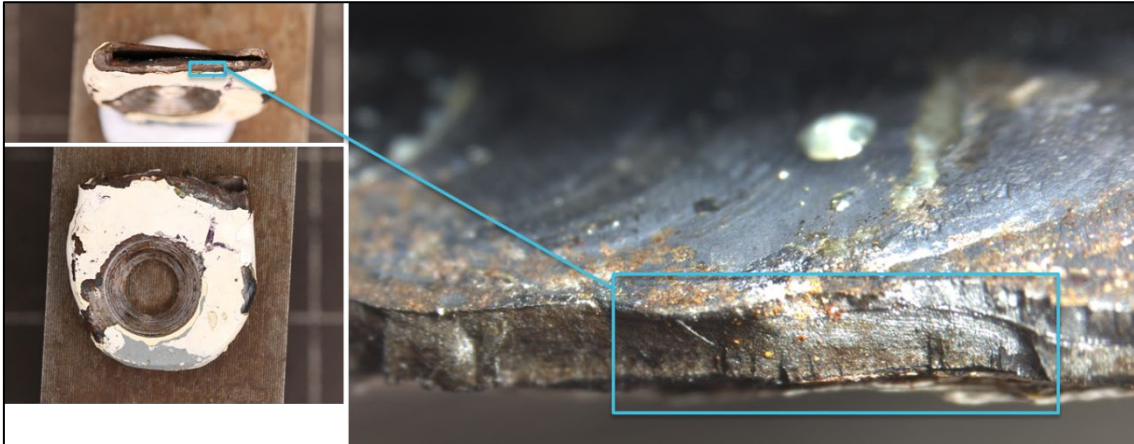
**Figure A6: Optical examination of the roll brace from the left cabane strut showed indications of pre-existing fatigue in the welded region**

Visual examination of both roll braces that had been attached to their respective cabane strut showed that they had fractured at the upper connection to the trunnion joint. Each fracture location was coincident with the position of the upper cabane strut eye bolts. ATSB's laboratory examination identified that the left roll brace had fractured with about 60% of its cross-section showing features consistent with fatigue (such as crack progression markers and a flat surface profile) (**Figure A6**). The remainder of the fracture was one of ductile overstress.

The right roll brace contained an almost identical fracture profile, however, due to the extent of corrosion development, no salient features could be identified to conclude whether the strut contained fatigue cracks prior to its final fracture.
