Runway excursion involving Raytheon B200, VH-MVP

Lord Howe Island Airport, New South Wales on 18 February 2022

ATSB Transport Safety Report

AO-2022-007

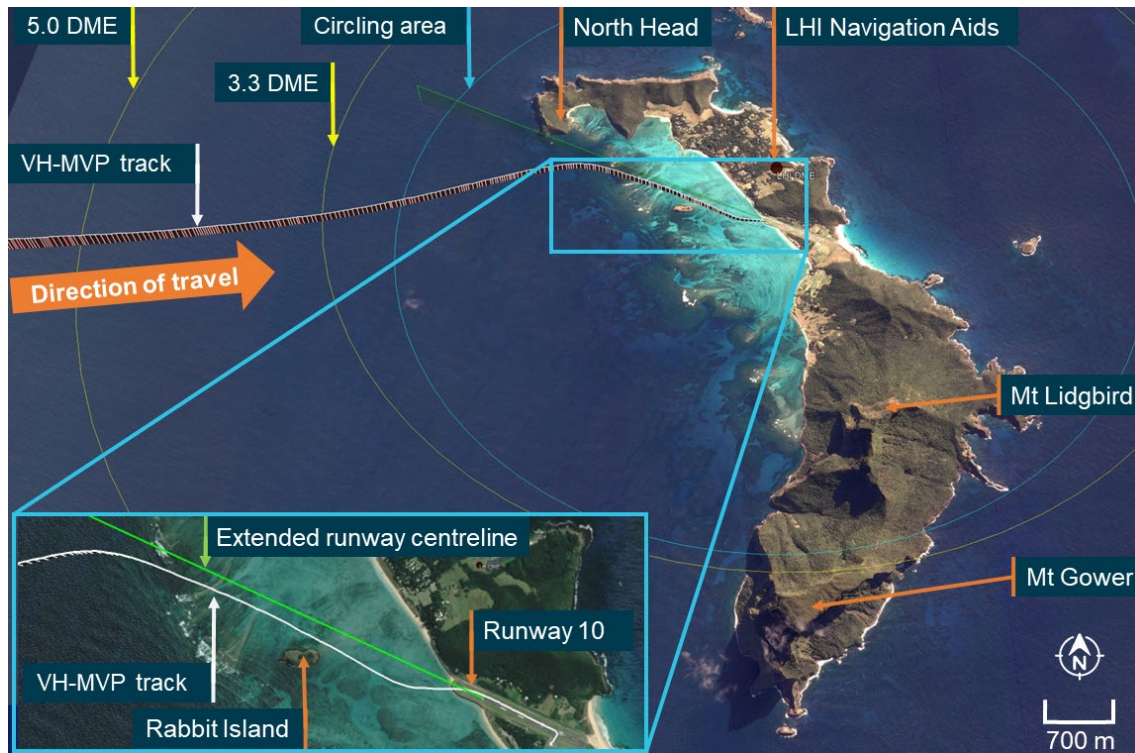
Figure 1: VH-MVP approach into Lord Howe Island

Early in the DME arrival procedure, the pilot established visual flight conditions, and at about 10 NM from the DME (10 DME), the aircraft descended below the 1,700 ft⁹ segment lowest safe altitude for the arrival procedure. The pilot continued descending the aircraft towards the aerodrome, passing 1,000 ft at about 7 DME, and 600 ft at 5 DME. Near 5 DME, the aircraft commenced a slow left turn to track towards a point between North Head and Rabbit Island. At 3.3 DME, the aircraft descended to about 400 ft and then entered the aerodrome's circling area.¹⁰

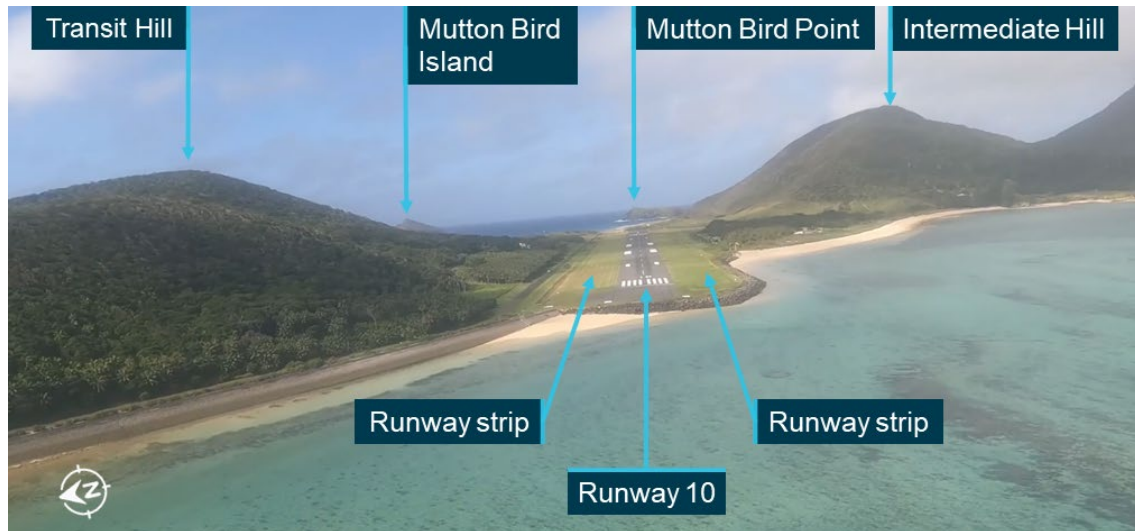
Figure 2: Approach to runway 10

The runway is located on level terrain between two hills, Transit Hill (433 ft) to the north, and Intermediate Hill (809 ft) to the south-east (Figure 2). The runway is at a height of 17 ft and aligned 100 °M and 280 °M (10/28). The sealed runway is 30 m wide, and the associated runway strip 90 m wide.¹⁸ The published aerodrome information required operations to be confined to the runway's sealed surface.

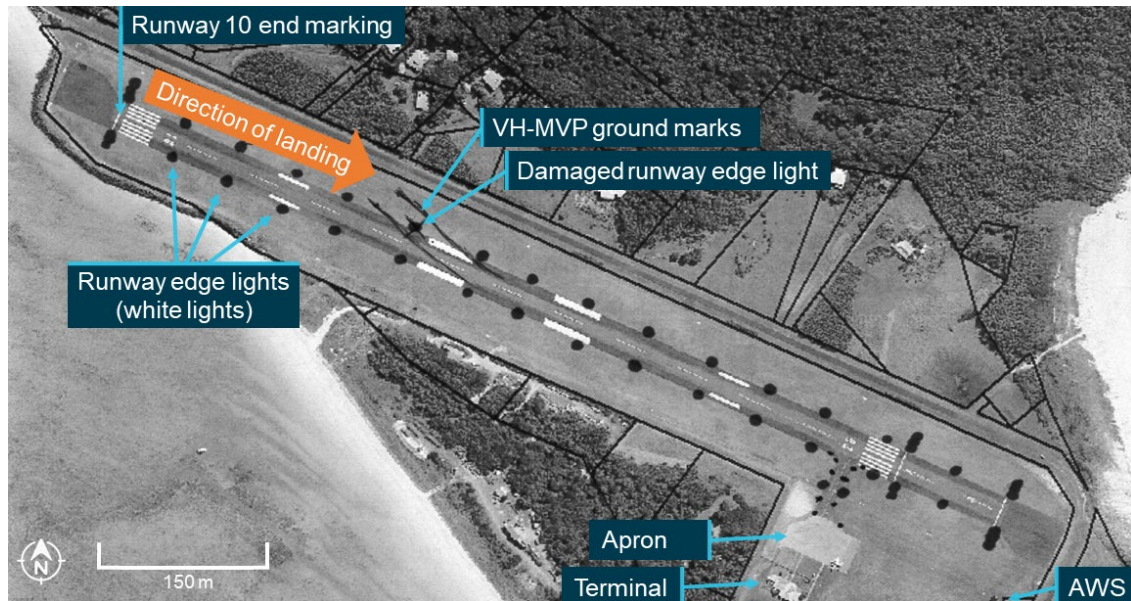
Figure 3: Runway 10 damage

After receiving notification about the off-runway landing by VH-MVP, the aerodrome operator inspected the runway. The inspection identified ground marks from an aircraft's tyres along the left section of the runway strip, and a broken runway edge light on the left side of the runway about 1,000 ft (300 m) from the threshold of runway 10 (Figure 3). The ground markings indicated that the aircraft had touched down on the runway strip, with the closest main landing gear to the sealed runway surface about 2 m from the edge, and that the aircraft had quickly regained the runway shortly after touchdown.

The late manoeuvring to reacquire the runway centreline resulted in the aircraft deviating left of the runway's sealed runway surface and touching down to the left of the runway. Although the aircraft quickly recovered to the runway, it damaged a runway light.

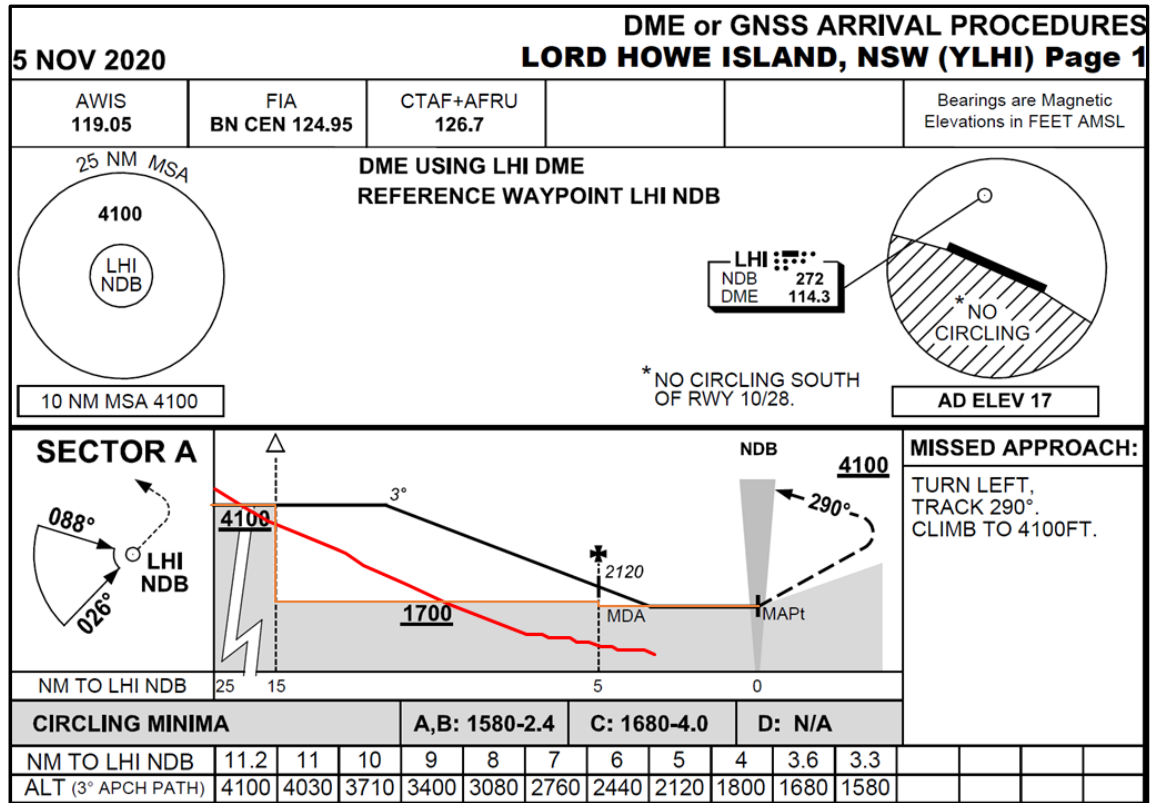
Figure 4: DME arrival procedure with VH-MVP descent profile superimposed

The DME arrival procedure provided obstacle clearance for an IFR flight by positioning the aircraft within the aerodrome's circling area at the circling MDA. From that point, the pilot was required to conduct a visual circling procedure, which required the pilot to establish visual contact with the landing runway and then manoeuvre to join that runway's circuit pattern.

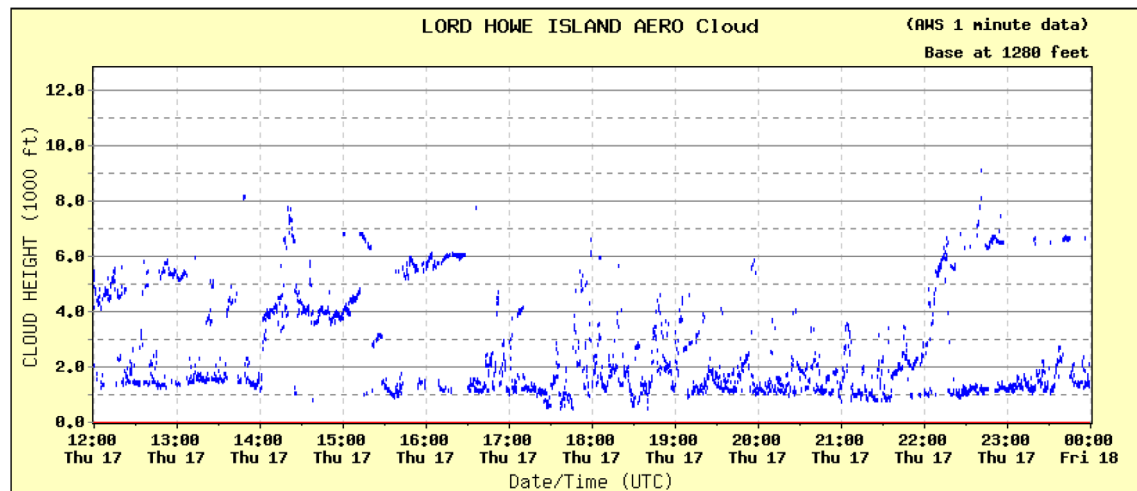
Figure 5: YLHI ceilometer data

The ceilometer used a single vertical-pointing laser beam to obtain spot heights of the cloud base directly above. The cloud base was identified as being the height of the peak reflected light intensity. Only heights up to 12,500 ft were reported. Cloud type was not reported. Processing data over time produced an estimate of cloud amount. There were several limitations to ceilometer data, including misreporting of stationary cloud amounts due to minimal cloud movement, and a time lag in reporting rapidly changing cloud conditions, as well as other limitations related to the accuracy of the ceilometer output associated with the instrument and the sampling method used. Figure 5 displays the recorded ceilometer data for the YLHI AWS covering the period 17 February at 1200 UTC to 2359 UTC (17 February at 2300 to 18 February 1100 local time).

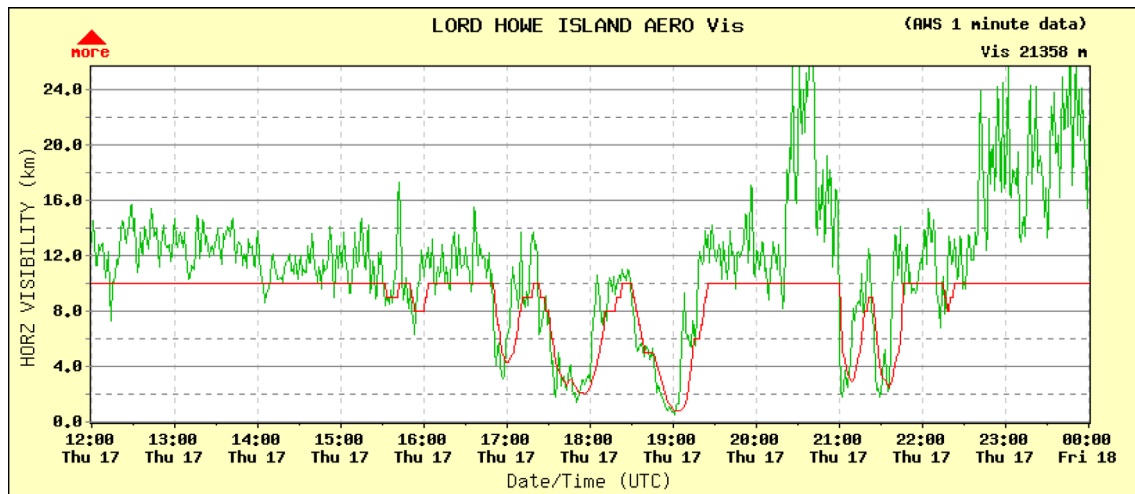
Figure 6: YLHI visibility meter data

When an air mass with reduced visibility moved across the airfield, such as a fog bank or a shower, the sensor will not detect that reduced visibility unless it also moved across the sensor. There may be other limitations as to the accuracy of the visibility output associated with the instrument and the sampling method used. Figure 6 displays the recorded ceilometer data for the YLHI AWS covering the period 17 February at 1200 UTC to 2359 UTC (17 February at 2300 to 18 February 1100 local time).
