# In-flight fire and collision with terrain involving Beechcraft B58 Baron, VH-NPT

near East Kimberley Regional Airport, Kununurra, Western Australia on  
16 April 2022

## **ATSB Transport Safety Report**

AO-2022-026

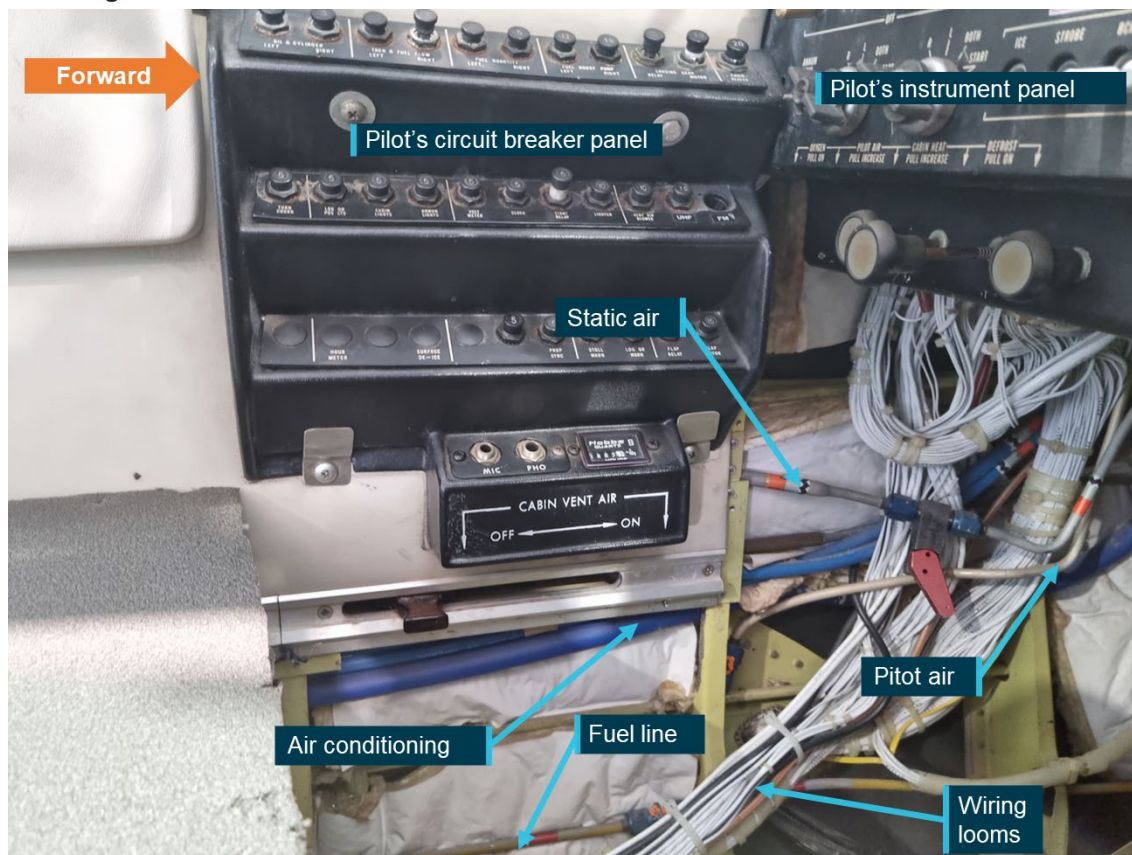
**Figure 7: Circuit breaker and instrument panel of an exemplar B58 showing the position of wiring looms.**

Electrical power was supplied to several systems including drive motors for the landing gear and flaps, aircraft lighting, avionics and communications. A circuit breaker panel on the pilot's left side protects the circuits from overload and damage. Wiring was routed from the circuit breaker and instrument panels down along the left side of the aircraft in a series of looms. Figure 7 shows the area forward of the circuit breaker panel and below the pilot's instrument panel in an exemplar aircraft.

The wiring for these systems, and several other electrical systems, are bundled together in the area where the pilot reported the fire started. The ATSB's review of the aircraft electrical wiring schematics was not able to identify a single point of failure, either through a short between systems or to ground or an open circuit, which could have caused all 3 symptoms that the pilot reported. However, the bundling of multiple wires and the possibility of live circuits contacting one another meant that a multiple point failure in the landing gear, or within other electrical circuits, leading to the symptoms the pilot reported was possible.

The ATSB issued a Safety Advisory Notice encouraging operators of B58 aircraft to conduct a detailed examination of the wiring and heater fuel line on the left side of the aircraft, forward of and below the pilot's circuit breaker panel.

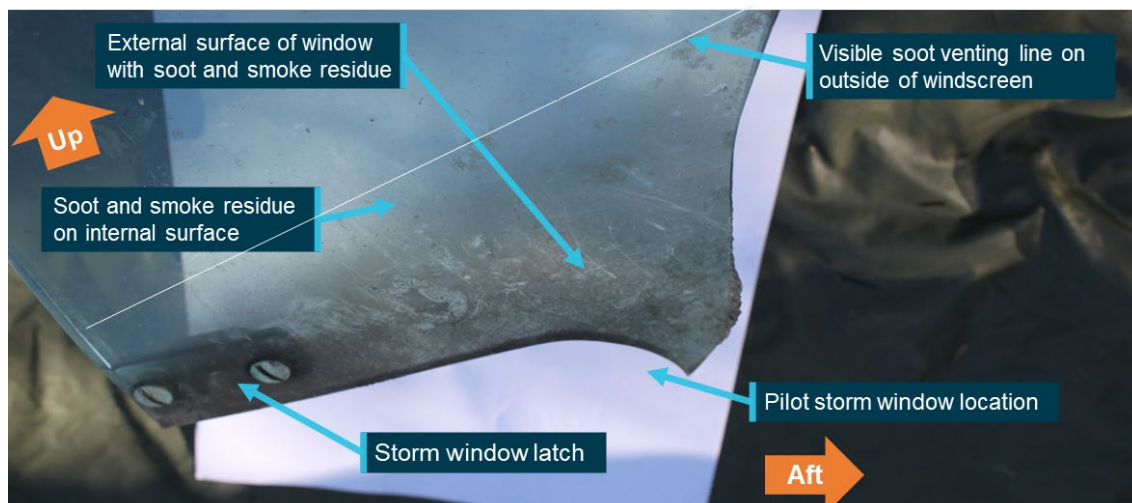
**Figure 9: Smoke and soot indications on window surfaces adjoining the pilots storm window**

The upper, aft corner of the pilot's storm window surround (Figure 9) was located with the outer surface down, closer to the post-impact fire than the windscreen. Soot was located on both sides with the external surface, consistent with soot being drawn out of the window by the airflow.

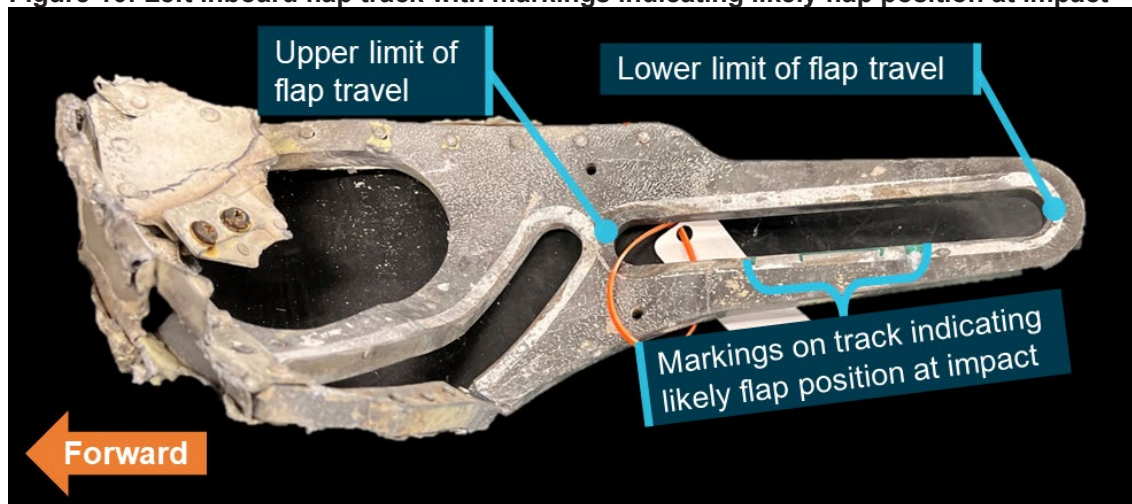
**Figure 10: Left inboard flap track with markings indicating likely flap position at impact**

Due to fire damage to the flap actuators, the specific position of the flaps at impact was unable to be determined. The aircraft's flap tracks were recovered for further examination at the ATSB's technical facilities in Canberra. Impact markings on the flap tracks indicated that the flaps were likely extended to the first of the 2 flap positions (15°) at the time of impact (Figure 10). This corresponded with both the pilot's report of having extended the flaps one position prior to activating the landing gear and the operator's procedures that required first stage flap extension as part of the setup of the aircraft for the approach.

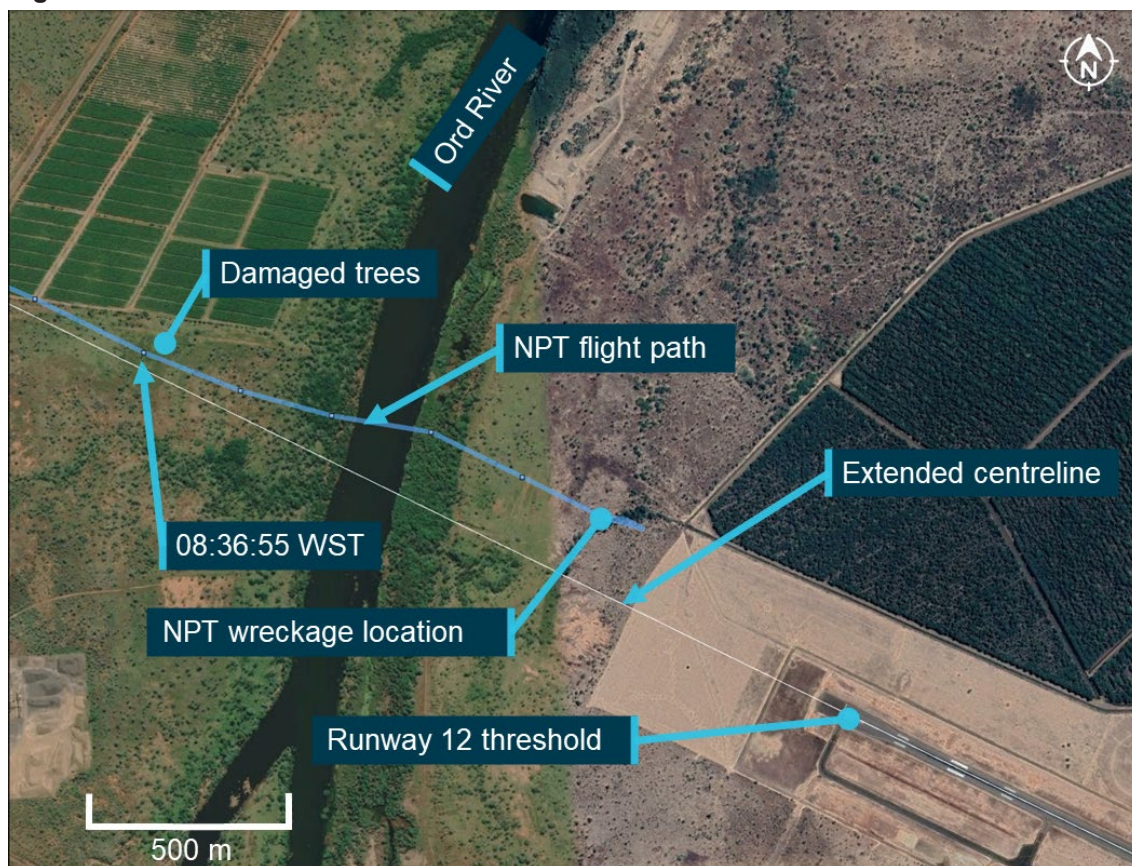
**Figure 11: Possible tree strike location**

In response to witness reports that the aircraft skimmed trees prior to the ground collision, the operator conducted an airborne search on the western side of the Ord River. This search identified a grouping of 4 trees in the approach to runway 12 that had damage consistent with aircraft contact.

The trees were approximately 500 m west of the river and 60 m north of the extended runway 12 centreline (Figure 11). Their position was consistent with the aircraft's approach path, and were close to the lowest point in the aircraft's flight path data on the western side of the Ord River. Tree damage was between 15 and 20 ft above ground level and the direction of the breaks and fallen limbs were consistent with the aircraft's direction of travel.
