Birdstrike and in-flight break-up involving a Bell 206L-1, registered VH-ZMF

Near Maroota, NSW, on 9 July 2022

ATSB Transport Safety Report

AO-2022-034

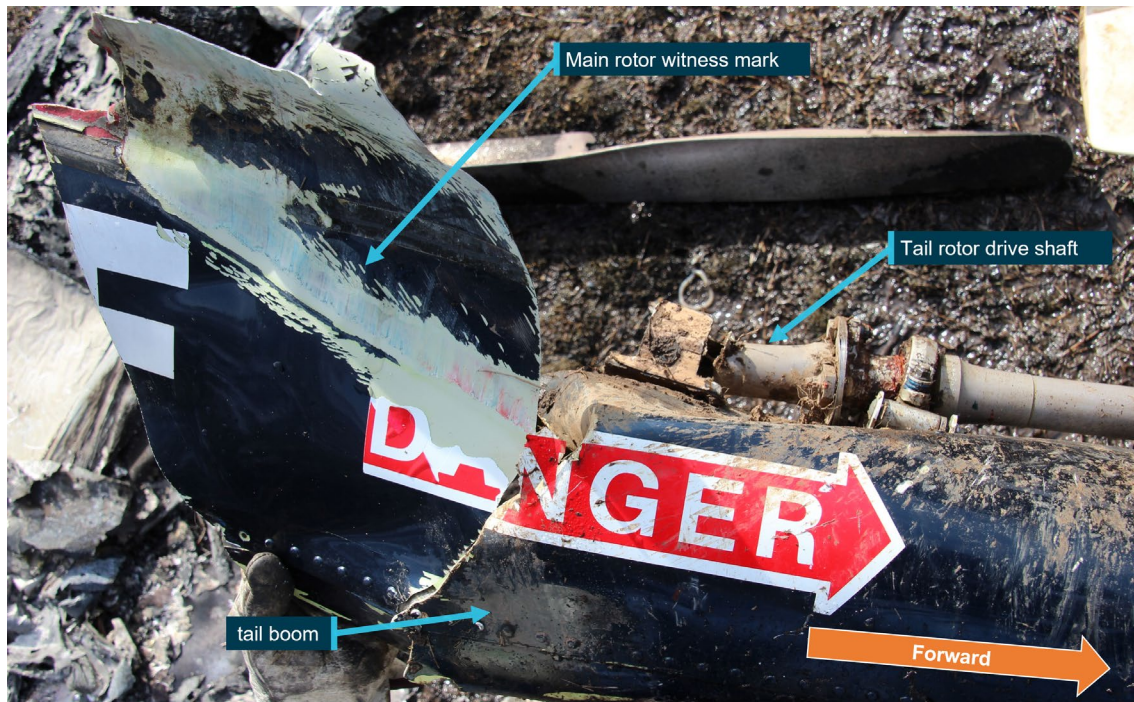
Figure 4: Tail boom impact

The main accident site, including the engine, main cabin, and fuselage, was located in relatively flat and open farmland, between 2 ridgelines (Figure 5). The tail rotor assembly, vertical stabiliser and a section of the tail boom were found about 93 m to the north, with no signs of pre-existing component failure or damage. However, the main tail boom and drive shaft (Figure 4) were both severed at roughly the same fuselage station, consistent with a main rotor blade strike.

Abrupt cyclic inputs and low to negative g rotor loading are a well-documented and accepted limitation of two-bladed teetering rotor head systems commonly used in light to medium helicopters. Analysis of the impact marks on the tail boom of VH-ZMF and the separation of rotor blade tips, indicate that the tail boom was impacted and severed by contact with its own main rotor blades. This led to further break-up of the aircraft in flight, such as the main rotor system and transmission due to severe rotational forces of a compromised and unbalanced main rotor assembly. Numerous witnesses observed and heard the impact of the main rotor blades on the tail boom and described the uncontrolled nature of the in-flight break-up.
