# Birdstrike and in-flight break-up involving a Bell 206L-1, registered VH-ZMF

Near Maroota, New South Wales, on 9 July 2022

Aviation Occurrence Investigation (Short)

AO-2022-034

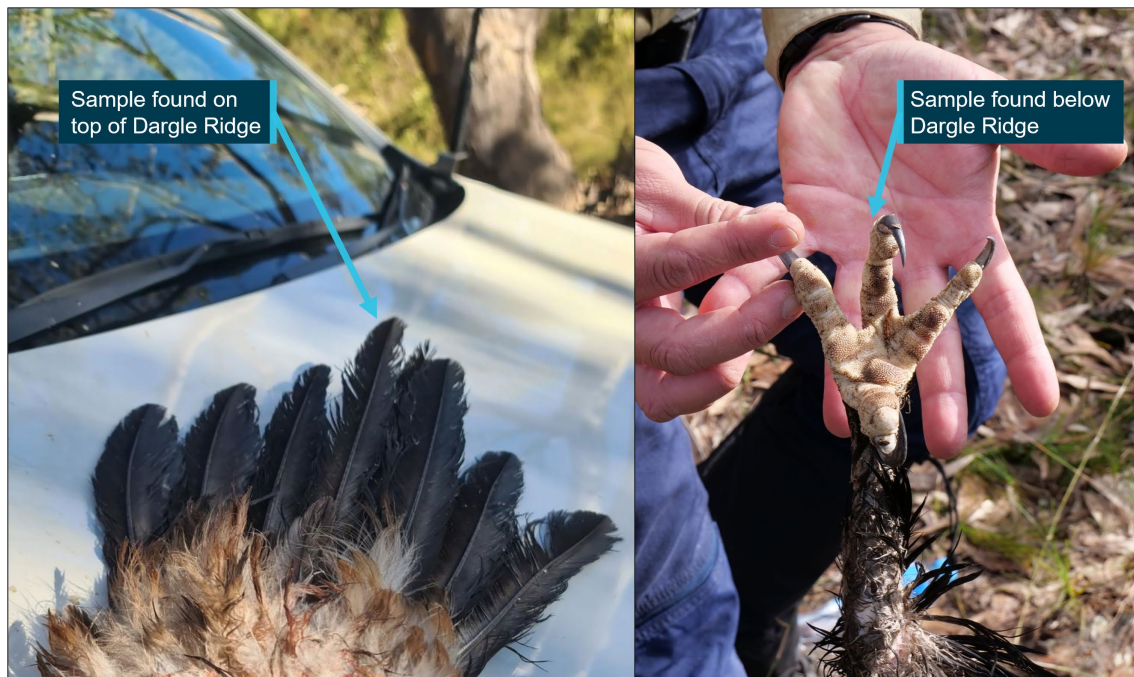
**Figure 3: Bird matter found near accident site**

The landowner, who arrived at the accident scene on the top of the Dargle Ridge lookout, identified a mass of biological tissue, which appeared to be a tail section of a bird (Figure 3), which was still warm. During the on-site phase of the investigation, further biological samples were recovered below the escarpment.

Recovered biological specimens, including the avian carcass and the biological residue found on external helicopter surfaces, were analysed by the Australian Centre for Wildlife Genomics, Airstrike section of the Australian Museum. The carcass and samples taken from the helicopter's main transmission cowling were identified as *Aquila audax*, commonly known as a wedge-tailed eagle.
