Birdstrike and in-flight break-up involving a Bell 206L-1, registered VH-ZMF

Near Maroota, New South Wales, on 9 July 2022

AO-2022-034

Final – 12 May 2023

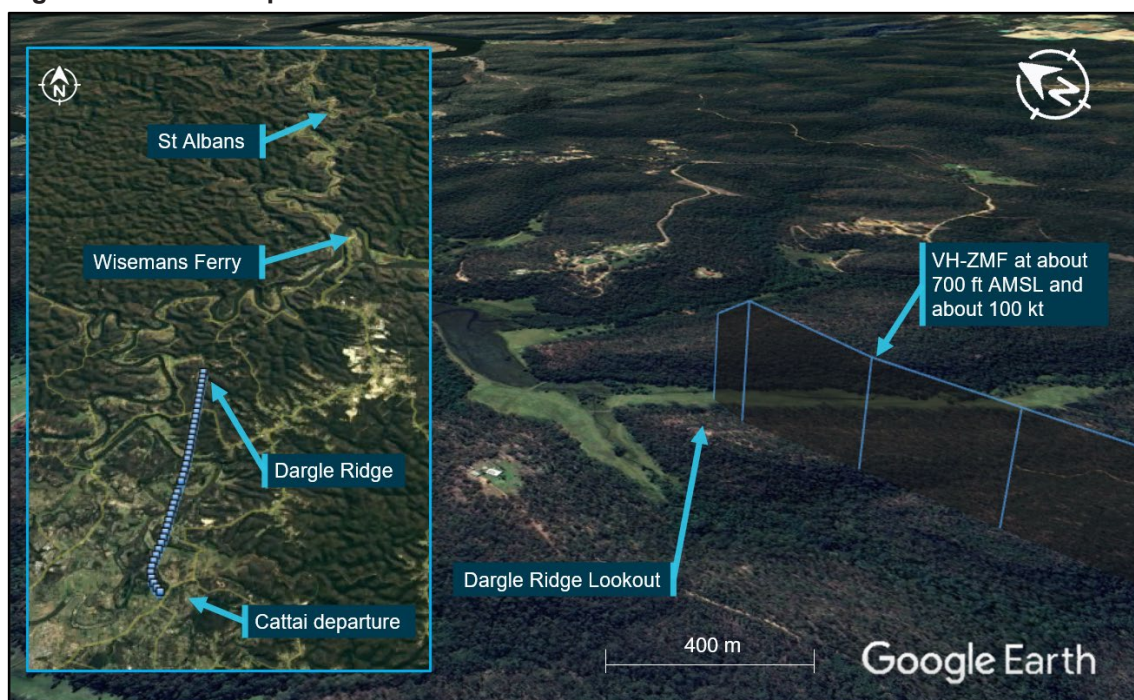
Figure 1: VH-ZMF departure and track

At about 1139 local time on 9 July 2022, a Bell 206L-1 LongRanger, registered VH-ZMF, departed a private helipad at Cattai, New South Wales, for a private flight to a property at St Albans (Figure 1). The pilot was the sole occupant on board.

The pilot obtained an airways clearance from air traffic control and recorded data showed the helicopter tracked to the north towards St Albans, climbing to about 700 ft above mean sea level (AMSL).

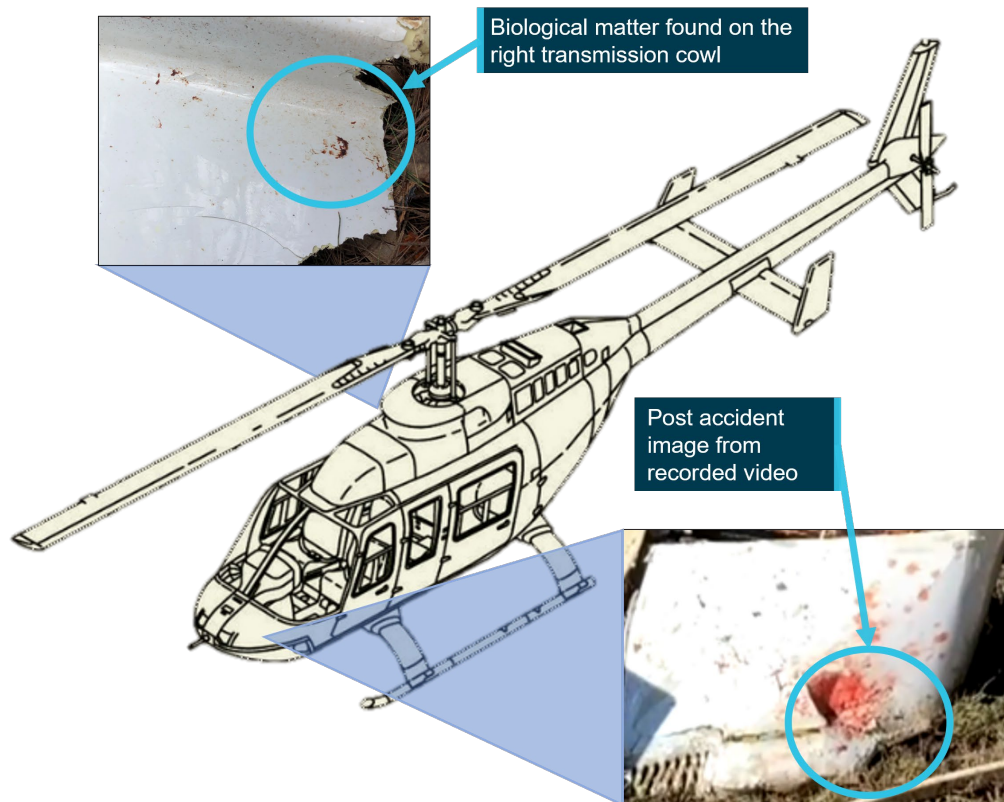
Figure 2: Locations of biological matter

A nearby news helicopter, filming local flooding, was the first to arrive on scene and landed nearby to render assistance. Camera crew continued filming the accident scene before it was consumed by the post-impact fire. Biological matter was observed in that recorded video on the outside of the left nose cowl of the helicopter (Figure 2).

Analysis of biological samples found on external surfaces of the helicopter and nearby the accident site, confirmed the airborne contact with a wedge-tailed eagle (*Aquila audax*). First responder film footage of the cockpit and fuselage impact site, prior to being consumed by fire, indicated a large external impact of biological matter on the front left nose cowl of VH-ZMF, indicating a likely initial impact point of the birdstrike.

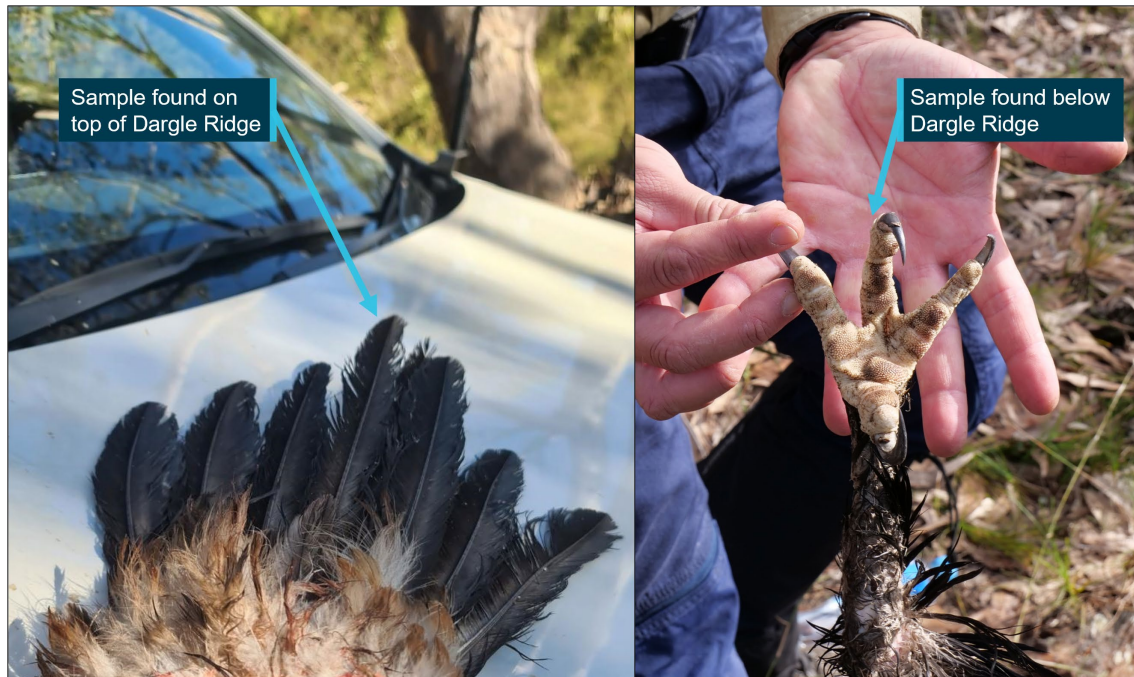
Figure 3: Bird matter found near accident site

The landowner, who arrived at the accident scene on the top of the Dargle Ridge lookout, identified a mass of biological tissue, which appeared to be a tail section of a bird (Figure 3), which was still warm. During the on-site phase of the investigation, further biological samples were recovered below the escarpment.

Recovered biological specimens, including the avian carcass and the biological residue found on external helicopter surfaces, were analysed by the Australian Centre for Wildlife Genomics, Airstrike section of the Australian Museum. The carcass and samples taken from the helicopter's main transmission cowling were identified as *Aquila audax*, commonly known as a wedge-tailed eagle.

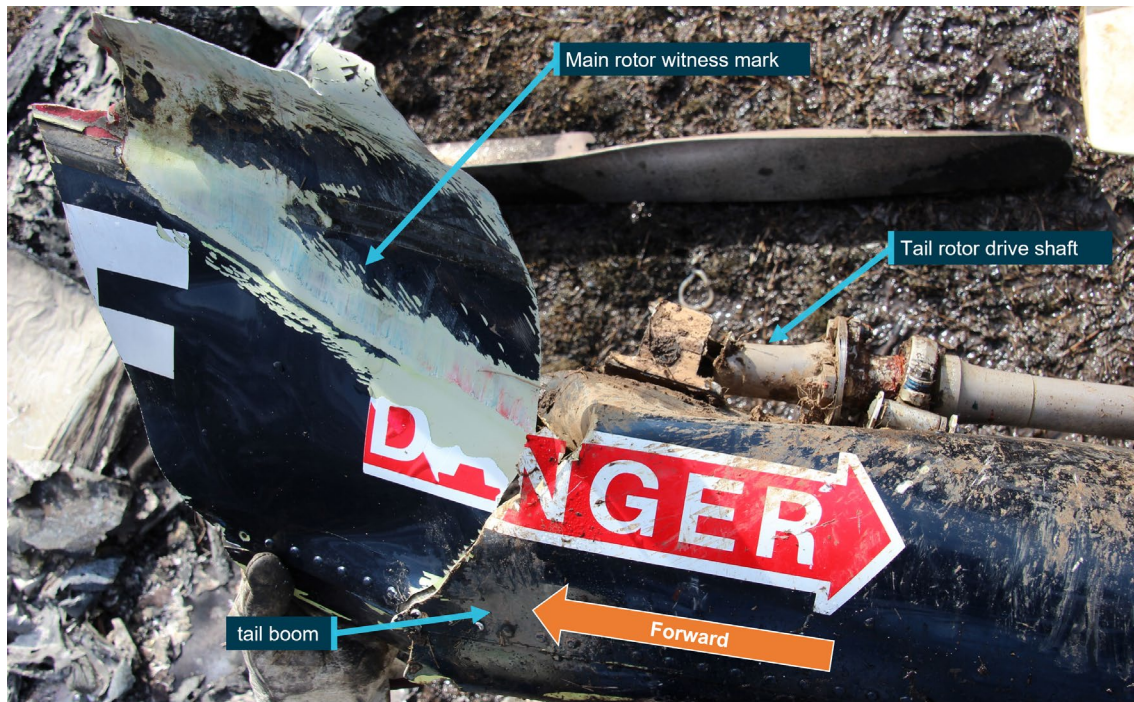
Figure 4: Tail boom impact

The main accident site, including the engine, main cabin, and fuselage, was located in relatively flat and open farmland, between 2 ridgelines (Figure 5). The tail rotor assembly, vertical stabiliser and a section of the tail boom were found about 93 m to the north, with no signs of pre-existing component failure or damage. However, the main tail boom and drive shaft (Figure 4) were both severed at roughly the same fuselage station, consistent with a main rotor blade strike.

Abrupt cyclic inputs and low to negative g rotor loading are a well-documented and accepted limitation of two-bladed teetering rotor head systems commonly used in light to medium helicopters. Analysis of the impact marks on the tail boom of VH-ZMF and the separation of rotor blade tips, indicate that the tail boom was impacted and severed by contact with its own main rotor blades. This led to further break-up of the aircraft in flight, such as the main rotor system and transmission due to severe rotational forces of a compromised and unbalanced main rotor assembly. Numerous witnesses observed and heard the impact of the main rotor blades on the tail boom and described the uncontrolled nature of the in-flight break-up.

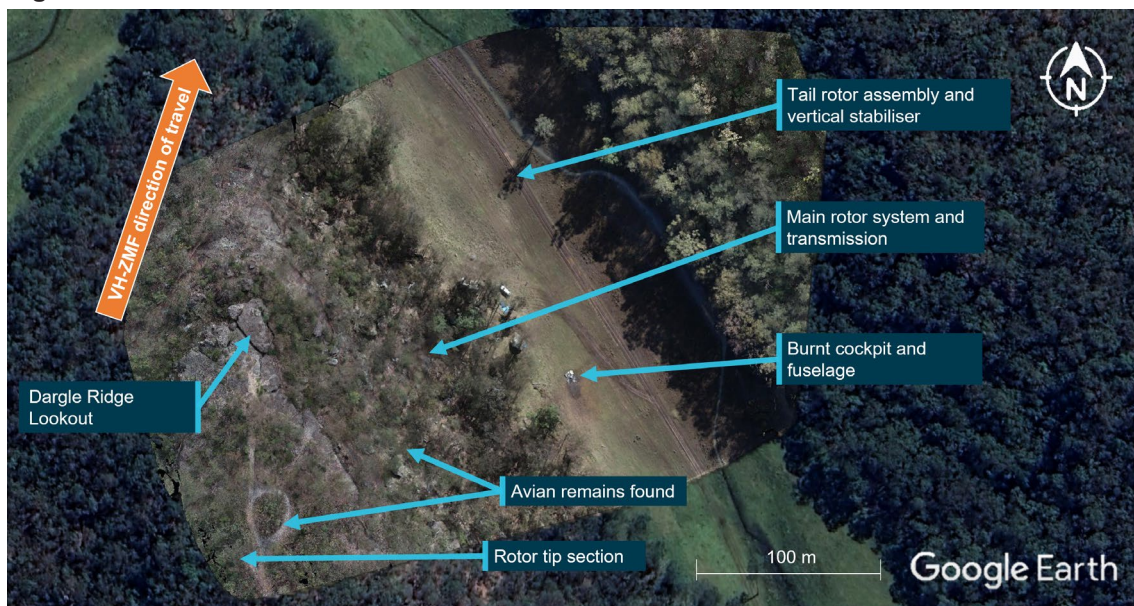
Figure 5: VH-ZMF accident site

The main rotor system, including the transmission cowl, gearbox, and main rotor blades, was located about 68 m to the west in a heavily wooded, sloping escarpment. The teetering main rotor head was still attached to the transmission with multiple severed control rods attached to the transmission mounting structure.

The composite main rotor blades had separated just outboard of the main rotor grips and had impacted heavily with vegetation and delaminated. One of the main rotor blade tips was located about 150 m before the main wreckage on top of the ridgeline.

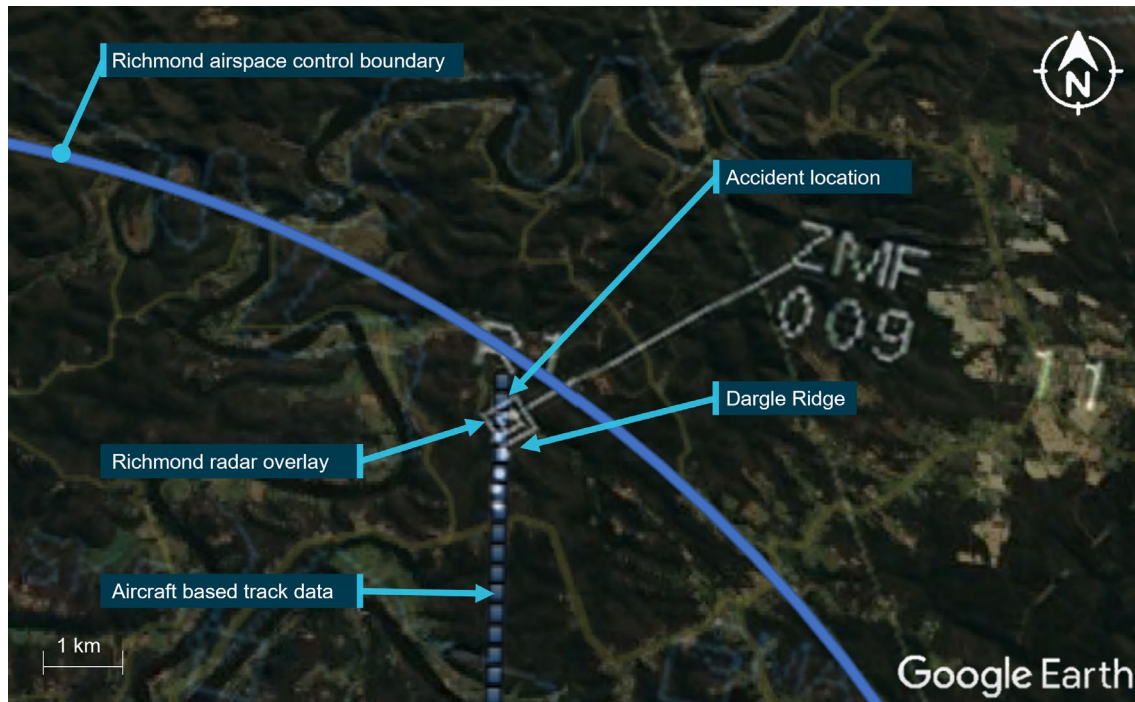
Figure 6: Richmond radar overlay

Data collected from radar and aircraft-based sources indicated that VH-ZMF was travelling in a northerly direction at about 100 kt prior to crossing the Dargle Ridge Lookout. The data then showed a track deviation to the right and an increase in 100 ft of altitude coupled with rapid deceleration and an increased vertical descent rate prior to impact with terrain.

Audio from RAAF Richmond air traffic control recorded that at 1143:37 the air traffic controller advised the pilot of VH-ZMF that they were 2 NM (3.7 km) from the airspace boundary and gave the pilot traffic of another media helicopter in the vicinity of Wisemans Ferry.

At 1143:58, the pilot confirmed that the frequency change. Three seconds later static was heard on the radio which lasted for about 2 seconds with no discernible audio. Recorded radar images show VH-ZMF approaching the control boundary before appearing to slow remarkably and descend at 1144:12 before disappearing from radar at 1144:45.
