Fuel starvation involving Cessna 310R, VH-JQK

Sunshine Coast Airport, Queensland, on 18 August 2022

ATSB Transport Safety Report

AO-2022-040

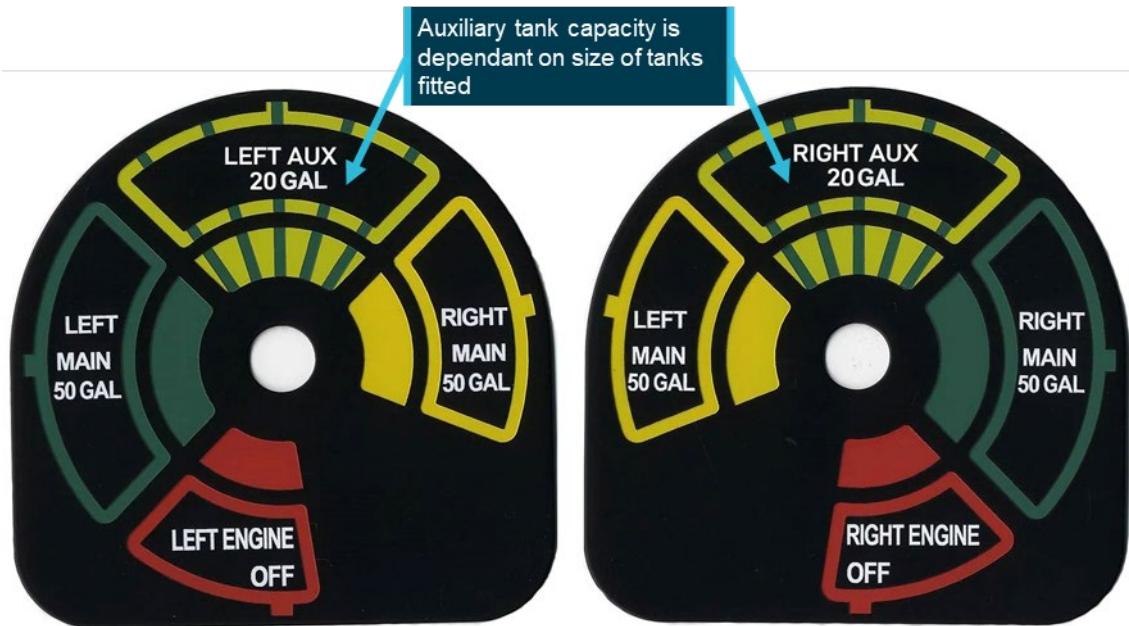
Figure 2: Correct aircraft fuel selector plaques

The fuel selector plaques displayed the amount of fuel available in each of the tanks. Fuel selector plaques under the Cessna 310 type certificate were required to show the fuel amount in US gallons. An exemplar is shown in Figure 2.

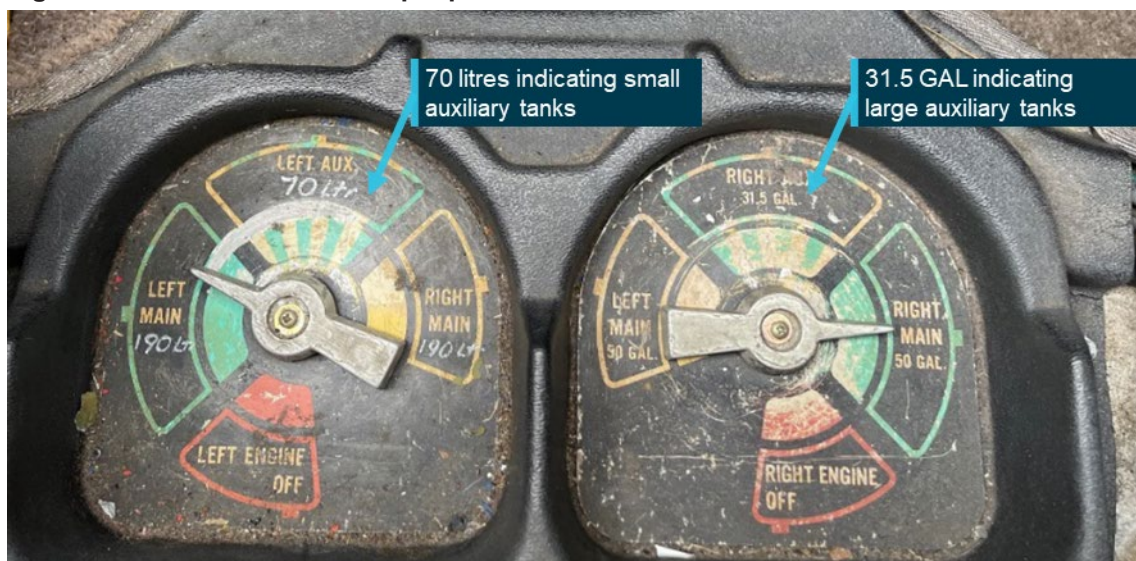
Figure 3: VH-JQK fuel selector plaques

VH-JQK's fuel selector plaques showed fuel quantities in differing units (Figure 3). On the left plaque only, an indication of fuel tank capacity was handwritten in white permanent marker with the quantities in litres. The right plaque had what appeared to be original markings from an aircraft with different auxiliary tank capacity. The left auxiliary tank was indicated as having a capacity of '70 Ltr' (70 L, equivalent to 18.5 gallons), corresponding to the smaller auxiliary tank capacity (as was fitted to VH-JQK). The right plaque gave that side's auxiliary tank capacity as '31.5 GAL' (31.5 gallons, or 119.3 litres), corresponding to the larger auxiliary tank capacity.

The ATSB was not provided the aircraft logbooks or maintenance releases to confirm when the modification of the plaques, both the incorrect right-side plaque and handwritten quantities, took place.

The ATSB determined that the fuel selector plaques did not contribute to the occurrence as both the instructor and student instructor did not recognise the inconsistent markings on the selector. However, inconsistent and incorrect markings have the potential to cause pilots to inadvertently make incorrect fuel calculations.

After an internal investigation, Aircraft Australia implemented a new fuel log specific for the Cessna 310R. They have released an internal memo for the company operations manual outlining the changes to the data sheet for the Cessna 310R to ensure all pilots and student are aware of the fuel configuration of the aircraft. The operator has also requested fuel selector plaques replacement to ensure the correct data labels are installed.

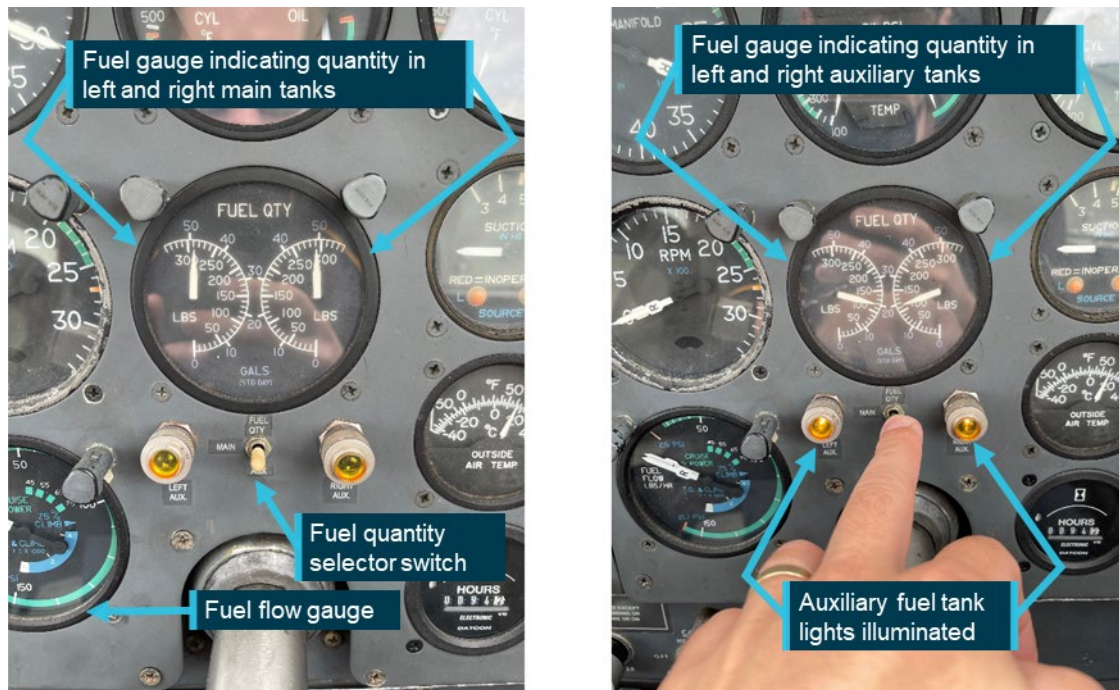
Figure 4: Fuel gauges in VH-JQK

The fuel quantity gauge (Figure 4) was located above the right side control column and normally indicated the fuel quantity (in both gallons and pounds) in the selected tanks. The fuel quantity in the non-selected tanks could be displayed instead through the use of a momentary toggle switch below the gauge. Two yellow lights (one for each side) illuminated when the auxiliary tank on that side was selected.
