# Drive belt tensioning motor failure involving Robinson R44 helicopter, VH-ZUJ

Hamilton Island Airport, Queensland 8 January 2023

Aviation Occurrence Investigation (Short)

AO-2023-005

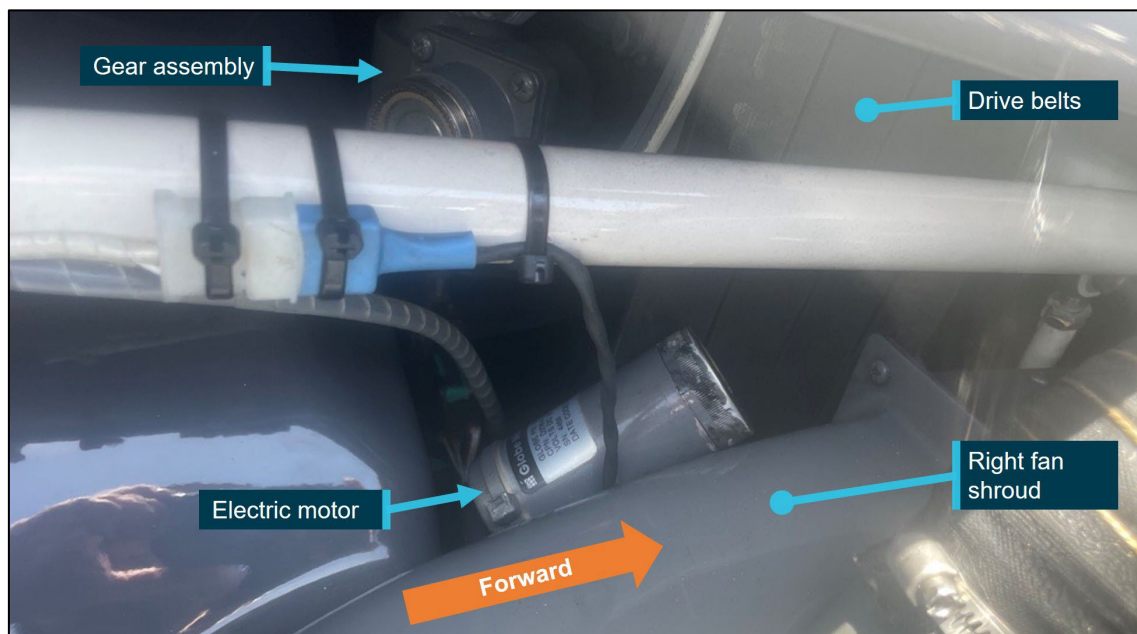
**Figure 1: Electric motor position**

Ground crew visually inspected the drive belt tensioner assembly and found that the clutch actuator electrical drive motor had separated from the gear assembly and was found between the drive belts and fan shroud. The motor was still attached electrically to the aircraft, and the gear assembly was securely attached to the drive belt tensioner assembly. (Figure 1)

It is likely that the electric motor separated from the gear assembly sometime between the pilot engaging the clutch after start, and the continuous illumination of the clutch caution light immediately prior to landing. The clutch system attempted to re-tension the belts and as the motor had separated from the gear assembly, the motor ran continuously, illuminating the clutch caution light.

On noticing the clutch caution light and waiting the requisite 10 seconds, the pilot carried out the clutch caution light emergency procedure and was able to land immediately. Had the landing been delayed in this incident it is possible that the position of the electric motor, between the drive belts and right fan shroud, could have caused damage to the drive belts and created a hazard to the safety of flight.

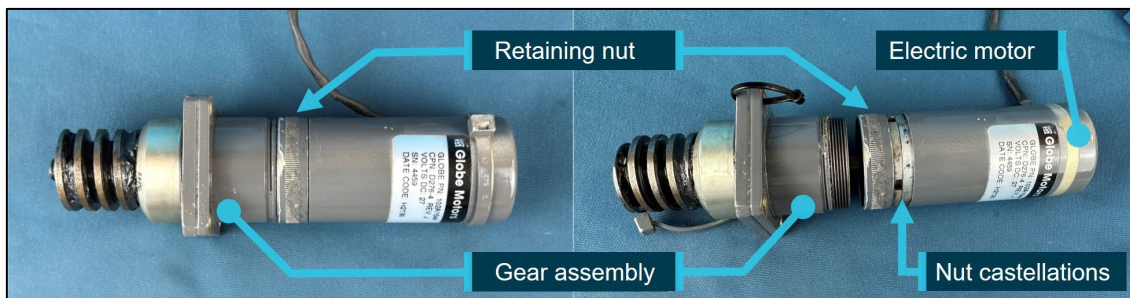
**Figure 3: Gearmotor assembly**

The clutch actuator electrical motor and gear assembly, collectively known as the gearmotor assembly, are factory assembled. The assembly is not field serviceable or repairable, requiring return to the manufacturer if unserviceable. The motor is attached to the drive gear by a threaded, free-rotating, captive retaining nut. The retaining nut is secured with a commercially available thread locking adhesive and torqued with a c-spanner using castellations built into the nut. The electric motor case is then partially slid over the retaining nut, covering the castellations. (Figure 3) The design does not include a mechanical locking device, and no visual indication of loosening creep is embodied.

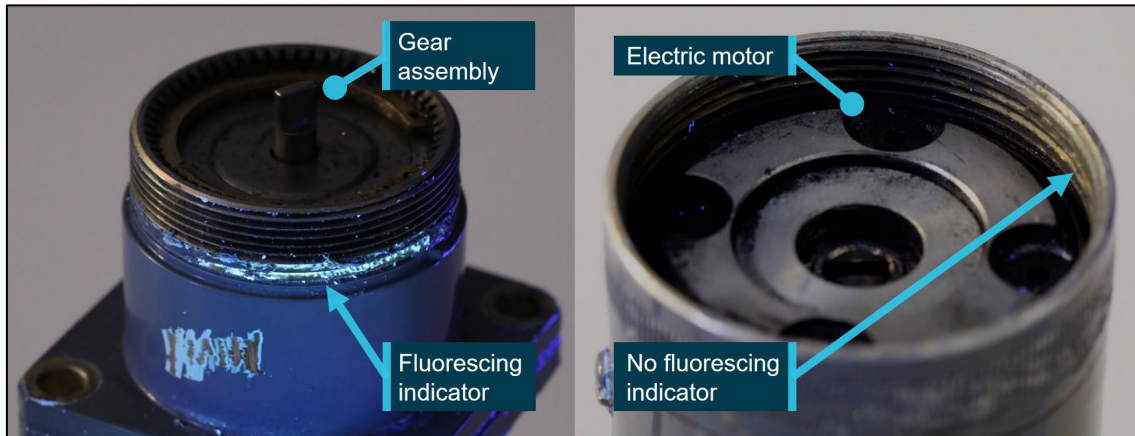
**Figure 4: Gearmotor UV light inspection**

The incident gearmotor assembly was retained and inspected by the ATSB. The inspection noted the following (Figure 4):

- No unusual damage to the threads of the electric motor or gear assembly was evident.
- A black residue was found in the root of the gear assembly threads. This residue was not chemically identified due to an insufficient amount available for analysis.
- The thread locking compound specified was designed to fluoresce in ultraviolet light to enable inspection of the fastener. The ATSB assembled a test piece with the locking compound and when disassembled the compound was evident when examined under ultraviolet light.
- No evidence of thread adhesive was found on the engaging threads of either part of the incident gearmotor assembly under ultraviolet, or visible light conditions.
- Fluorescent residue was found on a threaded section of the gear assembly, outside of the engaging threads section.

The gearmotor assembly process incorporated the application of a thread adhesive designed to act as a secondary locking device to prevent the inadvertent loosening of the electric motor due to normal helicopter vibrations in flight. ATSB inspection of the threaded sections of the incident gearmotor under ultraviolet light showed that the thread adhesive was not visible in an area that would reliably ensure the security of the motor. This resulted in loosening of the motor due to normal operating vibrations. The reason for the absence of thread locking adhesive on the mating surfaces of the threads could not be determined.

The absence of thread adhesive during assembly, and its associated lubricating effect, probably reduced the intended design clamping force between the gear assembly and electric motor. It is important to note that the residue found in the gear assembly threads was not chemically identified so the impact it had on adhesion or lubrication, could not be assessed. The extent to which these factors influenced the failure of the gearmotor assembly was not determined, but it is possible that a reduced assembly clamping load contributed to the failure.

Robinson Helicopter Company advised that they are actively working with the component manufacturer to rectify identified quality issues with the gearmotor assembly and are considering updating the procedures for the inspection of the clutch actuator assembly.
