Birdstrike and collision with terrain involving Air Tractor AT-502B, VH-KDR

32 km east-north-east of Chinchilla Airport, Queensland, on 19 September 2022

ATSB Transport Safety Report

AO-2022-043

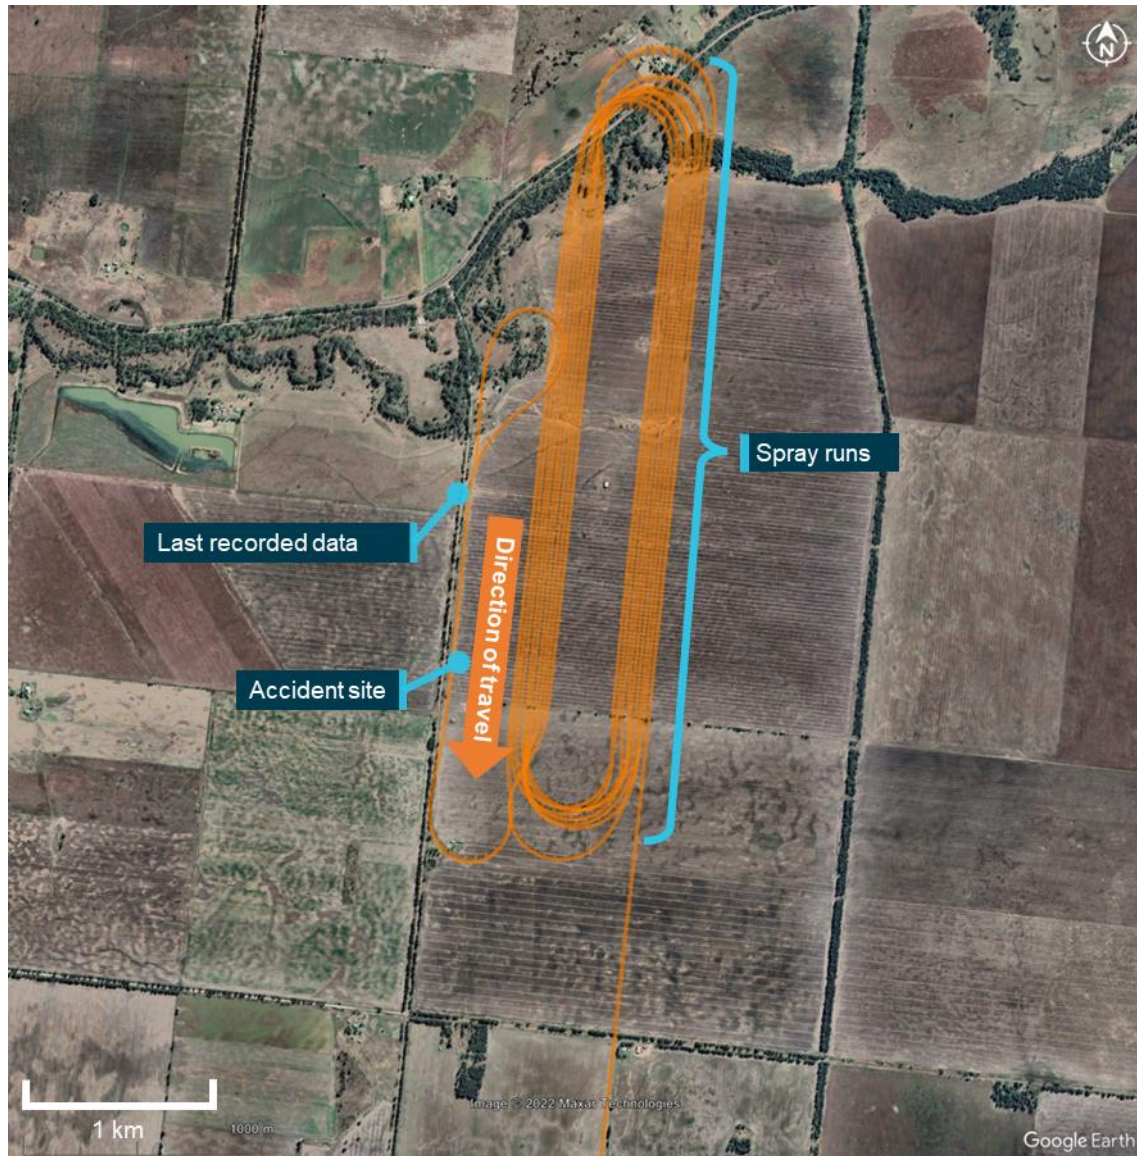
Figure 2: Accident site and spray runs (orange)

At the conclusion of run 17, the aircraft was turned onto a northerly heading, flown parallel to the fence line, before being turned onto a reciprocal heading to spray this area (Figure 2). The final

GPS data point recorded by the Satloc system was at 11:25:41, 3 seconds after the pilot had commenced the southerly fence line spray run.

The SatLoc data's final recorded point was about 800 m north of the wreckage, and 500 m from the location of the severed bird wings (Figure 2). Based on the aircraft's previously recorded ground speed and direction of travel, there were about 5 seconds between the birdstrike occurring and the impact with the ground. The ground speed of the aircraft was about 116 kt (200 km/h),

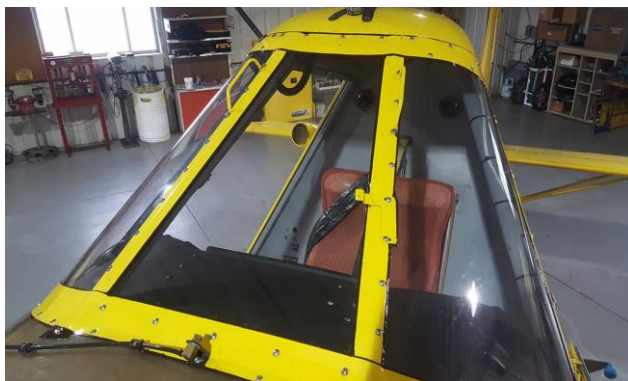
Figure 3: Air Tractor AT-502B windshield

The Air Tractor 502B windshield is constructed of 3 pieces being either glass or Perspex (Figure 3). The centre windshield is manufactured from glass. The thickness of the glass on VH-KDR was 1/4-inch, which was the standard thickness when the aircraft was manufactured. The 2 side pieces were manufactured from Perspex.

The ATSB contacted Air Tractor regarding the availability of thicker side windshields and they advised that there had been no consideration for using thicker material. The manufacturer stated that the windshield design on the Air Tractor is standard for the agricultural aviation industry, and in previously reported birdstrikes where the bird had entered the aircraft through either side windscreen, the bird missed the pilot and hit the back wall. Further, they described difficulties in replacing the Perspex windshield with glass due to the curvature of the design, which would increase the likelihood of glare and would add weight.

In 2009, Air Tractor issued a service letter advising that thicker centre windshields were being installed in current production aircraft. The thicker windshields were 3/8-inch thick glass compared to the original 1/4-inch. The letter also advised that the thicker windshields could be installed in existing aircraft, though not mandatory. This letter was issued after operators had reported on

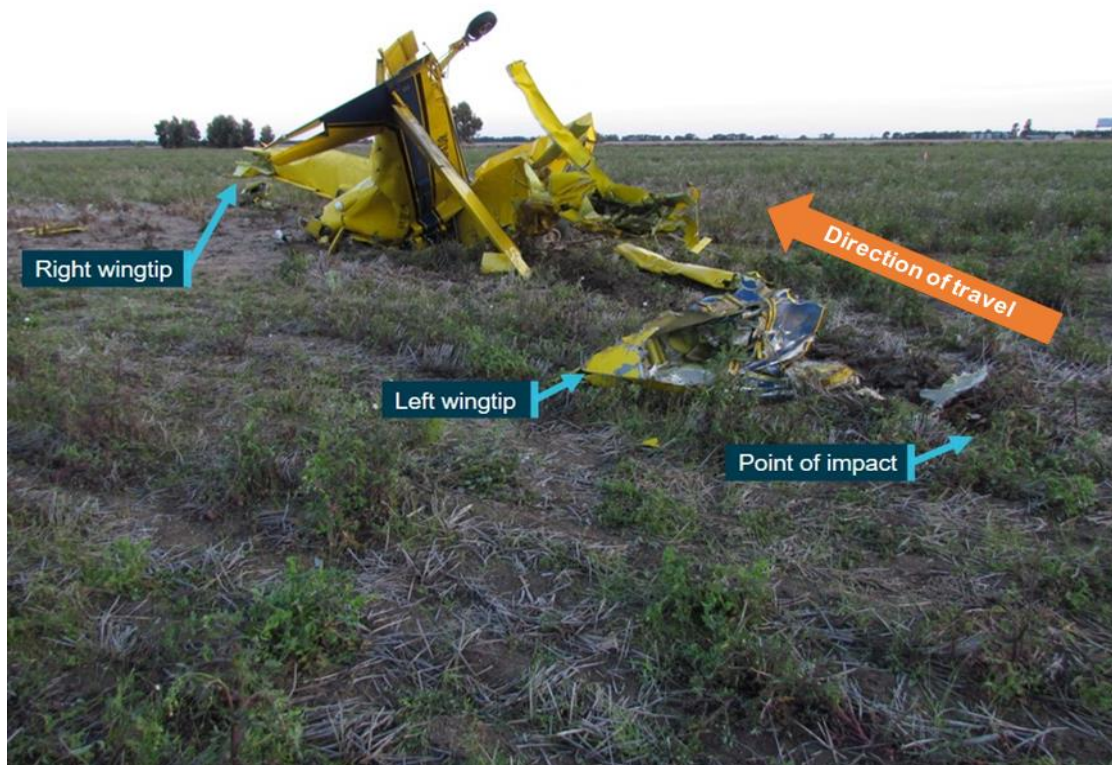
Figure 4: Aircraft wreckage at the accident site

The ATSB's on-site examination found that the aircraft had impacted the ground, adjacent to the fence line. The aircraft's orientation was consistent with the direction of travel. The left wing had initially impacted the ground, followed by the fuselage, in a near vertical attitude. The propeller and engine were buried in the soft earth, with the spread of wreckage contained to a small area. Ground scars and damage to the left wing indicated that the wing struck the ground at about 30° to the horizontal (Figure 4). The length of the ground scar from the point of impact to the fuselage was about 12.6 m.

Examination of the wreckage identified that:

- Inspection of the propeller and engine indicated the engine was delivering power at the time of the impact.
- Fuel and chemical product residues were also found at the accident site.
- There was no post-impact fire.
- Due to the extent of damage to the cockpit in the accident sequence, it was not possible to determine the position of the engine controls prior to the impact. However, where possible, control continuity was established.

- It was very likely the aircraft was trimmed 'nose-up',³ which was reported by the operator to be the configuration⁴ typically used when conducting low-level aerial spraying.
- There were no pre-existing technical failures with the aircraft that would have contributed to the accident.

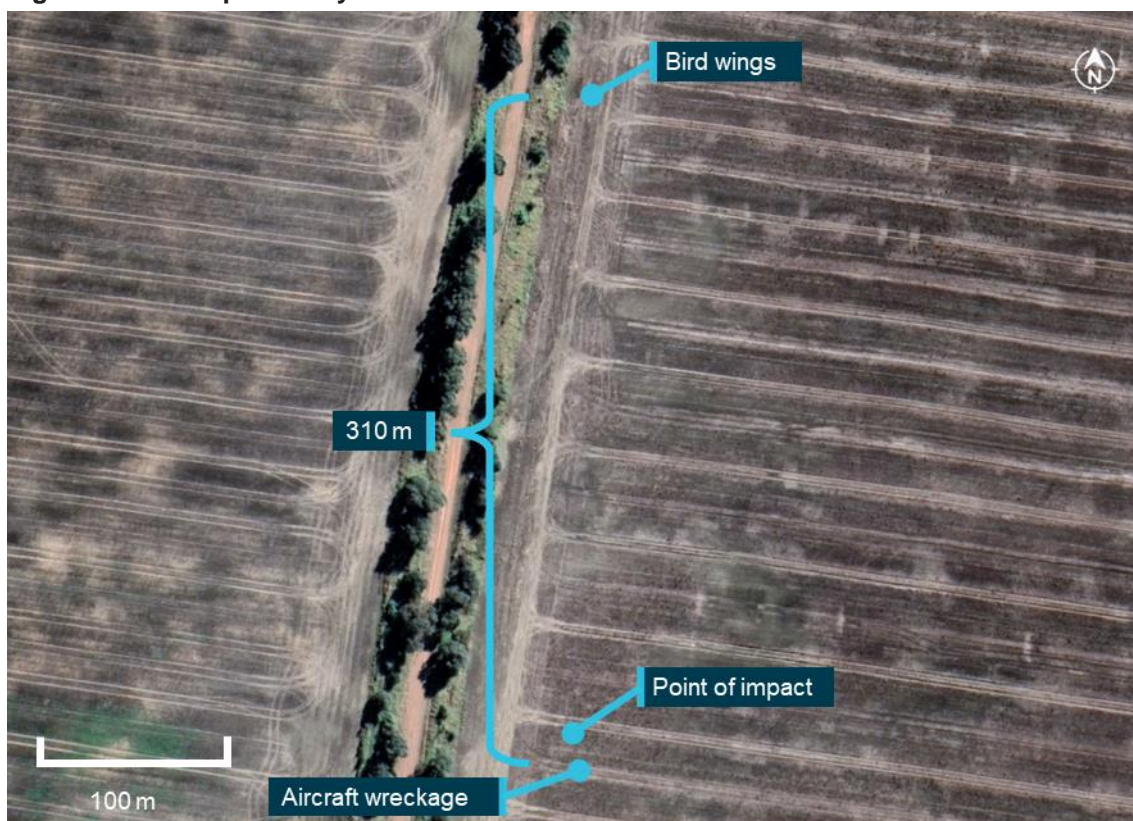
Figure 5: Site map with key locations

A large bird carcass was found in the cockpit and severed bird wings were located about 310 m north of the wreckage, in-line with the aircraft's track along the fence line, which indicated the approximate location of the initial birdstrike (Figure 5). Bird feathers were found along flight path in between location of wings and aircraft wreckage. Biological residue from the bird was found outside the right cockpit window and among the pieces of Perspex from that window. Further biological residue was found on the left side of the cockpit behind the pilot's seat, indicating the bird passed through the right cockpit window in an upward trajectory towards the left side. There was no evidence of the bird striking any other part of the aircraft.

Given the expected track and speed of the aircraft, and the location of the bird wings to the wreckage, the aircraft sustained flight for about 5 seconds following the birdstrike. As the aircraft was operating around 8 ft above ground level, and the wingspan (total of 15.8 m) was longer than this height, it was likely the aircraft entered a short climb to result in a near vertical attitude at impact, indicative of a loss of control. There was also significant damage to the pilot's helmet as well as a small amount of bird biological residue found in the visor. However, in that time, the ATSB could not determine exactly what occurred as a result of the bird entering the aircraft as no flight data was recorded nor was the extent of the pilot's injuries from the birdstrike known. That is, whether the pilot sustained a level of incapacitation due to a direct strike from the bird, or whether they experienced a level of startle or distraction following the event.
