# Derailment of freight train 4BM4

Nana Glen, New South Wales, on 25 February 2021

**ATSB Transport Safety Report**  
Rail Occurrence Investigation (Systemic)  
RO-2021-004  
Final – 6 June 2023

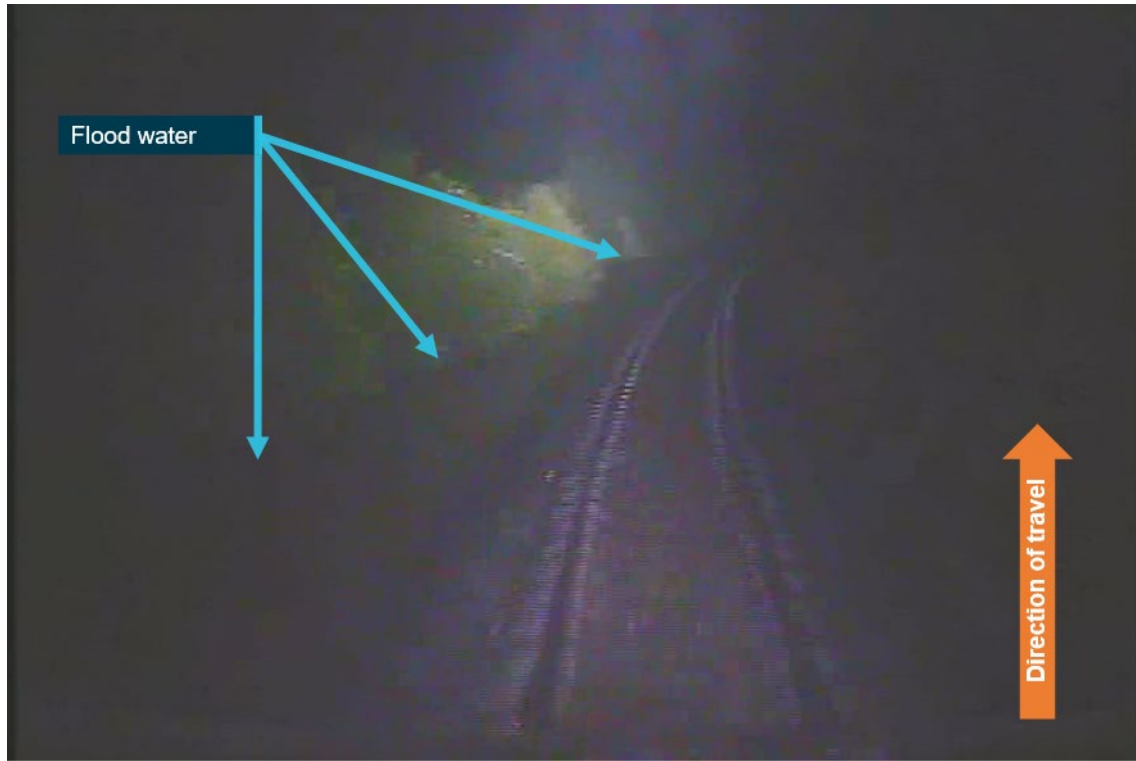
**Figure 3: Floodwater on approach to Nana Glen**

*The front of train footage showed an accumulation of water in the cess and on the formation primarily on the left-hand side about 130 m prior to the washaway.*

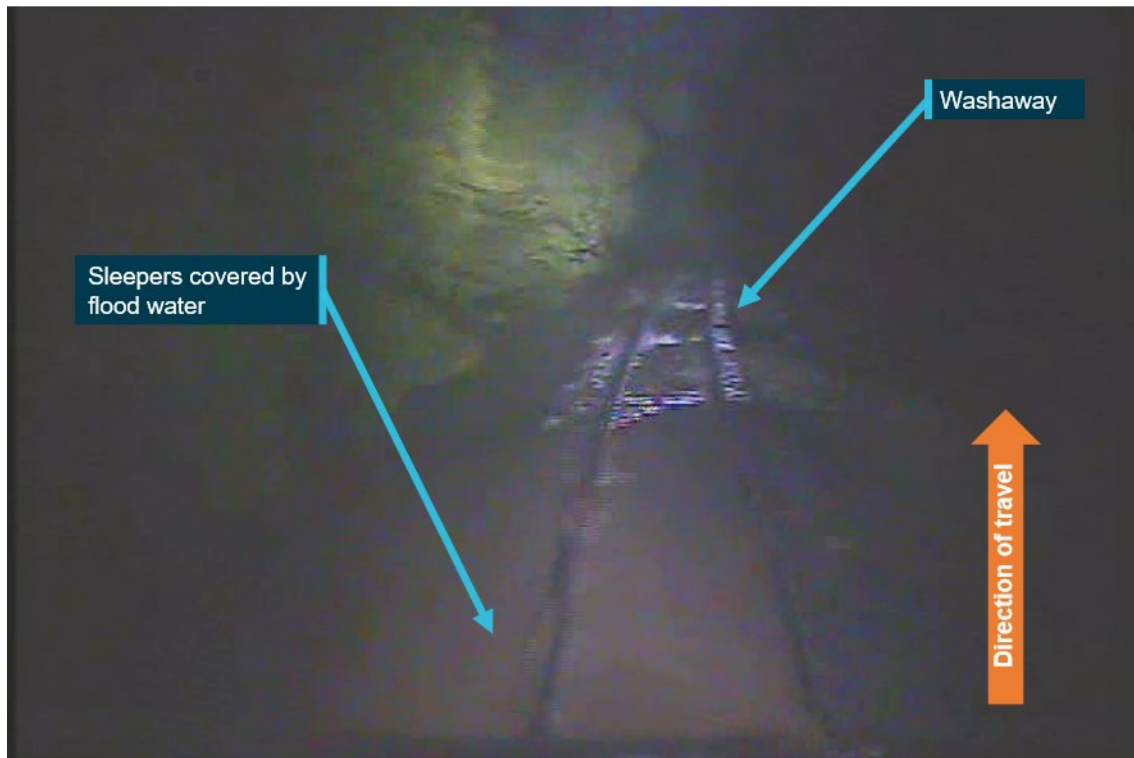
**Figure 4: Approaching the washaway**

*The image shows the front of train footage with the section of track immediately ahead of the locomotive.*  
Source: Pacific National, annotated by OTSI

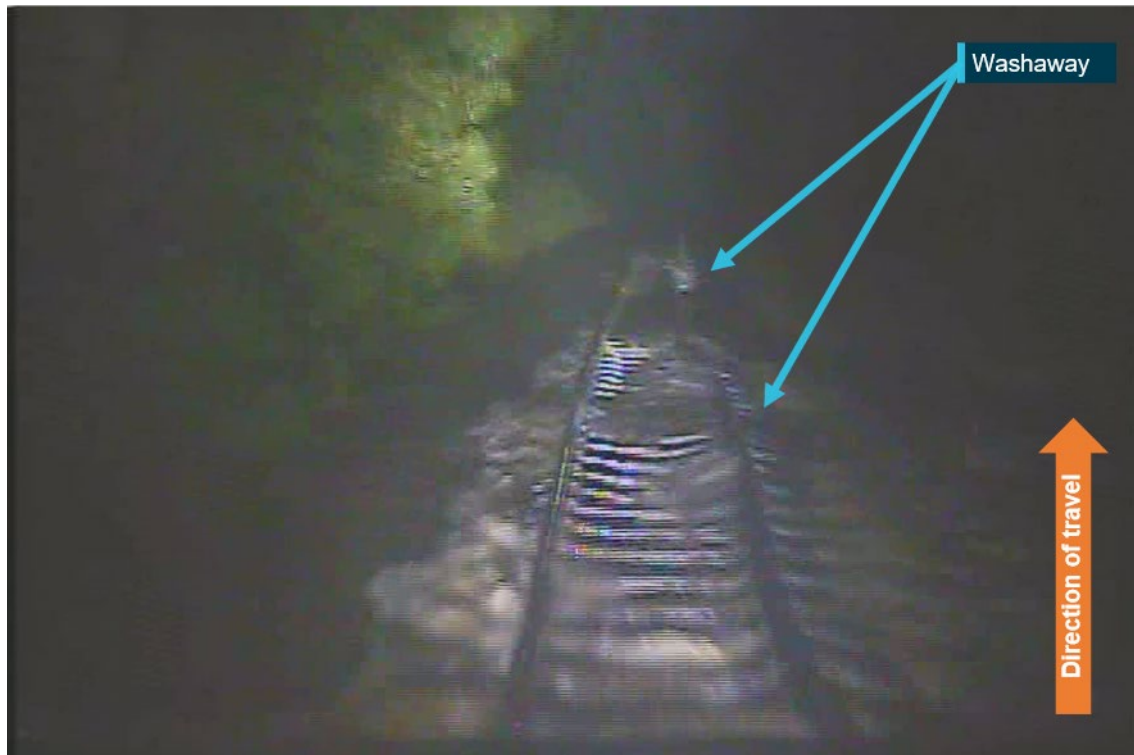
**Figure 5: Washaway**

*The image shows two sections washed away just prior to the train passing over. The floodwater was flowing from left to right.*  
Source: Pacific National, annotated by OTSI

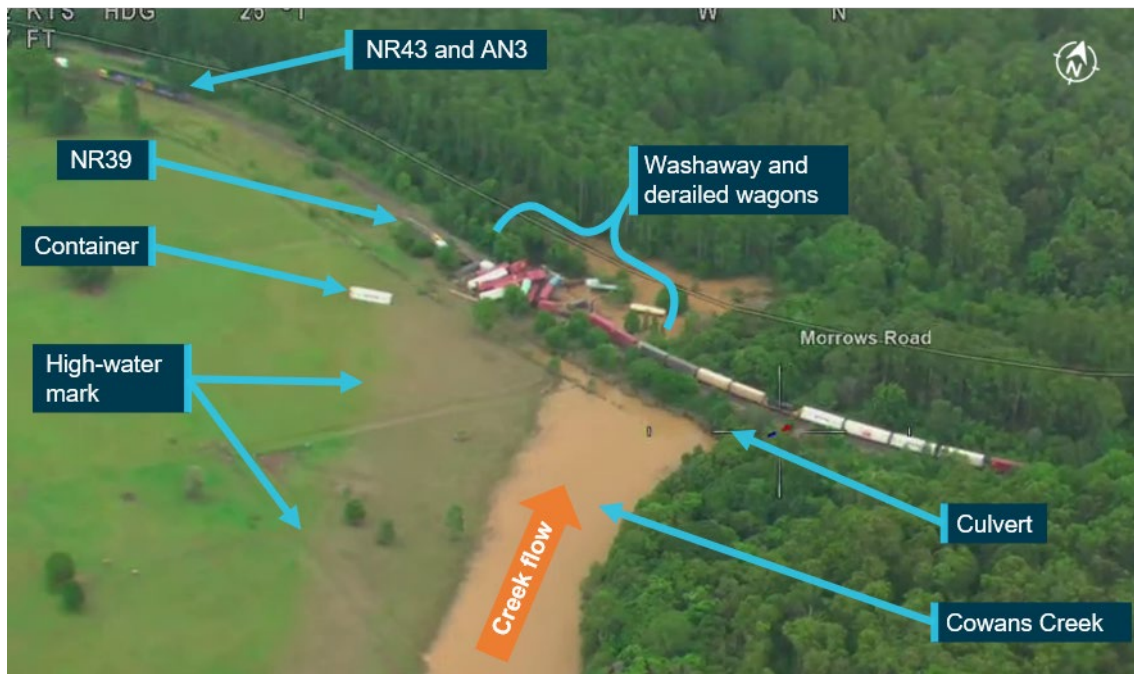
**Figure 6: Derailment site**

The first locomotive derailed the first and sixth axles and the second locomotive did not derail. Both locomotives remained upright and came to a stand approximately 360 m from the point of derailment (Figure 6). The train separated between the second and third locomotive with the third locomotive (NR39) coming to rest on its left-hand side in the direction of travel (Figure 7). The first 10 wagons in the consist derailed and concertinaed to the left and right of the rail line as the train came to a stand. A number of wagons entered the floodwaters on the Orara River (northern side) and one container came to a rest in the field on the southern side near the high-water mark (Figure 6).

The image was captured by a helicopter at 1528 on 25 February almost 14 hours after the derailment. At 1530 the river height at Glenreagh (6.48 km north west of the derailment site) was recorded at 10.02 m with water from the Orara River visible on the northern side of the derailment site. The location of the washaway and resting place of the locomotives and wagons are shown. Cowans Creek ran towards the Orara River and drained through a culvert at 643.849 km. The grass was stained with a high-water mark visible where the water had receded.

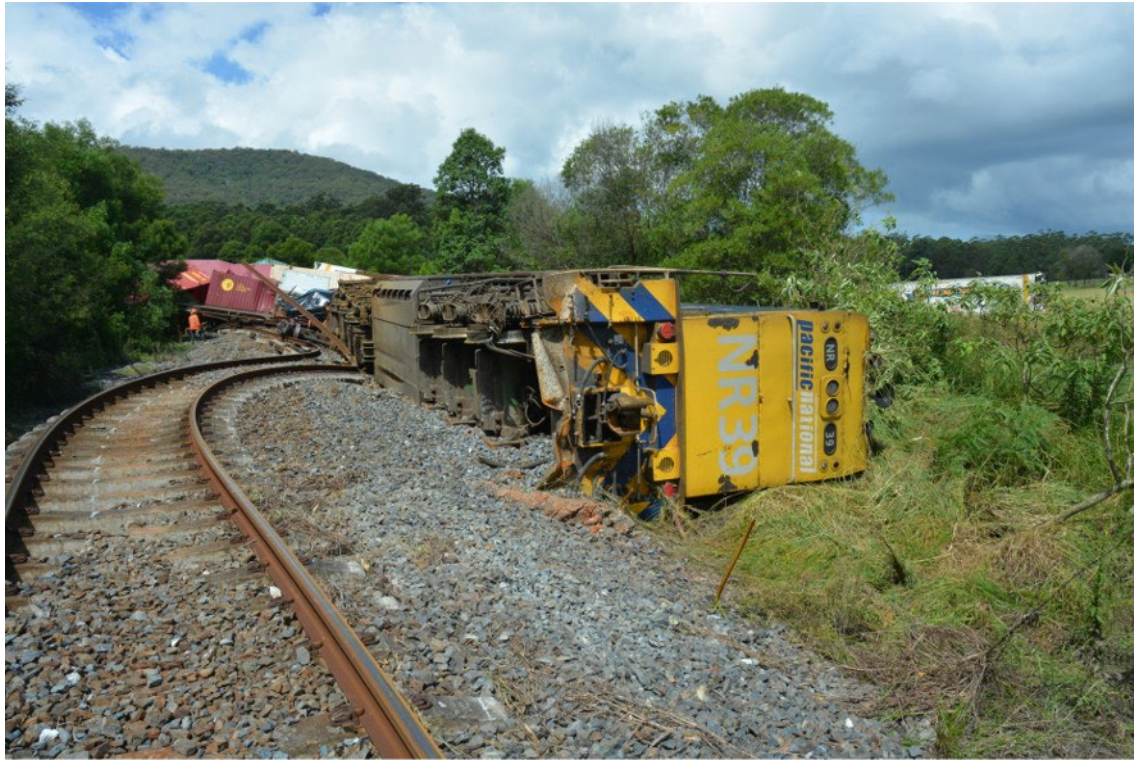
**Figure 7: Third locomotive NR39 derailed**

*NR39 shown laying on the side with wagons derailed behind. The topography of the area can be seen to rise behind the derailment site.*  
Source: OTSI

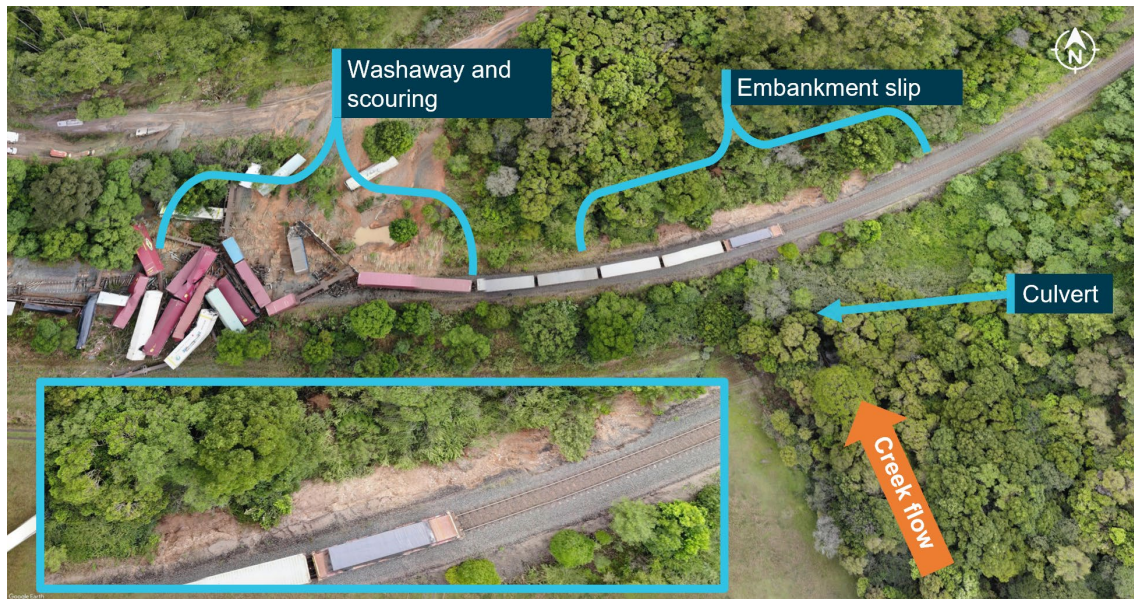
**Figure 8: Post derailment site**

There was damage to the track and embankment at the area of the washaway and derailment. There was scouring<sup>5</sup> on the downstream side of the embankment at the washaway due to the flow of water, with scouring to the toe of the embankment. A land slip had also affected a section of the embankment on the northern side between 643.820 and 643.900 km (Figure 8). The slip came within about 1 m of the end of the sleepers.

*The image shows the extent of the damage and scouring at the washaway as well as scouring to the embankment between 643.820 and 643.900 km. The inset image shows the proximity of the slip to the rail line and sleepers.*  
Source: Fire and Rescue NSW and Google Earth, modified and annotated by OTSI

The rail line was closed following the incident until the flood waters receded, rolling stock was removed and repairs could be completed. Approximately 140 m of track required repairs to the formation<sup>6</sup> and replacement of rail, sleepers, and ballast. Additionally, about 180 sleepers beyond the washaway also required replacement. The slip along the embankment and near the culvert outlet was repaired using geofabric and rock fill to stabilise the embankment. The rail line reopened with a temporary speed restriction at 2036 on 6 March 2021.

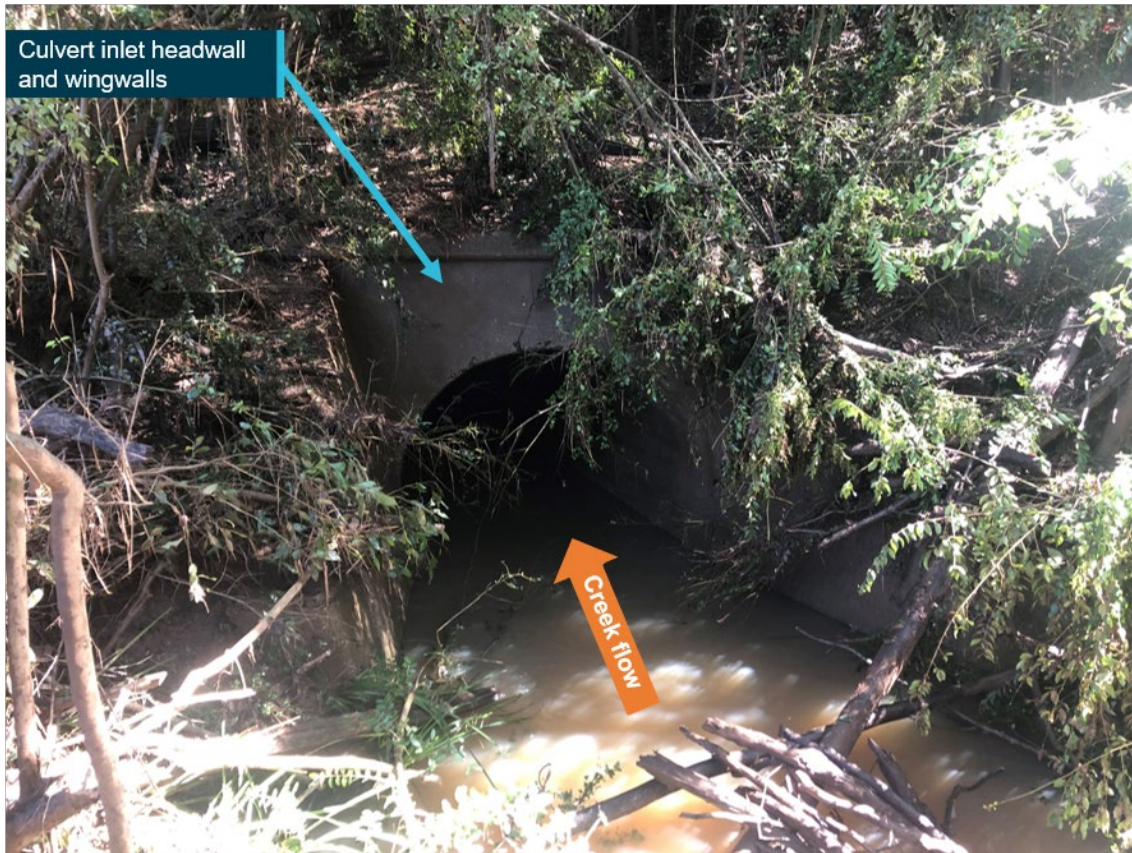
**Figure 18: Culvert inlet**

Photographs taken on 28 February and 1 March 2021 showed that some debris had collected around the inlet and some small branches were near the inlet. These photographs showed that the culvert about the water line was not blocked. Some of the debris would likely have moved as the water levels receded.

The inlet of the culvert at 643.849 km is shown with the headwall and wingwalls. Debris was present near the inlet with some small branches laying across the channel as well as collected above the culvert.  
Source: ARTC, modified and annotated by OTSI

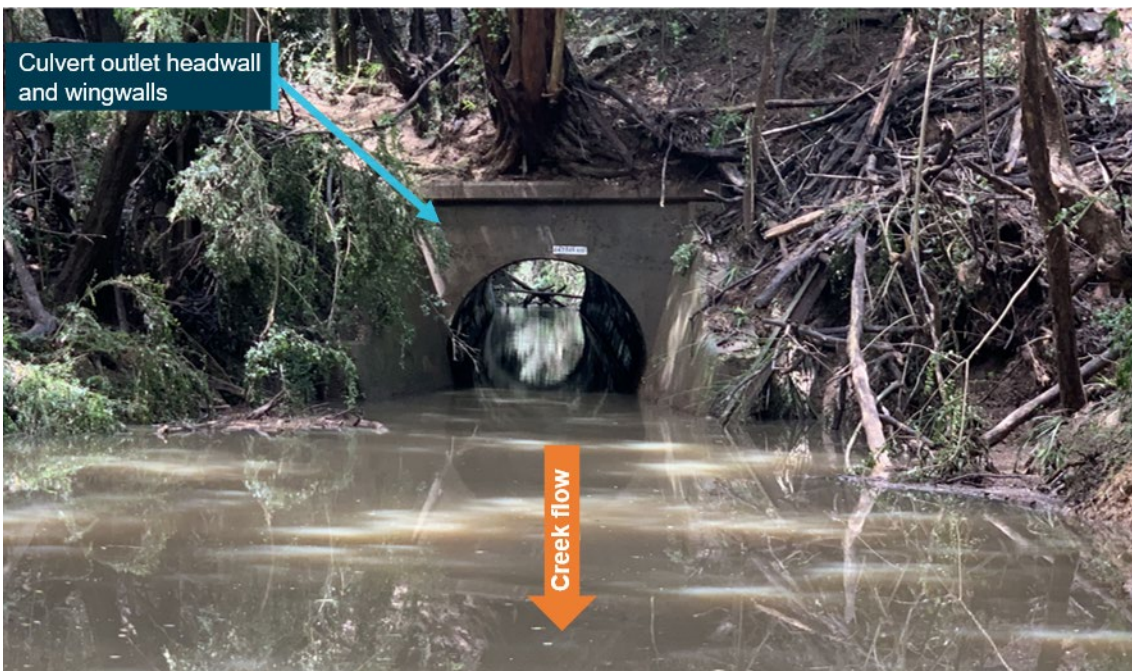
**Figure 19: Culvert outlet**

The outlet of the culvert at 643.849 km is shown with the headwall and wingwalls. The culvert was visibly clear above the waterline and the branches visible at the inlet could be seen.  
Source: ARTC, modified and annotated by OTSI

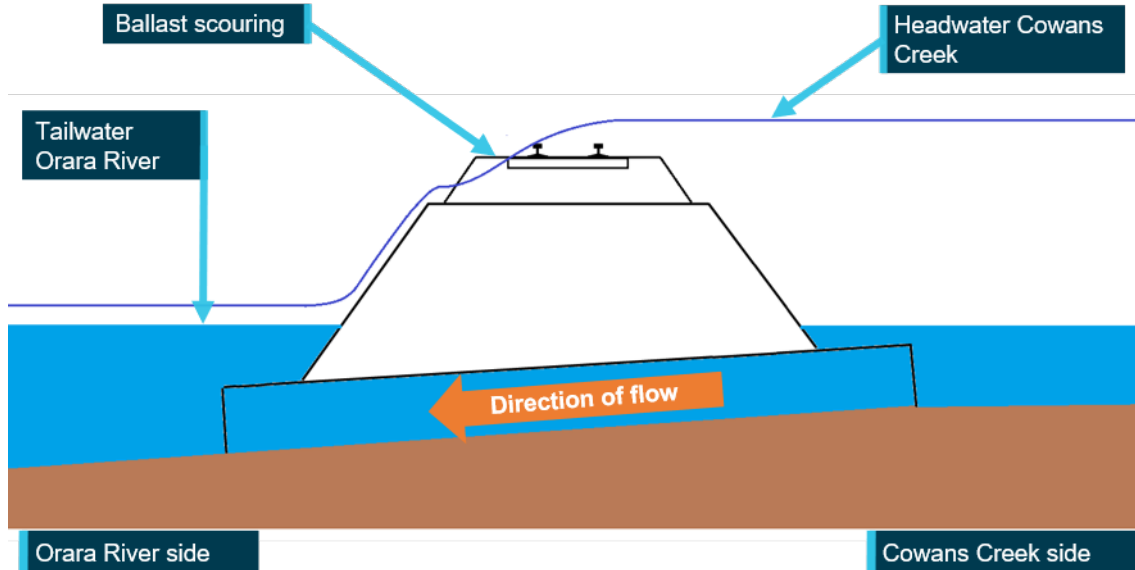
**Figure 23: Overtopping and washaway**

scouring of the ballast and embankment continued for some time after the derailment until the headwater level receded below the top of the embankment.

The diagram (not to scale) depicts the overtopping of the embankment and process of ballast scouring. Initially the ballast on the downstream side would have washed away before all ballast was displaced. The headwater from Cowans Creek is depicted as a blue line while the possible tailwater and floodwater level from the Orara River is shown as solid blue.

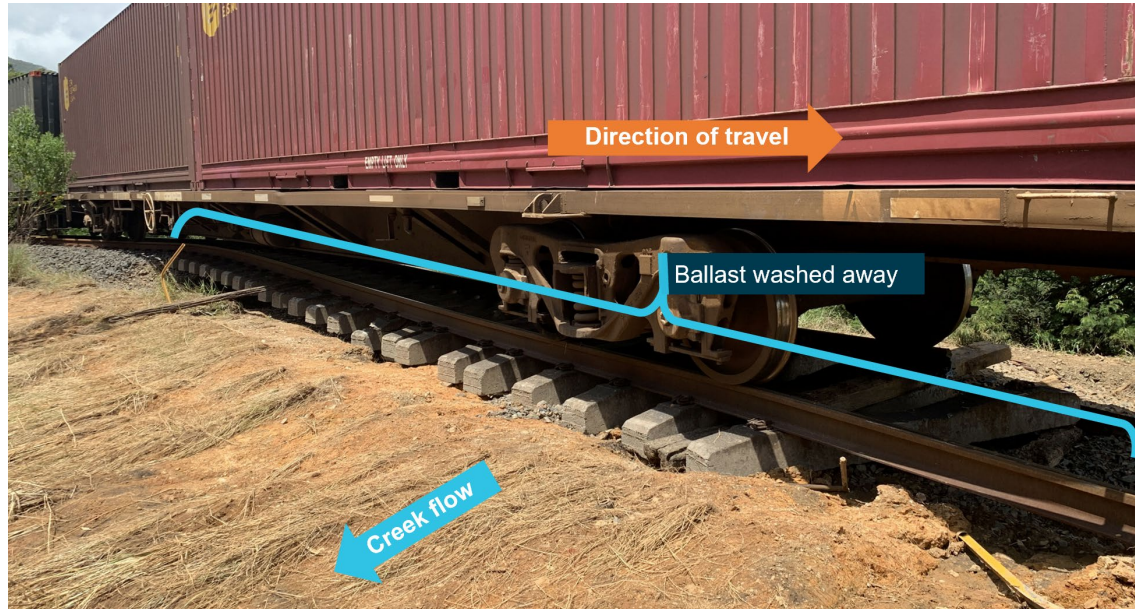
**Figure 24: Ballast washed away**

The image shows an area of the embankment where the ballast had washed away with the sleepers resting on the subgrade material. The vegetation can be seen to be lying flat due to the flow of water over the embankment.
