Collision with terrain involving Piper PA-28-180, VH-PXR

26 km west of Lakeside Airpark, Queensland, on 2 April 2023

ATSB Transport Safety Report

AO-2023-013

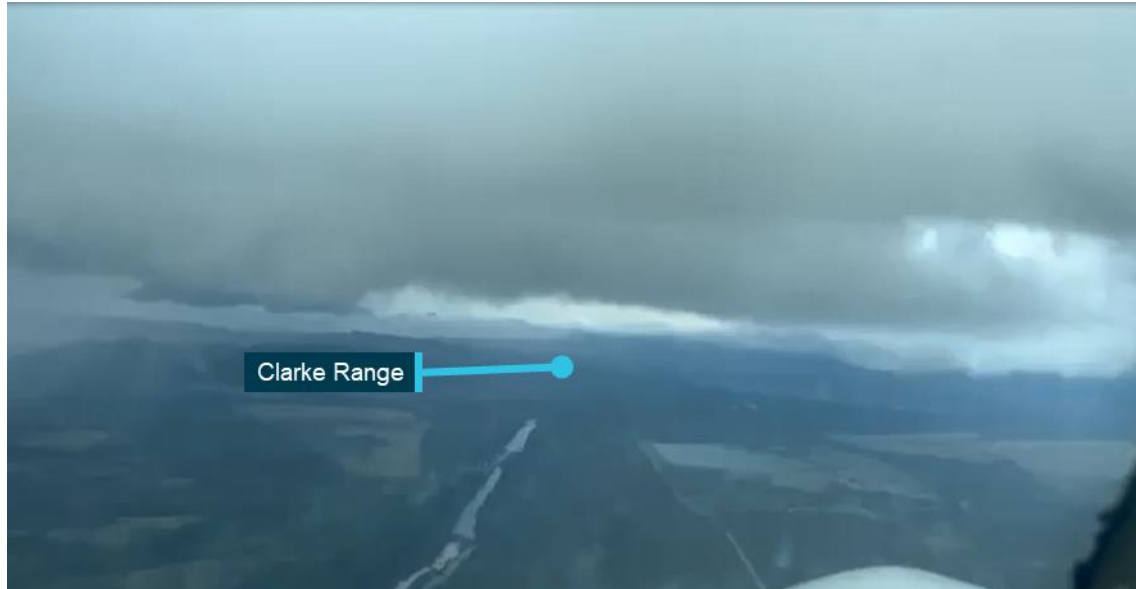
Figure 3: Image taken in-flight of the weather conditions ahead

The conditions over these ranges and toward the coast included significant low cloud, rain, and thunderstorms. All these phenomena led to reduced visibility. Immediately prior to the accident, the weather radar recorded rain in the area.

Images and video taken during the flight showed broken cloud ahead, with the base below the altitude of the aircraft. The ranges where the accident site occurred were obscured by low cloud, with rain visible (Figure 3).

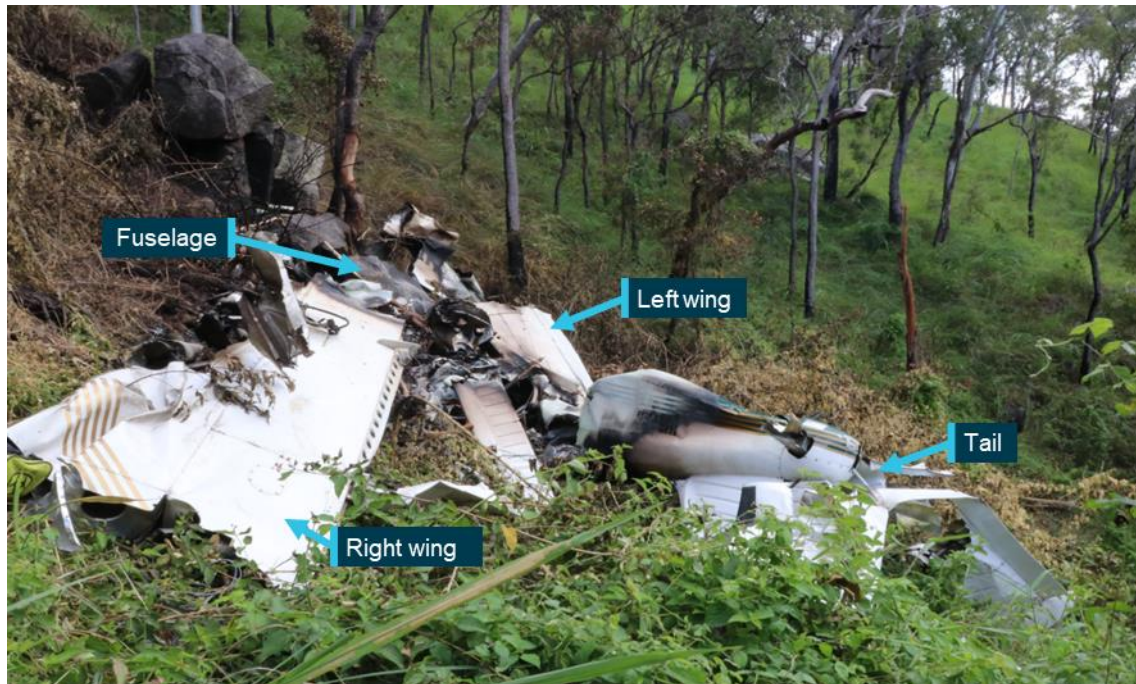
Figure 4: Aircraft wreckage

Due to the terrain, the ATSB did not attend the accident site. However, photographs and videos were obtained from Queensland Police and the Australian Maritime Safety Authority Joint Research Co-ordination Centre, and examined by the ATSB (Figure 4). Observations of the accident site included:

- About 80 m prior to the wreckage, a number of trees sustained damage. This damage was shown to have an increasing angle down towards the wreckage.
- The aircraft collided with terrain on a steep slope, and the wreckage was observed to be inverted. It was unknown if the aircraft collided with terrain inverted or became inverted during the accident sequence.
- There was minimal spread of the wreckage, and the wings, fuselage, and tail were in their expected positions relative to the structure of the aircraft.
- The leading edge of the right wing sustained damage consistent with a tree strike.
- The forward fuselage was destroyed by fire.
- The propeller was found intact, and showed impact marks and bending consistent with the engine producing power at the time of impact.

Consideration of these factors suggested that an in-flight break-up, engine failure or fuel exhaustion were unlikely to be contributory to the accident. The relatively contained wreckage was representative of a low speed, high angle of attack impact with the ground.
