Main rotor blade cracking involving Airbus Helicopters Deutschland, BO105 CBS-5, registration VH-NVH

Near Archerfield Aerodrome, QLD on 18 August 2021

ATSB Transport Safety Report

AO-2021-035

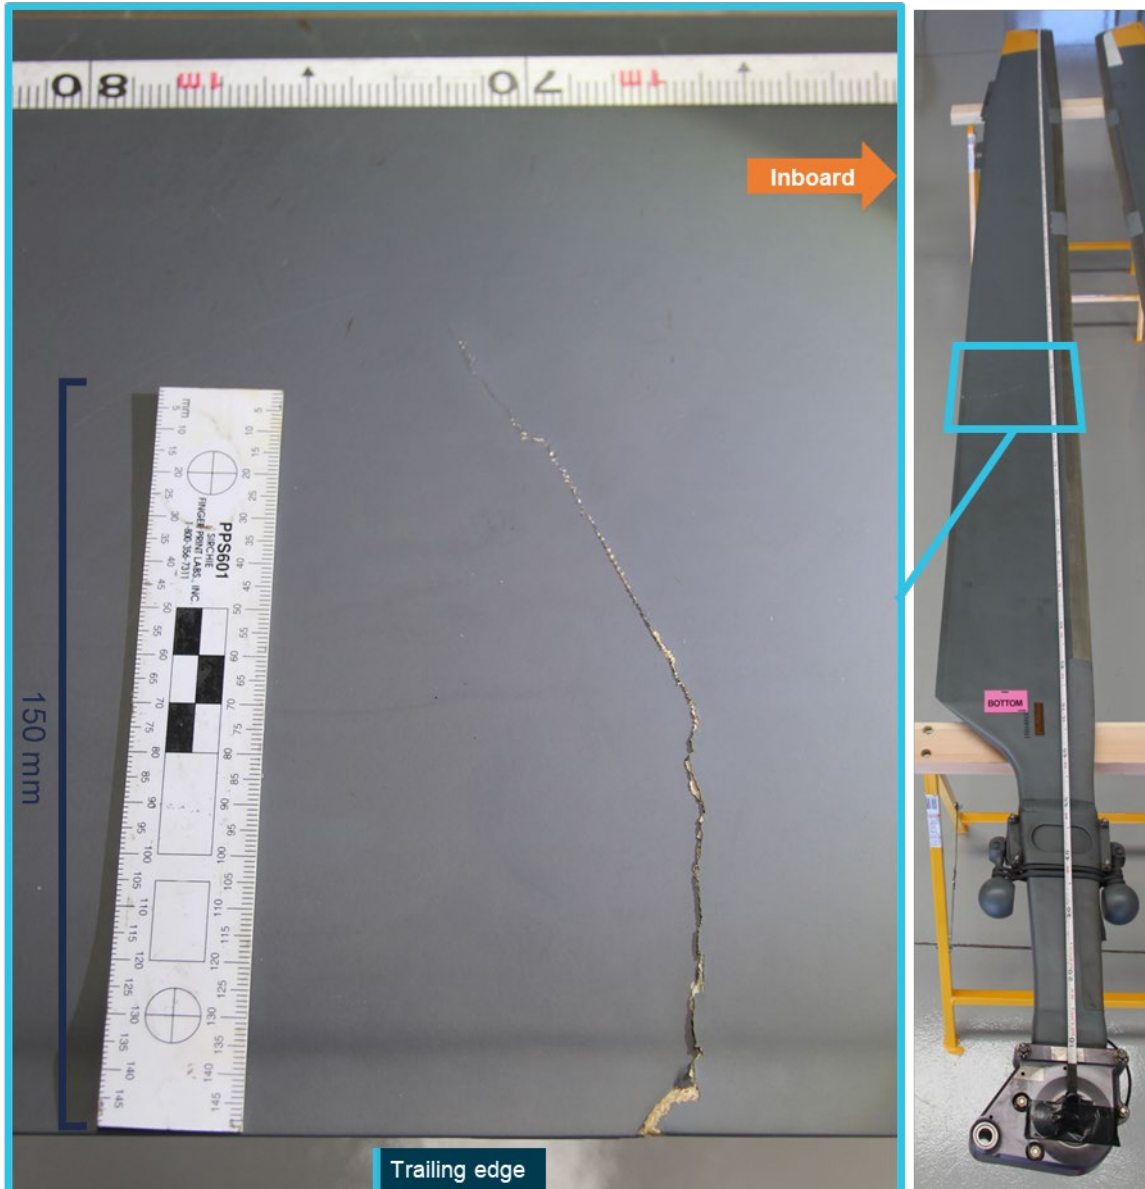
Figure 1: Main rotor blade crack

Blade serial number 783 was cracked approximately 1,700 mm from the blade root. The visible crack on the underside of the blade extended from the trailing edge of the blade for approximately 160 mm. The first part of the crack was parallel to the blade chord, before deviating at an angle towards the blade tip (Figure 1). On the upper blade surface, the crack extended chordwise for approximately 140 mm from the trailing edge.

Underside of main rotor blade S/N 783, 1,700 mm from the inboard end, showing crack extending over 150 mm from trailing edge.
Source: ATSB

Following initial visual examination and measurement, the paint layers were scraped back to examine the cracked area further. The cracked portion of the blade was also subjected to computerised tomography (CT) scan to examine for internal abnormalities. The examination found that the crack on the underside of the blade went through the middle of a previous repair. The repair had been conducted in accordance with the applicable blade repair instruction and there were no anomalies noted. No specific reason for the blade cracking was identified, although it was noted that cracks at repair sites were not unusual. It was also determined that the cracked blade, in its post-occurrence condition, was within repair limits.

There were also no blade material or manufacturing defects identified in the cracked blade, with the exception that the crack passed through the centre of a prior blade repair. The fact the blade was previously repaired in this location, in addition to the concurrent damage on the other 3 blades in the same location, suggested it was probably a region of high blade stress. The manufacturer also indicated that cracks at prior blade repair sites was not unusual and therefore, the blade repair probably influenced to some extent, the rate of cracking compared to the other blades. Despite this, there were no common factors identified outside of normal operation that likely contributed to the damaged blade set.

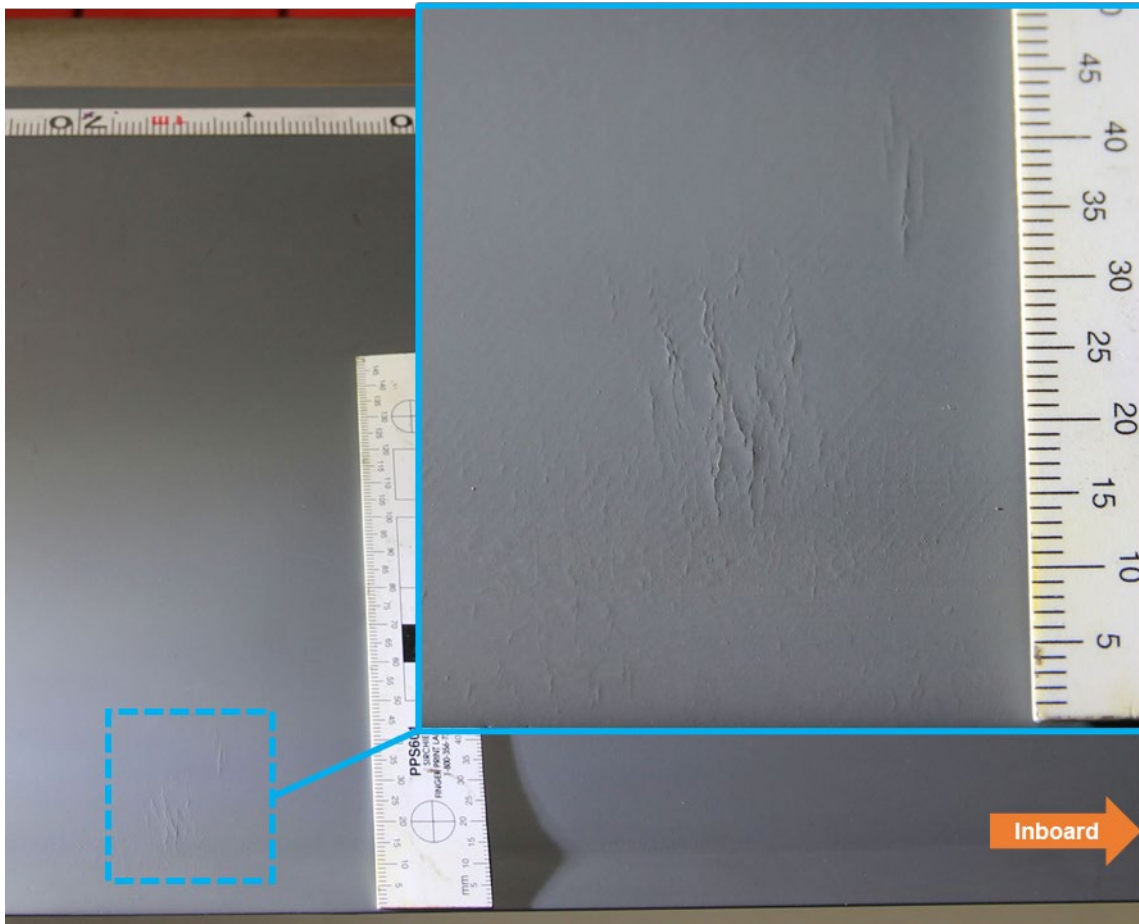
Figure 2: Main rotor blade damage indication

The remaining 3 blades from VH-NVH (serial numbers 780, 786 and 787) had visible indications of damage in the form of paint cracking or wrinkles, measuring 20-30 mm in length, at the same location along the blade (approximately 1,700 mm) from the inboard end. An example is shown in Figure 2.

Underside of main rotor blade S/N 780, 1,700 mm from the inboard end, showing paint wrinkles indicative of underlying damage.
Source: ATSB
