Clutch actuator lower bearing seizure and collision with terrain involving Robinson Helicopter Company R44, VH-KOV

near Nathan River Station, Northern Territory on 16 May 2022

ATSB Transport Safety Report

AO-2022-030

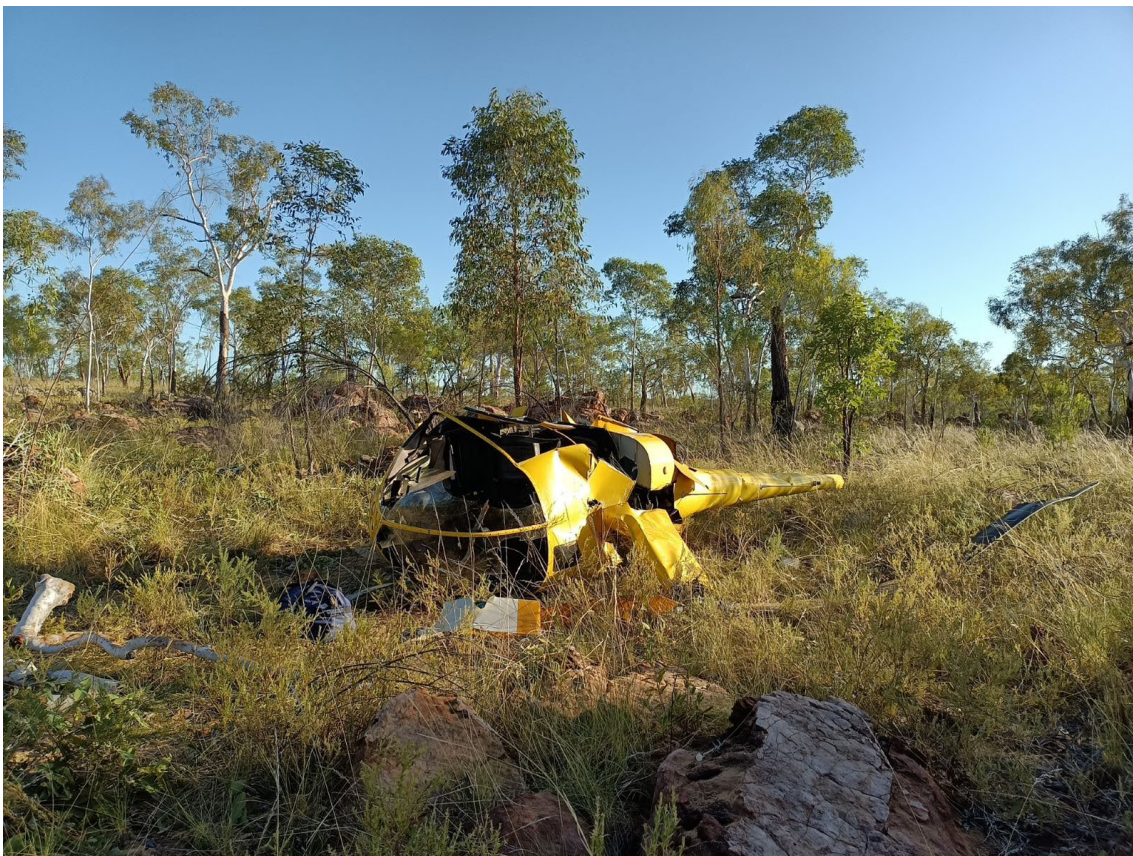
Figure 2: VH-KOV

The pilot advised that the helicopter fell through the trees, contacting the ground initially on the right front side, nose low, and then the helicopter spun and rolled on to the left side facing the opposite way to the direction of travel (Figure 2).

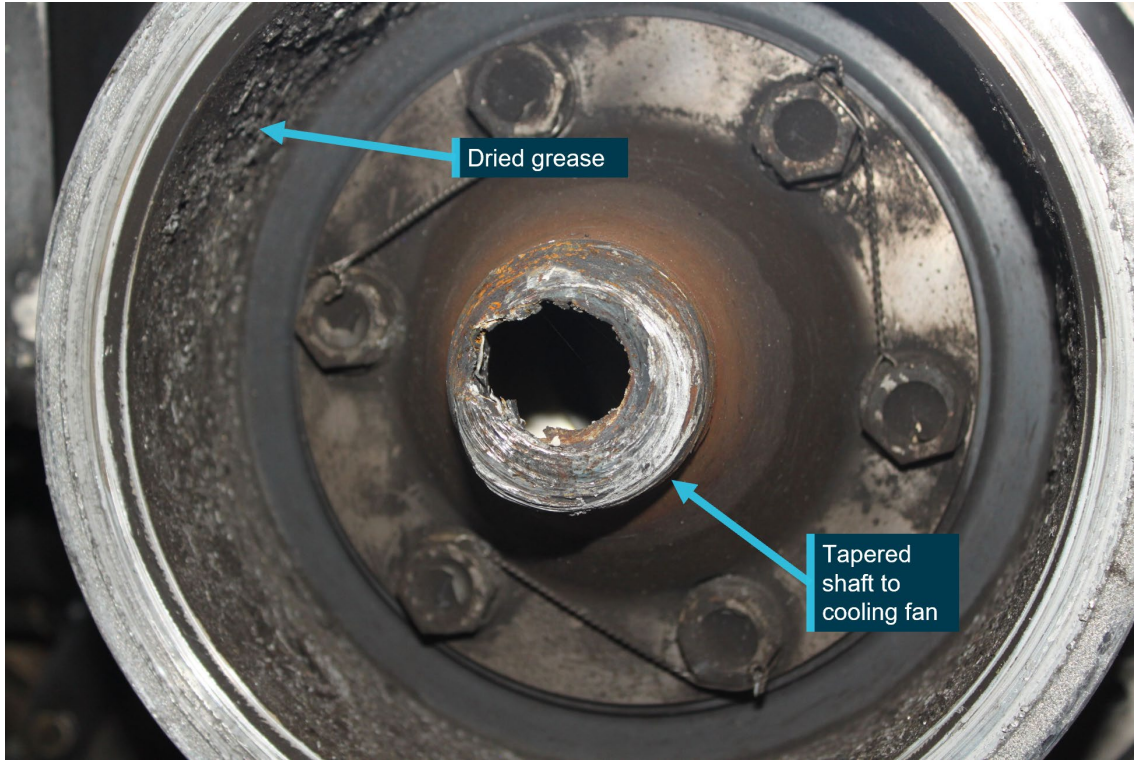
The fan shaft failed at the location of the lower bearing. The shaft exhibited deformation, necking, and gouging consistent with localised frictional heating. Circumferential scoring on the fracture surface was a result of the powered shaft contacting the bearing housing.

Figure 3: Lower sheave showing accumulated grease and failure of the shaft to the cooling fan

should have been evident. As detailed above, no noise or roughness was identified, but the accumulation of dried grease on the lower sheave indicated that grease had been leaking past the seal and/or over greased for an extended period. The bearing was also reaching the end of its service life.

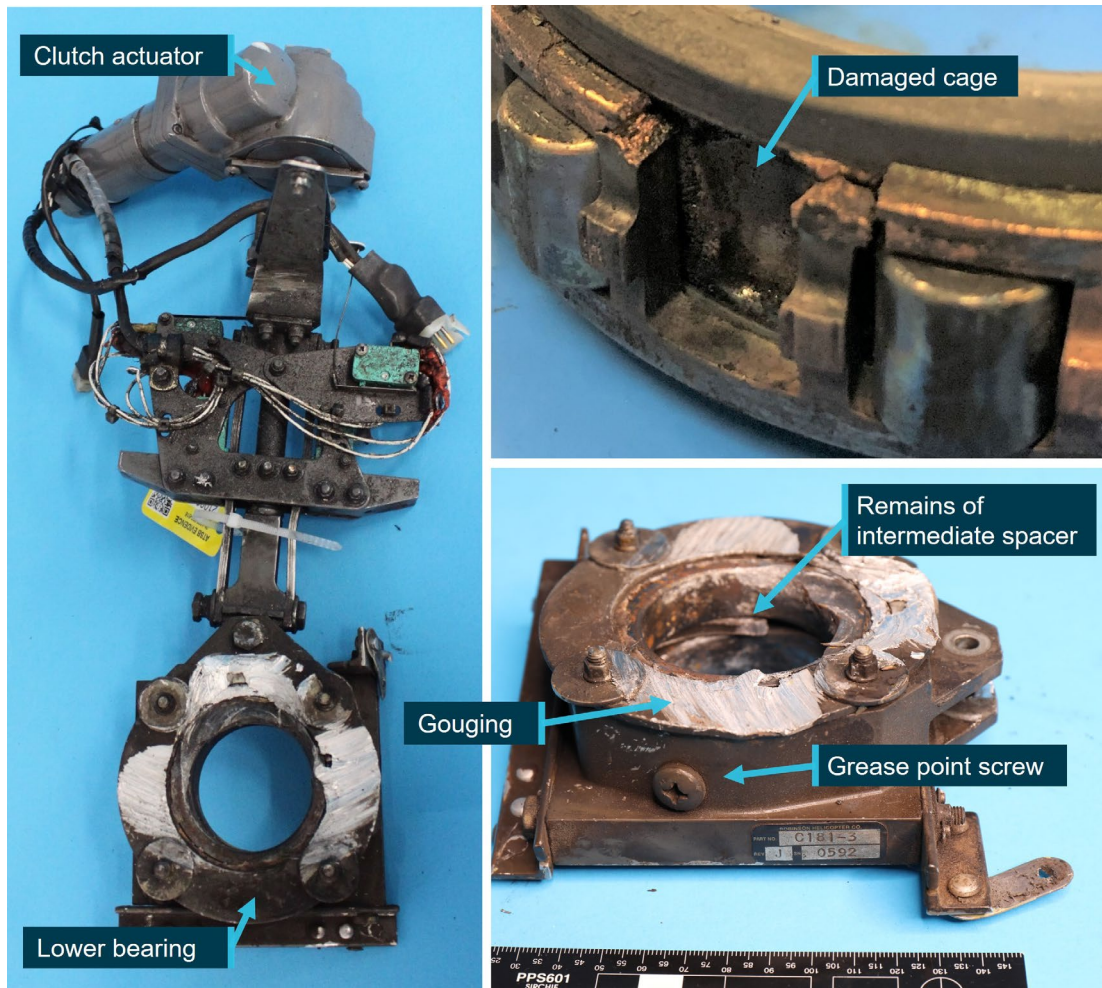
The ATSB examined the clutch actuator lower bearing at its Canberra technical facility. The forward face of the bearing housing exhibited matching gouging from contact with the rotating fractured engine output shaft (Figure 4). The cover plate was removed, and the bearing was found to have seized. The damage observed was consistent with intense heat and subsequent seizing of some of the rollers. The cage and intermediate spacer were also found to be heat-damaged.

Figure 4: Damage to lower actuator bearing

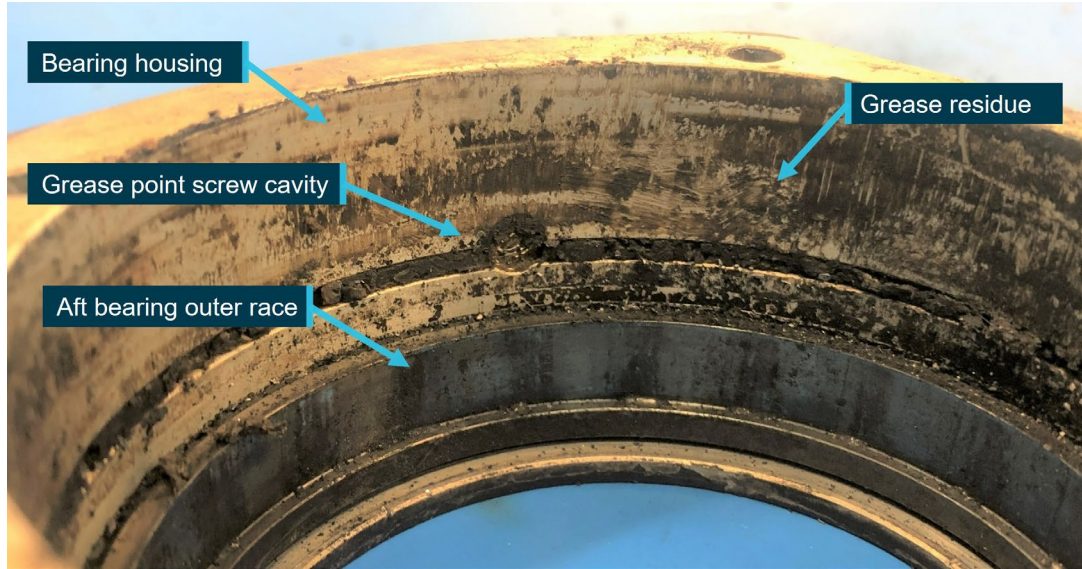
Grease residue was visible in the bearing housing (Figure 5) however, the intense heat associated with the bearing and fan shaft failure precluded the ability to determine the quality and quantity of grease and the condition of the seals prior to the occurrence.

Figure 5: Lower actuator bearing housing, showing minimal dried grease

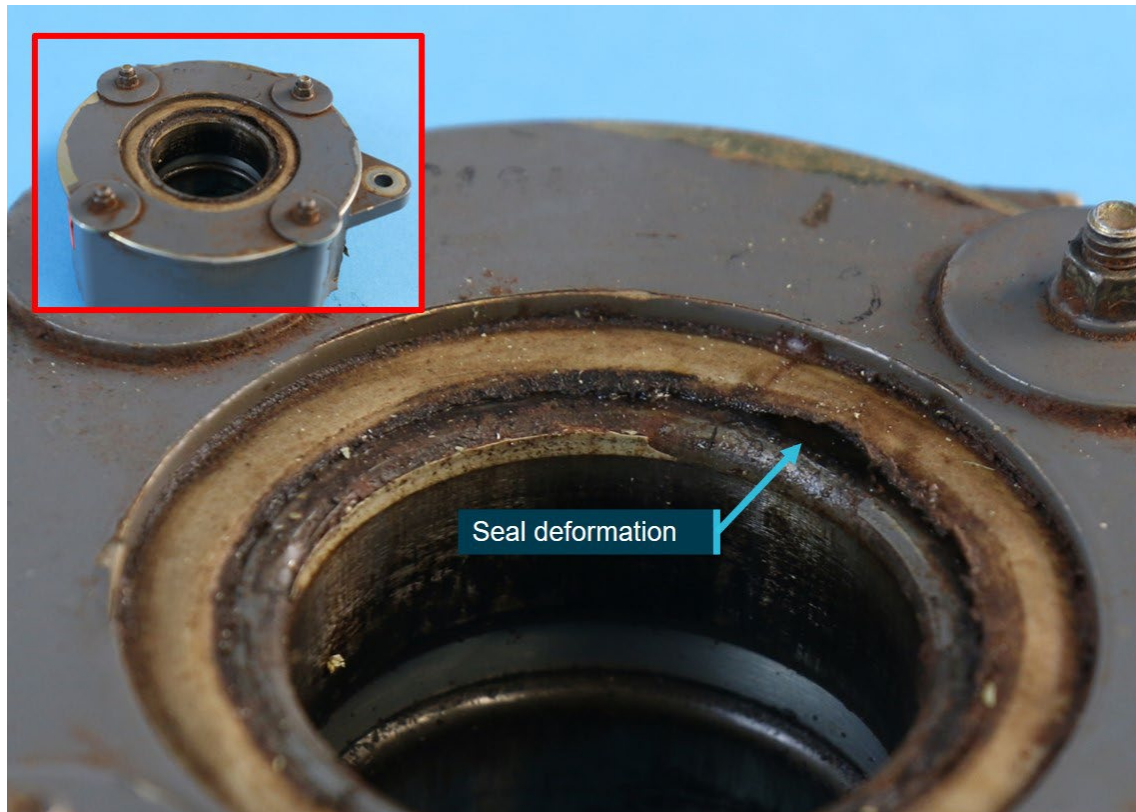
When questioned on the method for lubricating the upper bearing, the maintainer stated that they used the same method as for the lower bearing, via the screw hole. However, the ATSB inspected the upper bearing and noted the telatemp was covering the screw, with no evidence of it having been accessed. Additionally, the seal on the upper bearing, which was a type of rigid polymer, showed distortion consistent with the R22 syringe lubrication method (Figure 7). The grease was found to be solid and dark in colour (Figure 8). RHC advised that typically after 2,200 hours of operating, the grease will be dark brown but not grainy or gritty.

Figure 7: Distortion to the upper bearing seal

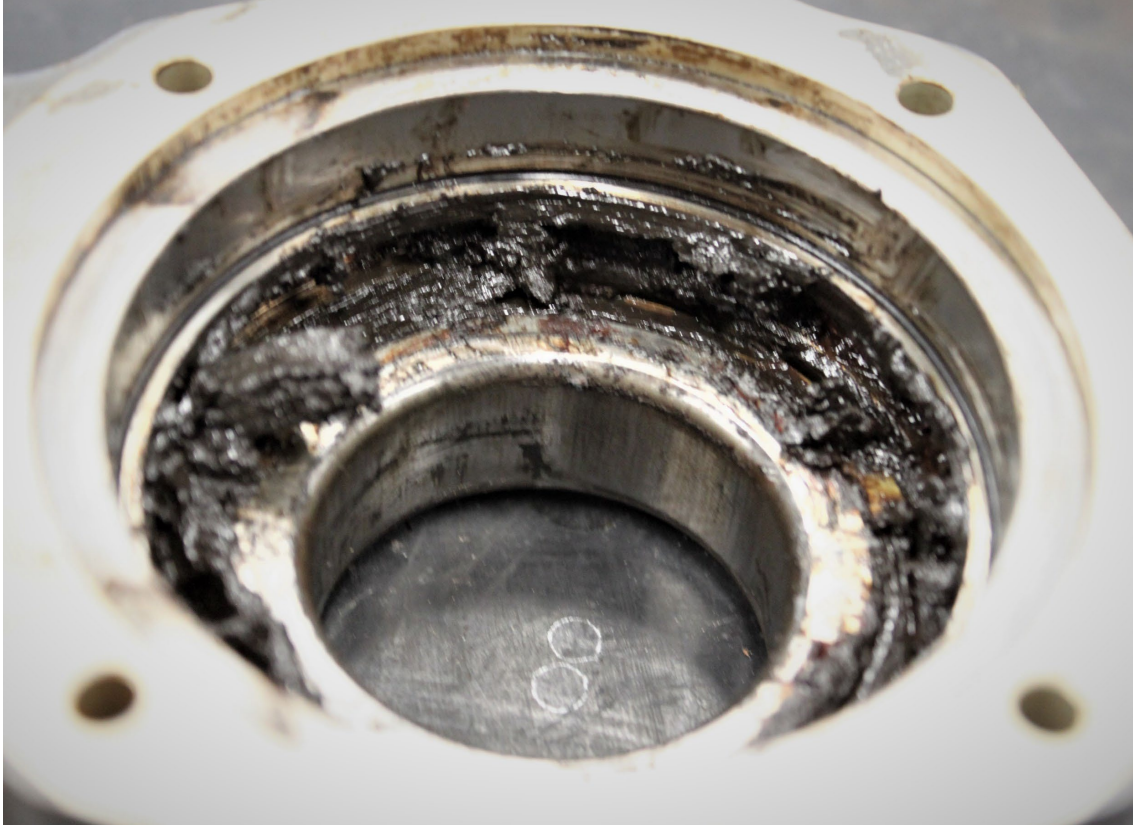
Figure 8: Grease found within the upper bearing
