Safety risks from rotor wash at hospital helicopter landing sites

ATSB Transport Safety Report
Aviation Data and Analysis Report
AD-2022-001
Final – 27 September 2023

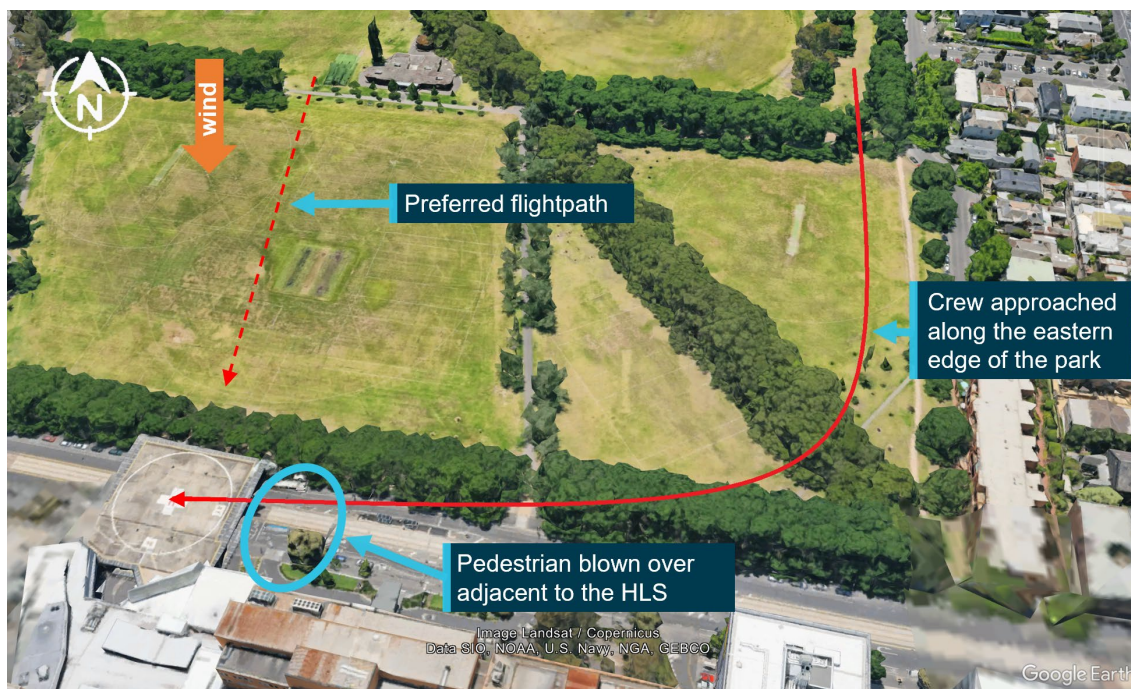
Figure 4: Approximate flight path based on reported information

On 27 December 2020 at about 1300 local time, a pedestrian was walking along the footpath adjacent to the Alfred Hospital HLS as an AgustaWestland AW139 helicopter was on approach to land. The crew altered their approach to account for the 35-knot wind on the day by tracking along the nearby park before turning towards the HLS on late final (Figure 4). As the helicopter approached the HLS, the pedestrian was blown over and sustained a broken sacrum.

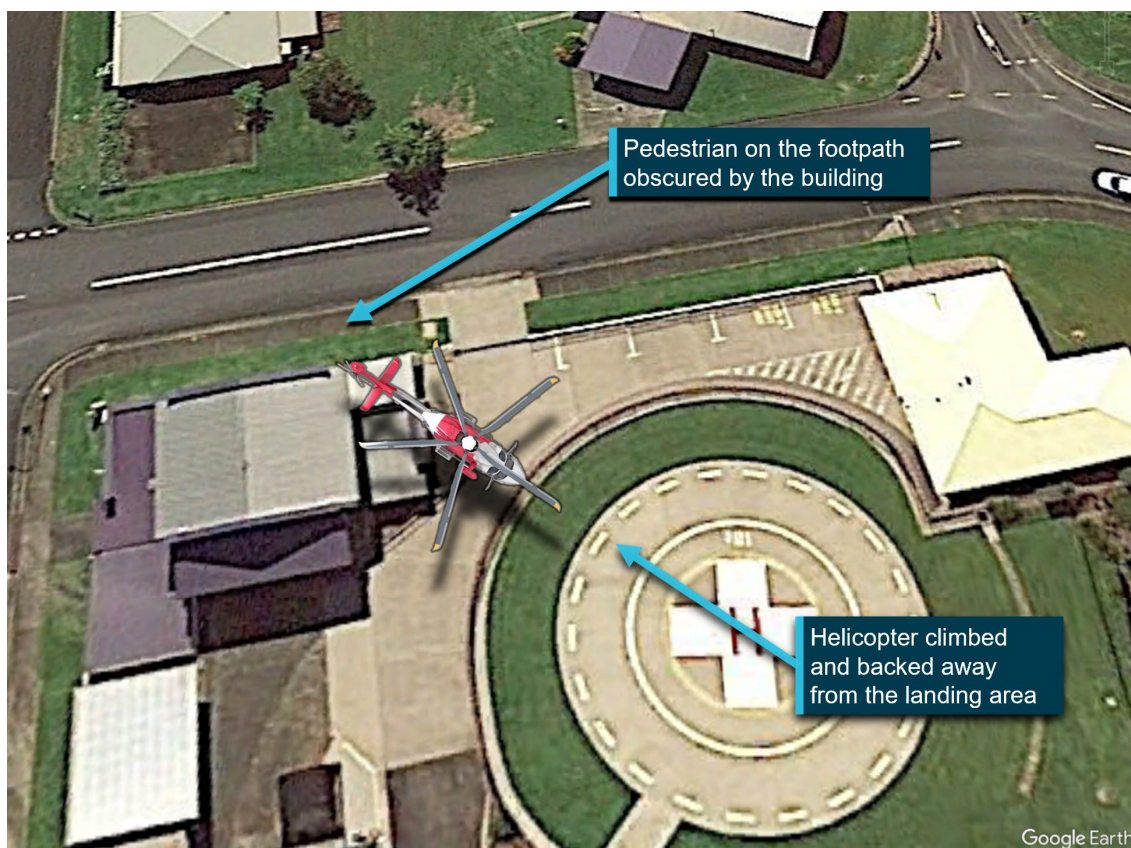
Figure 5: Approximate flight path based on operator report

vertically and back away from the helipad slightly so the pilot could keep the landing area in sight in case of an abort before flying away (Figure 5). As the helicopter backed over the top of a hospital building towards the nearby roadway, a pedestrian walking on the adjacent footpath was blown over and sustained a serious head injury. The pedestrian was not visible to the crew from the helipad.

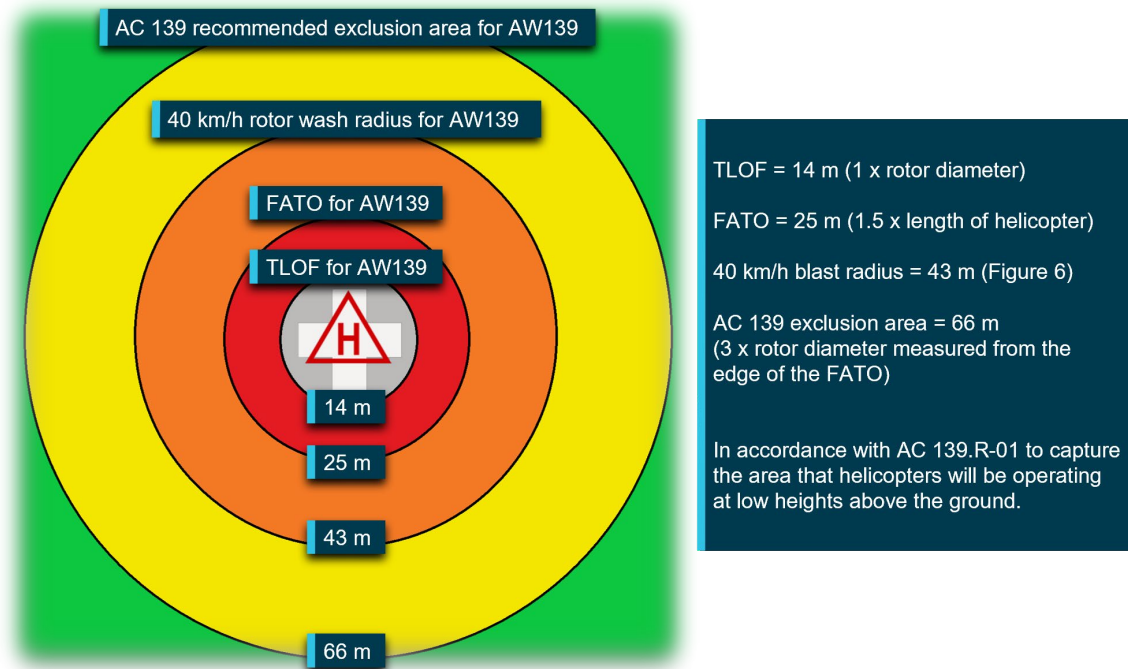
Figure 11: HLS rotor wash regions of consideration for an AgustaWestland AW139⁹

- A HLS exclusion area should be in accordance with the danger area for the design helicopter as published in AC 139.R-01 v1.0, or as determined by a plot of the HLS rotor wash danger area. If this is not feasible, then an alternative strategy may need to be evaluated. Examples of hospital HLS sites in *Appendix 3: Area of consideration* are based on the guidance for an AgustaWestland AW139 as per Figure 11 below, which recommends an exclusion area based on a 66 m radius.

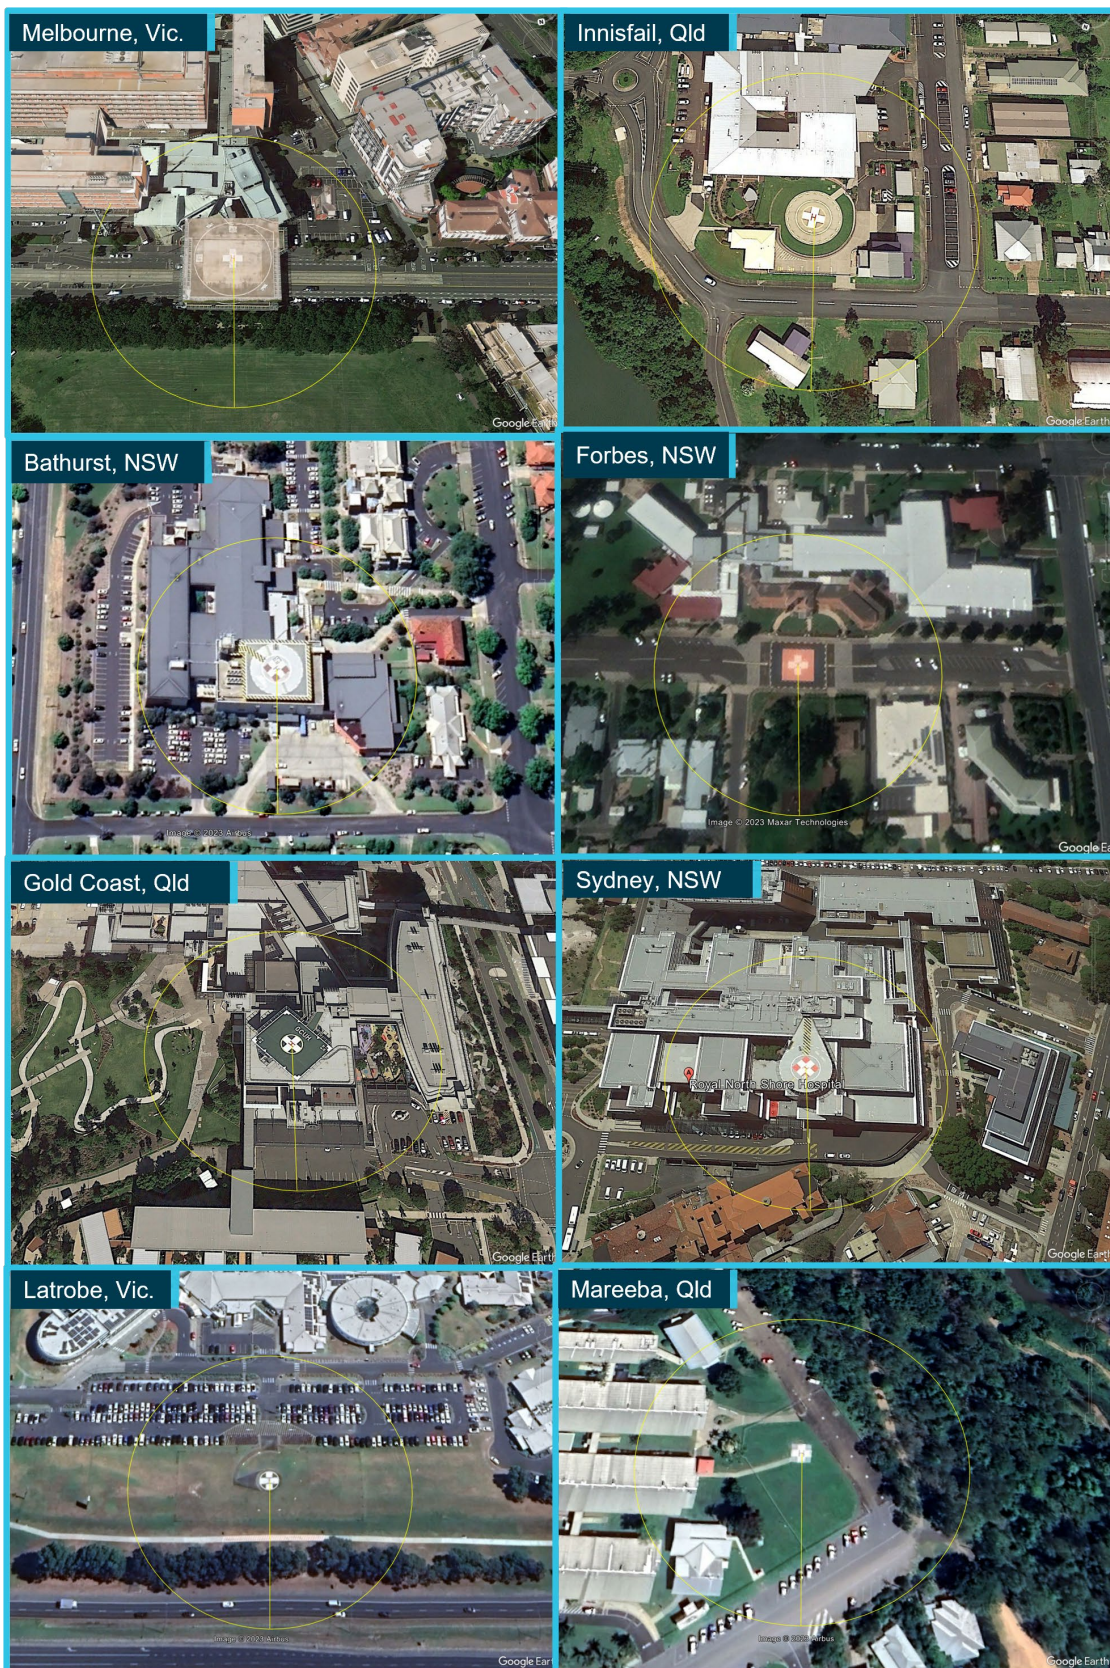
Appendix 3: Area of consideration

Adapted from the guidance in AC 139.R-01. All images show a 66 m radius circle indicating the area that CASA recommended was kept clear of all loose objects and non-essential people.
