# Fatal fall from the pilot ladder of *Formosabulk Clement*

5 nautical miles east of Caloundra, Queensland on 9 August 2021

**ATSB Transport Safety Report**

MO-2021-004

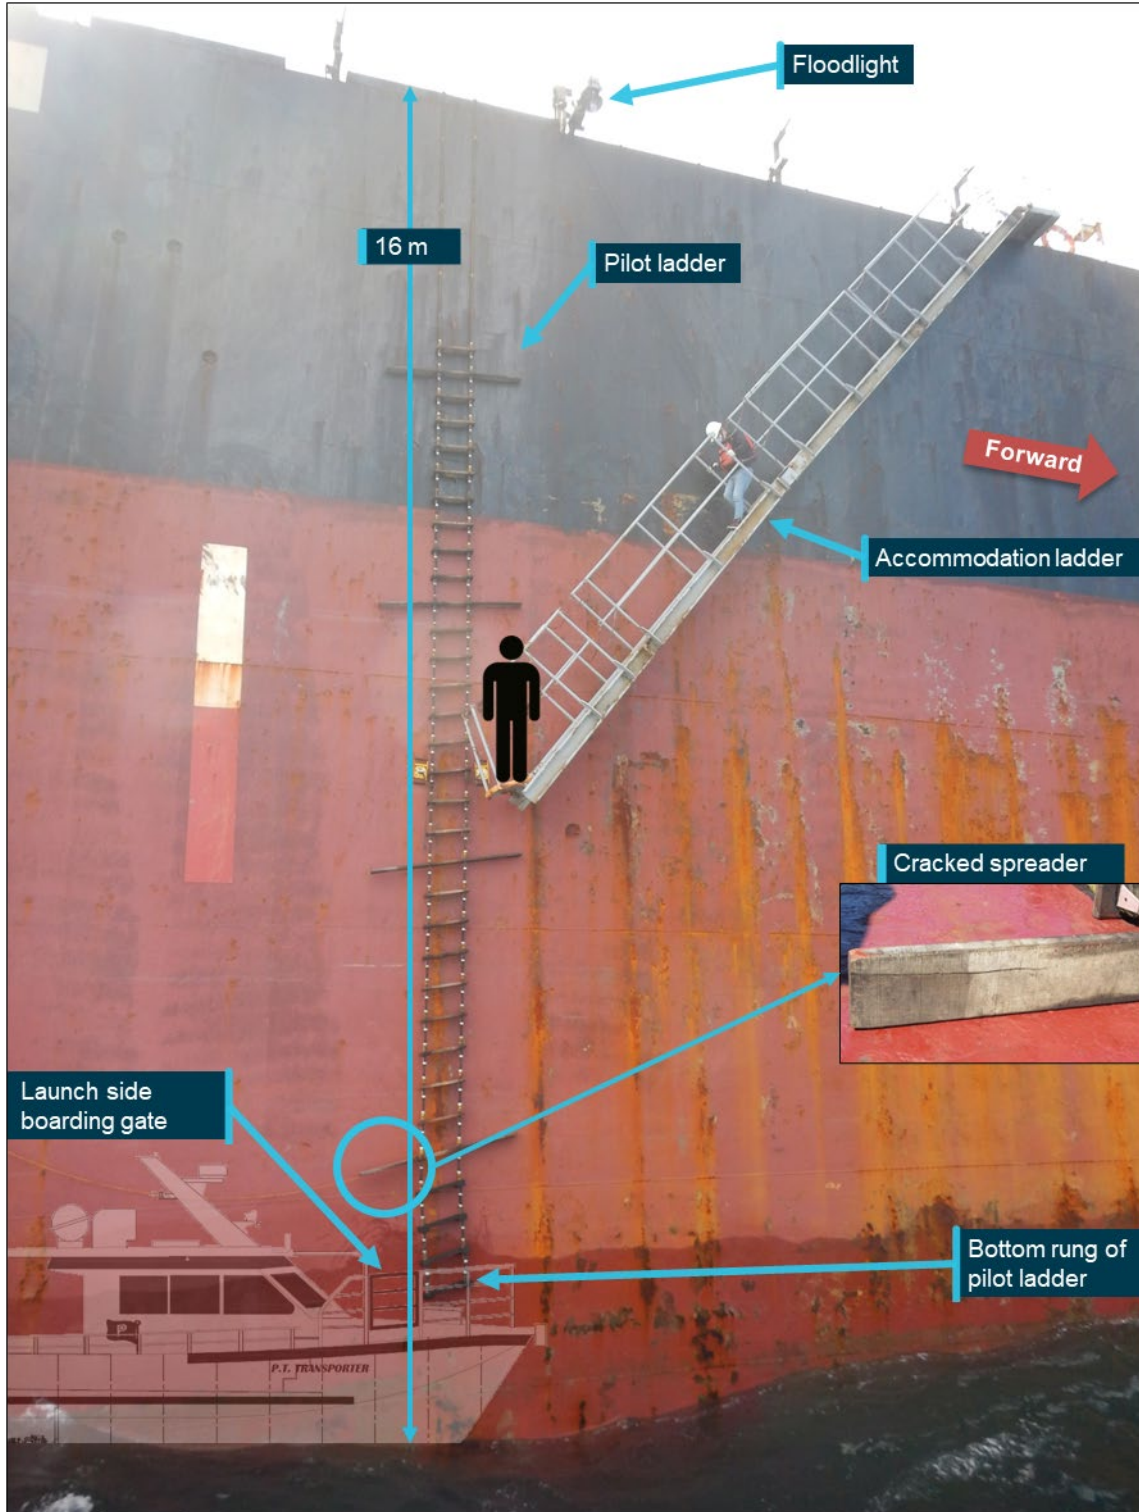
**Figure 2: Starboard side boarding site and ladder arrangement**

Following the accident, PSC inspection found the pilot ladder defective, as, among other issues, the lower spreader was cracked (possibly due to contact from the launch during the transfer). The ship was detained by AMSA under the *Navigation Act 2012*, in part, due to deficient safe means of access to the vessel. The rope pilot ladder was replaced prior to the ship sailing from Australia and the deficiency was closed.

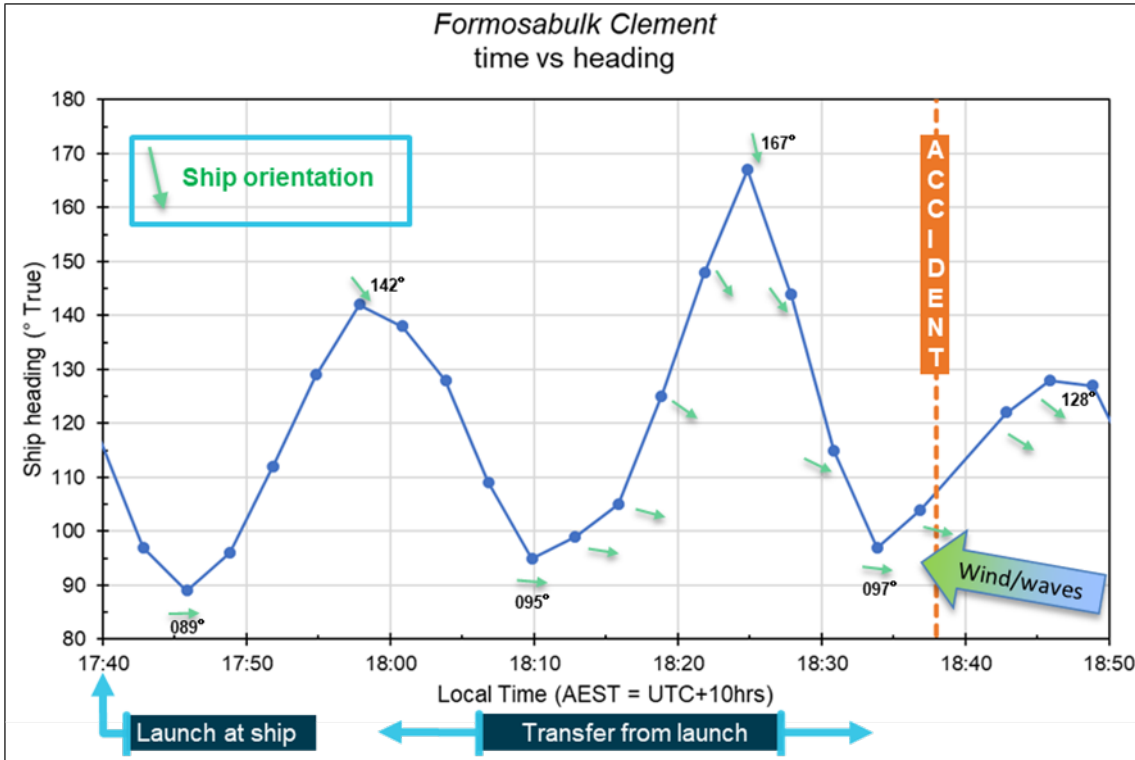
**Figure 3: Ship yaw leading up to the accident**

At 1745,<sup>7</sup> *Formosabulk Clement* was at one extreme of yaw about the anchor with the starboard side exposed to the weather (heading 089° with weather from 100°—Figure 3). The launch skipper recalled there was a little bit of sea from the east-south-east and that it 'wasn't the calmest of conditions' (noting that several of the launch passengers had been sick during the journey). The

Nearing 1800, the ship was at the other extreme yaw angle about the anchor and was on heading 142° with the boarding area sheltered. The master radioed the launch and informed the skipper that the wind was now from the port side and it was suitable to ‘try once again’.

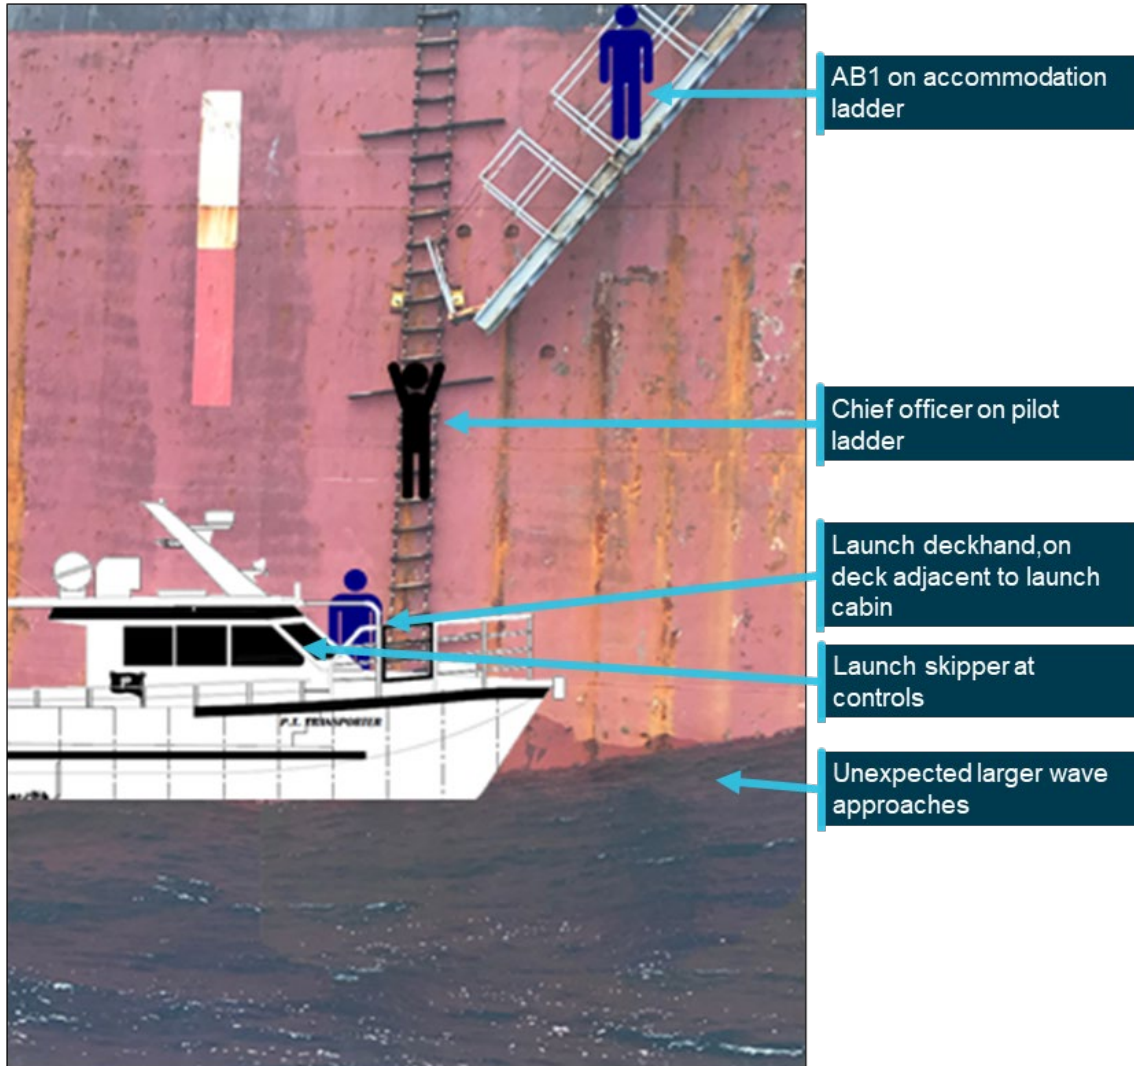
**Figure 4: Approximate positioning of the launch and personnel at 1838**

Soon thereafter, the launch came close alongside and the dCM began to descend the pilot ladder a second time. The deckhand felt the conditions were suitable and did not direct the dCM away. The launch skipper was unaware of the presence of the dCM on the pilot ladder or of the interactions between the deckhand and the dCM.

At the same time, the departing chief mate (dCM) climbed onto and down the pilot ladder in anticipation of boarding the launch. Neither the ship's master nor the launch skipper was aware that the dCM had descended the ladder. In addition, the deckhand did not know that the skipper only intended to assess conditions, not to embark anyone. The deckhand saw the dCM on the ladder, directed them clear of the approaching launch and anticipated signalling readiness when it was safe to board.

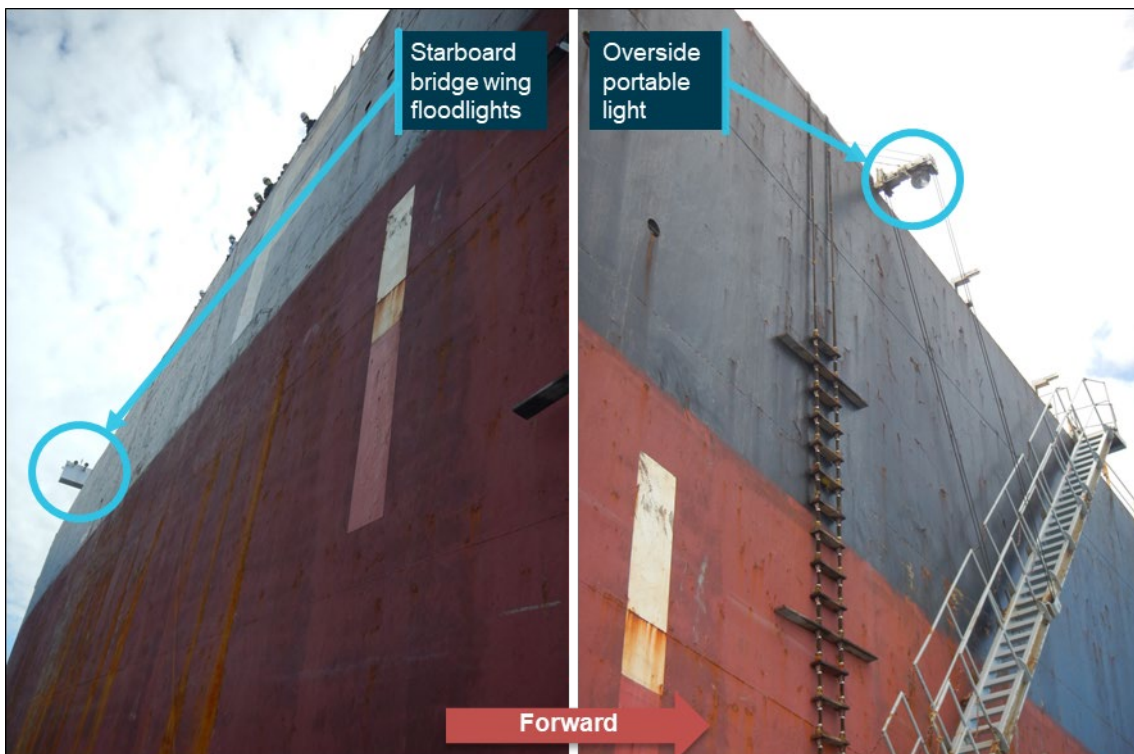
**Figure 5: Ship lighting for the starboard boarding area**

Lighting for the boarding area was provided by a portable floodlight mounted over the side at deck level and floodlights mounted on the ship's starboard bridge wing (Figure 5). Deck lighting was also used to illuminate the work area on deck. Sunset was at 1723, and the ship's crewmembers reported that there was sufficient lighting for the task.

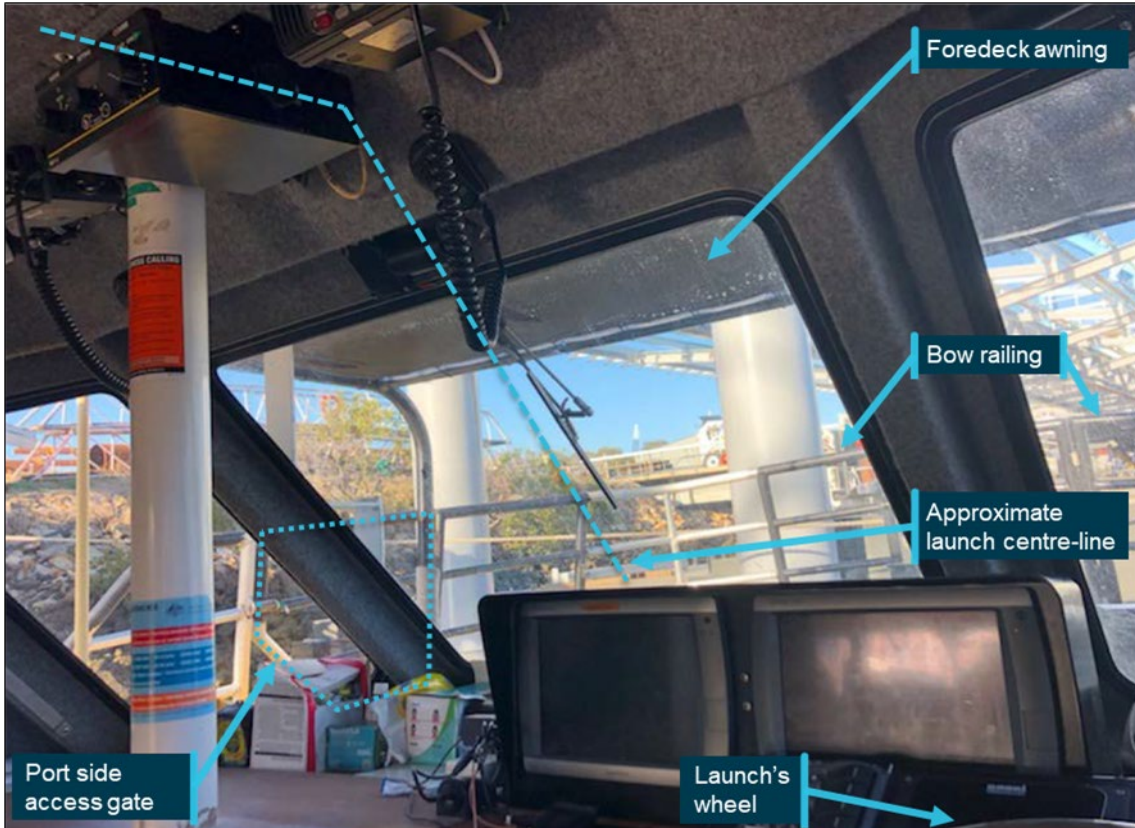
**Figure 7: The view from *PT Transporter*'s skipper's position at the helm**

The vessel's helm position was located to starboard of the centreline. The cabin layout combined with the foredeck awning limited the skipper's view upwards, especially in close quarters such as when the launch was alongside the ship (Figure 7).
