In-flight break-up, Robinson R44 Raven I helicopter, VH-NBY

3 km north of Broome Airport, Western Australia on 4 July 2020

ATSB Transport Safety Report

AO-2020-033

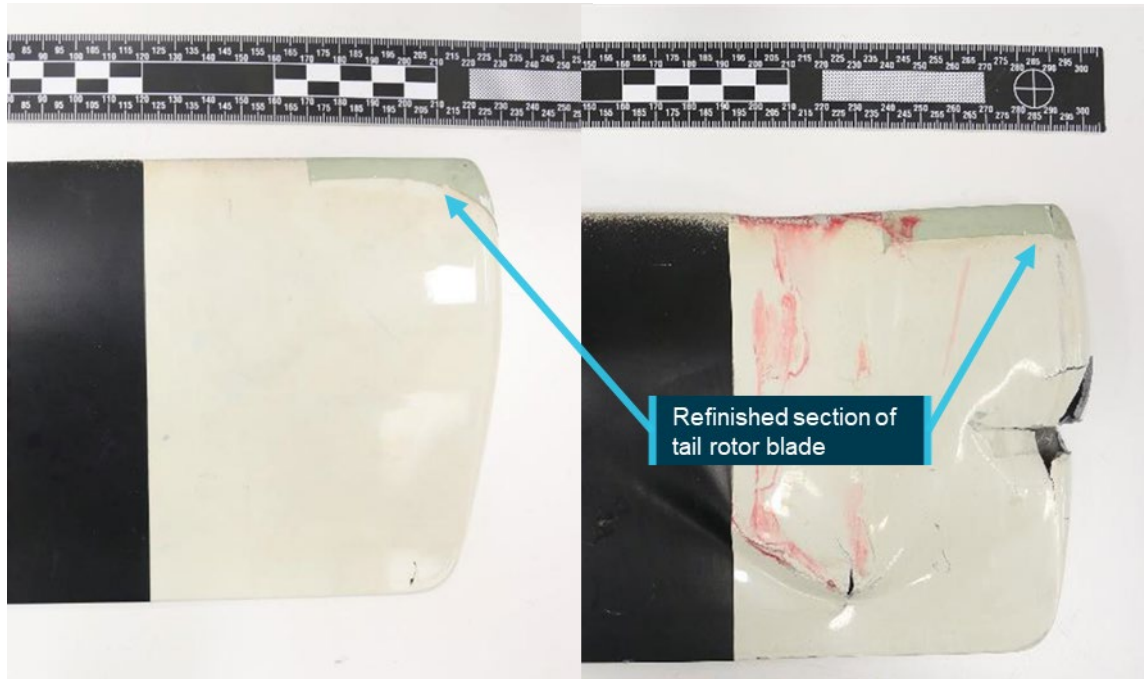
Figure 4: Refinished area of tail rotor blades (Paint transfer and damage due to accident)

The tail rotor blades are constructed with aluminium skins and root fittings. Maintaining the paint finish will reduce corrosion and erosion.

The tail rotor blades on VH-NBY were last refinished on 9 October 2019 and the balance was found to be within limits.

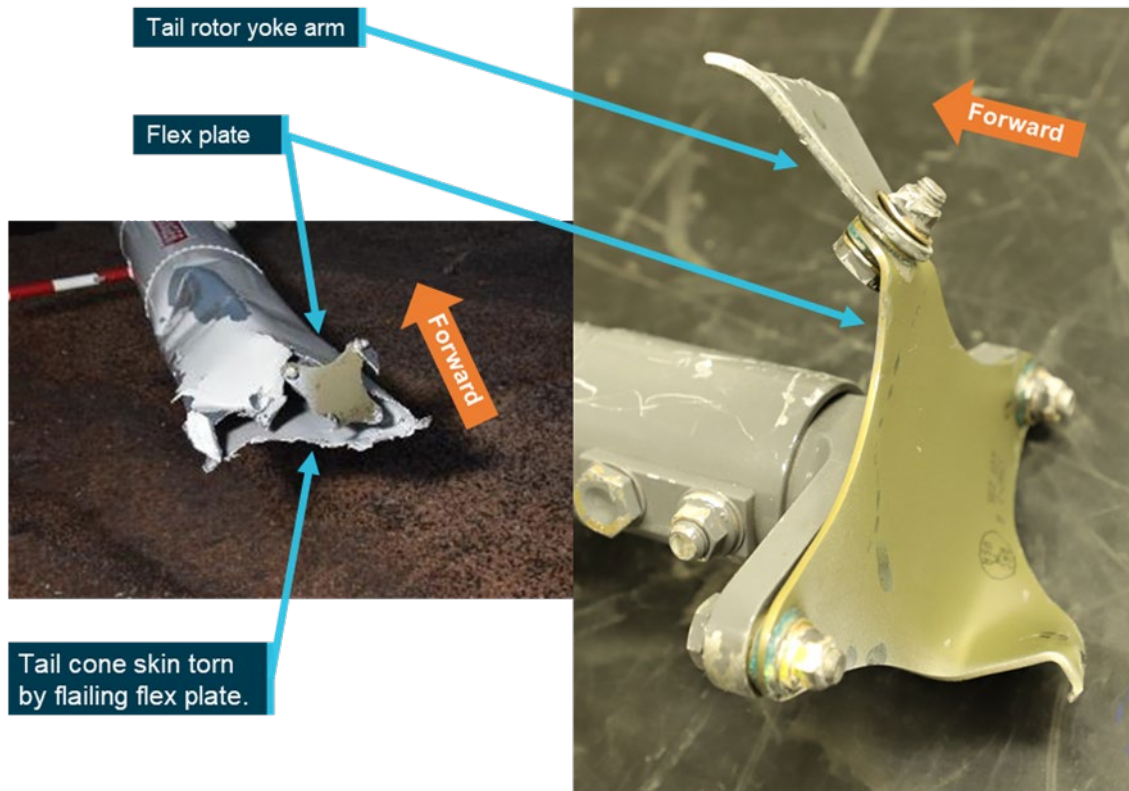
Figure 11: Tail cone and aft flex plate

Onsite examination showed that the forward end of the tail cone was securely attached to the fuselage of the helicopter with correct attaching hardware. At the aft end of the tail cone, the skin was cut and torn through from repeated impact and flailing of rotating driveshaft components (Figure 11).

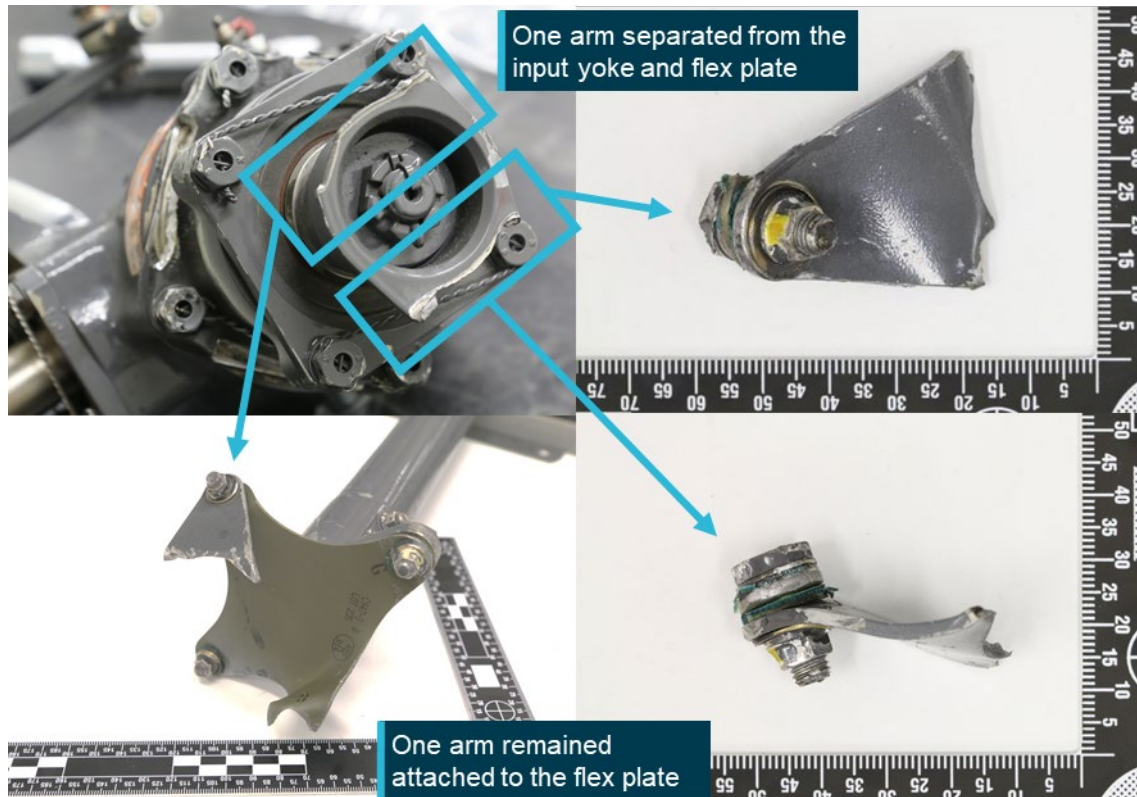
Figure 12: Tail rotor gearbox input yoke

It was concluded that the attachment yoke arms had fractured from cyclic bending loads during the break-up sequence.

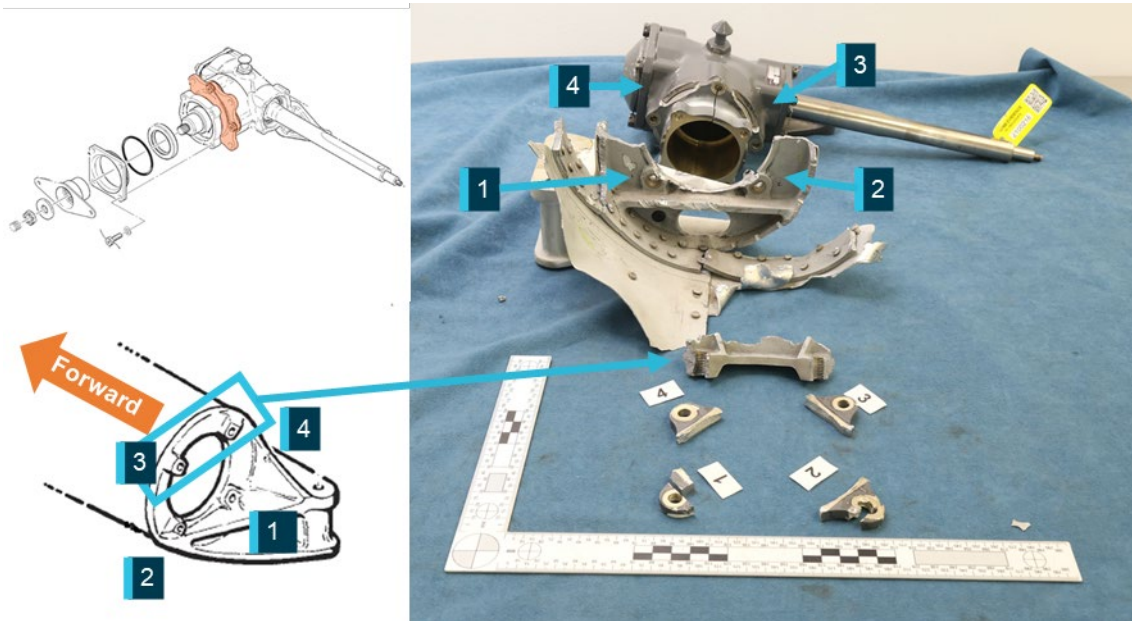
Figure 13: Aft tail cone bulkhead and input cartridge (shown in red)

SEM examination of the fracture surfaces confirmed a predominantly brittle surface of cleavage facets.¹⁰ Some minor locations showing shrinkage pores¹¹ and micro-dendritic defects¹² were observed, however, these were limited along the fracture surface and not considered to be contributory to the break-up. The SEM examination confirmed that the cast bulkhead had fractured in a brittle instantaneous manner. There was no evidence identified to indicate the surfaces had been rubbing, nor was there evidence found of any progressive crack mechanism (fatigue) through the structure.

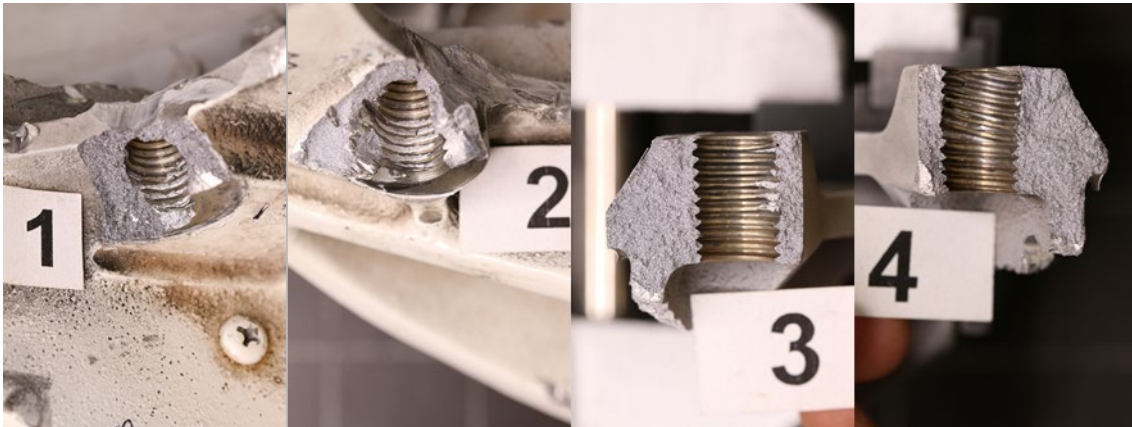
Figure 14: Threaded bolt holes of the aft tail cone bulkhead

The interior of the fragmented tail cone structure, which was still attached to the aft tail cone bulkhead section showed curling of the skin and contact marks from rotating contact damage by the flailing drive shaft.

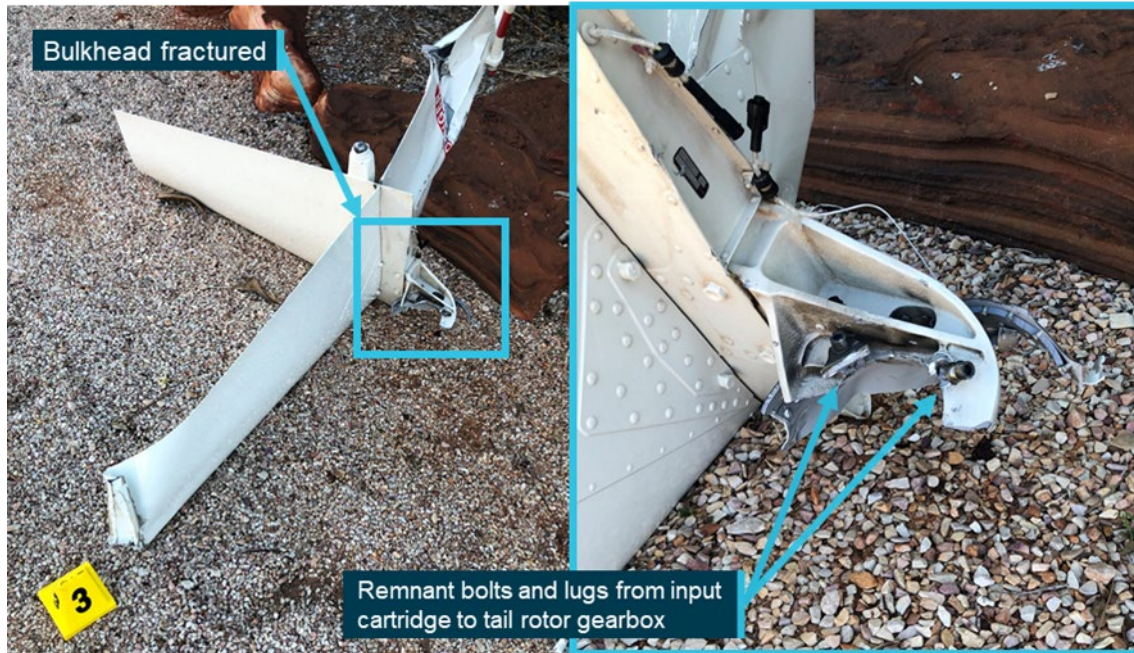
Figure 15: Empennage

The empennage separated following fracture of the aft tail cone bulkhead. There was impact damage on the lower vertical fin from a tail rotor blade strike and the upper fin had ground impact damage following the break-up. The horizontal fin also displayed minor levels of post break-up damage. The bulkhead had fractured horizontally and retained the bolts and a lug from the TRGB input cartridge (Figure 15). The tail skid situated below the lower vertical fin was unmarked.

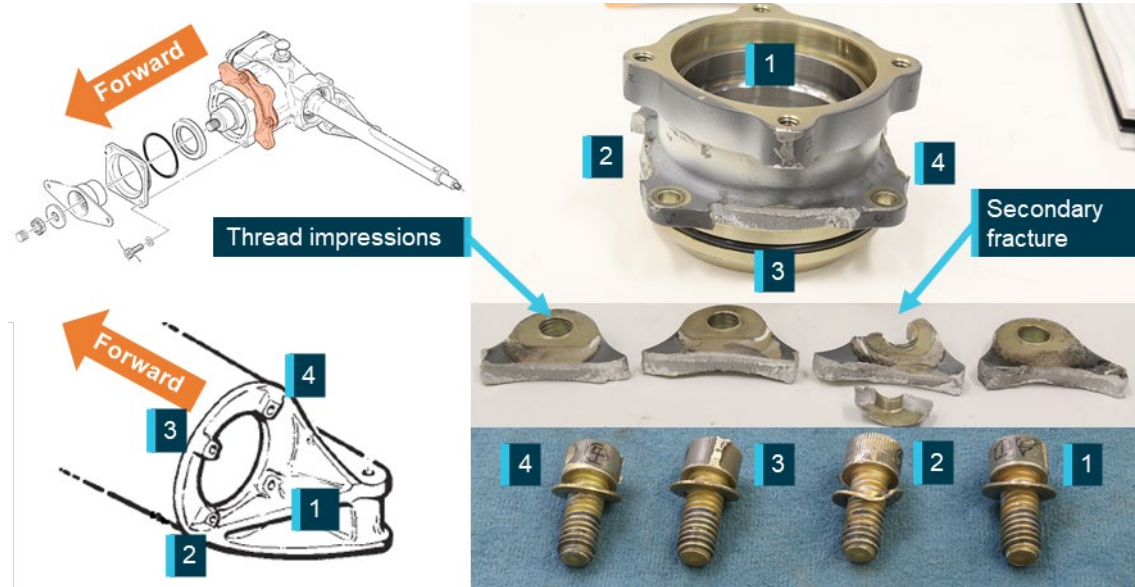
Figure 16: Tail rotor input cartridge

any of the lugs that might suggest that the input cartridge had contained a metallurgical defect (pre-existing cracking) that would otherwise have led to an increase in net section stresses from operational loads.

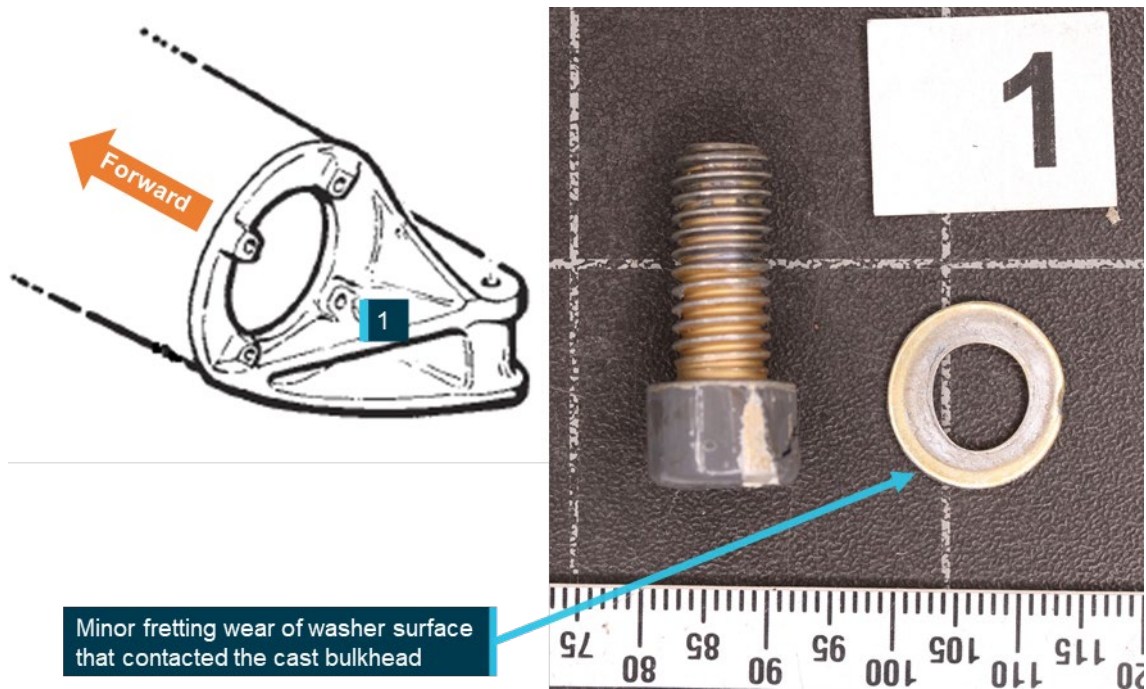
Figure 17: Input cartridge attachment bolt

Some evidence of micro movement of the fitted components was found on the washer surface facing the cast bulkhead at location 1 (Figure 17). Here, minor fretting and elongation of the washer was observed.

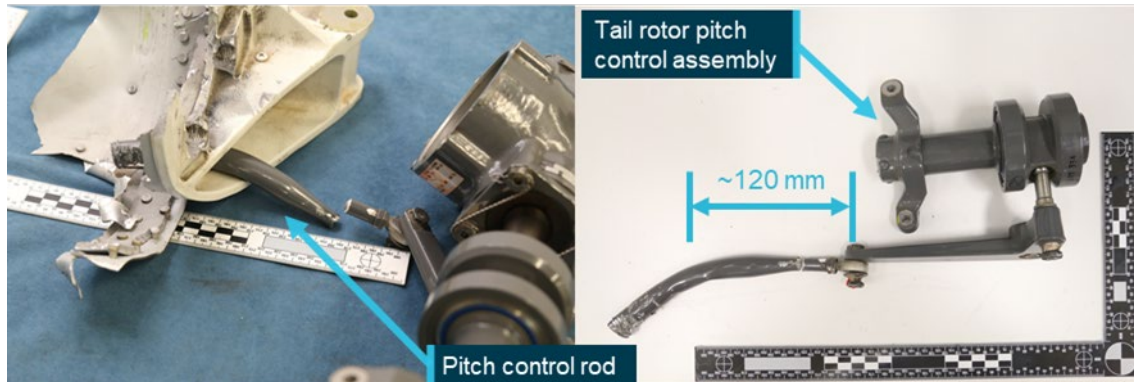
Figure 19: Pitch control rod

Fracture surfaces at the rod-end connection to the bell crank were characteristic cup-and-cone that indicated ductile overstress. The tail rotor pitch change rod was severed during the accident sequence from repeated rotating contact damage at the aft flex plate position. Additionally, there were no anomalies detected in the bell crank, pitch control assembly or pitch links.

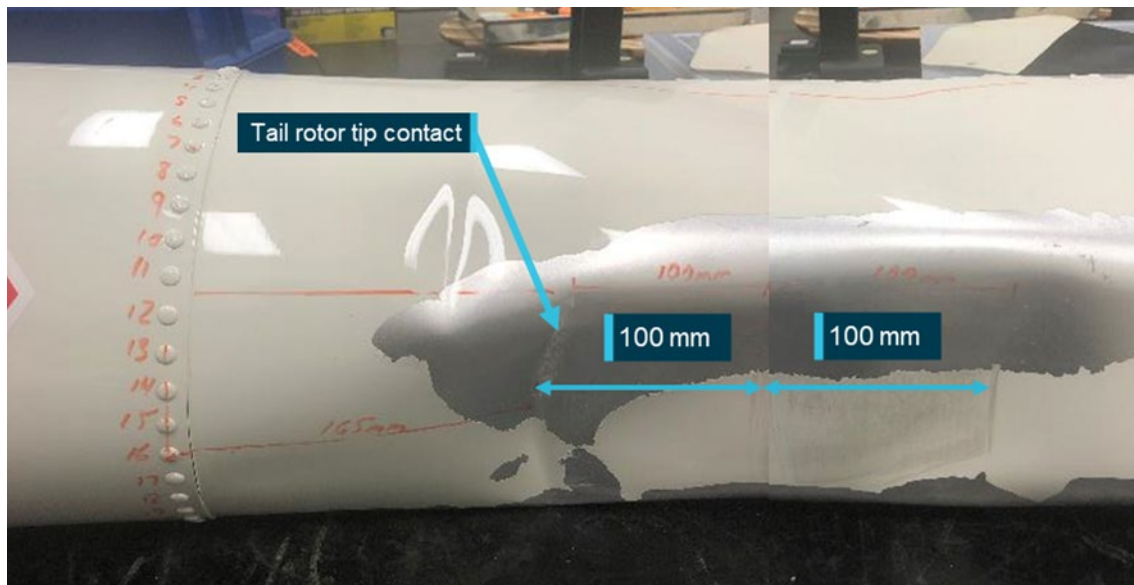
Figure 20: Tail rotor contact with tail cone

The skin surrounding the point of fracture was examined optically and using an SEM with predominantly angular tear ridges and ductile morphological features on the fracture surfaces. There was no evidence of a pre-existing defect such as fatigue, nor were there any anomalies noted with the blade construction.

Analysis of the break-up sequence identified that the TRGB was almost certainly separated from the end of the tail cone at the time of tail rotor blade contact with the tail cone, and with the lower vertical fin.

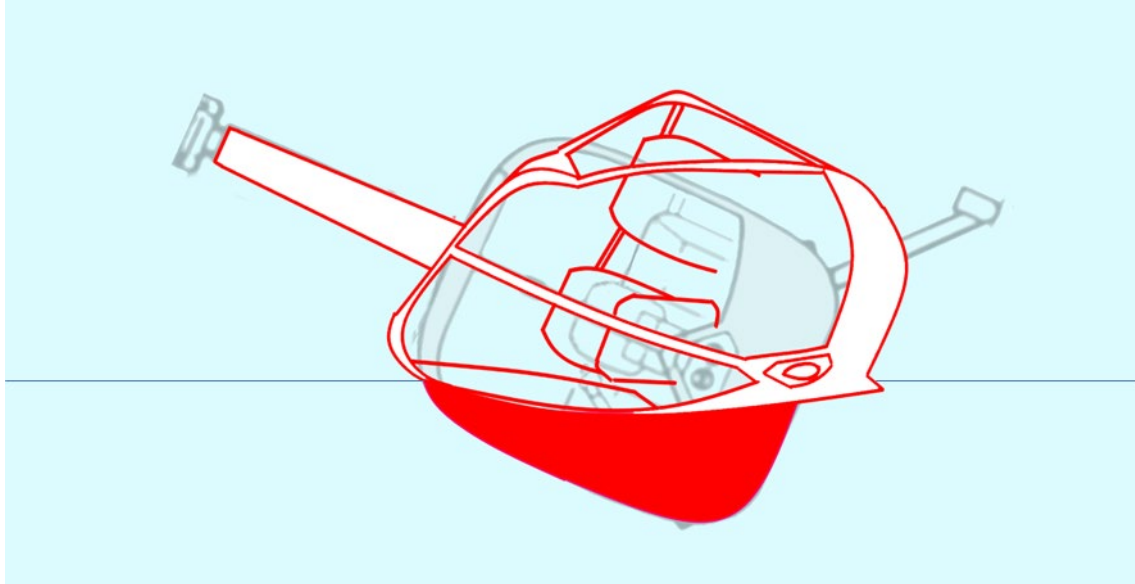
Figure 25: Diagram of cabin deformation in VH-NBY

Figure 25 illustrates the deformation in VH-NBY from the side impact. The tail rotor gearbox and empennage fractured from the tail cone at around 55 ft and the helicopter fell from about 75 ft above the ground.

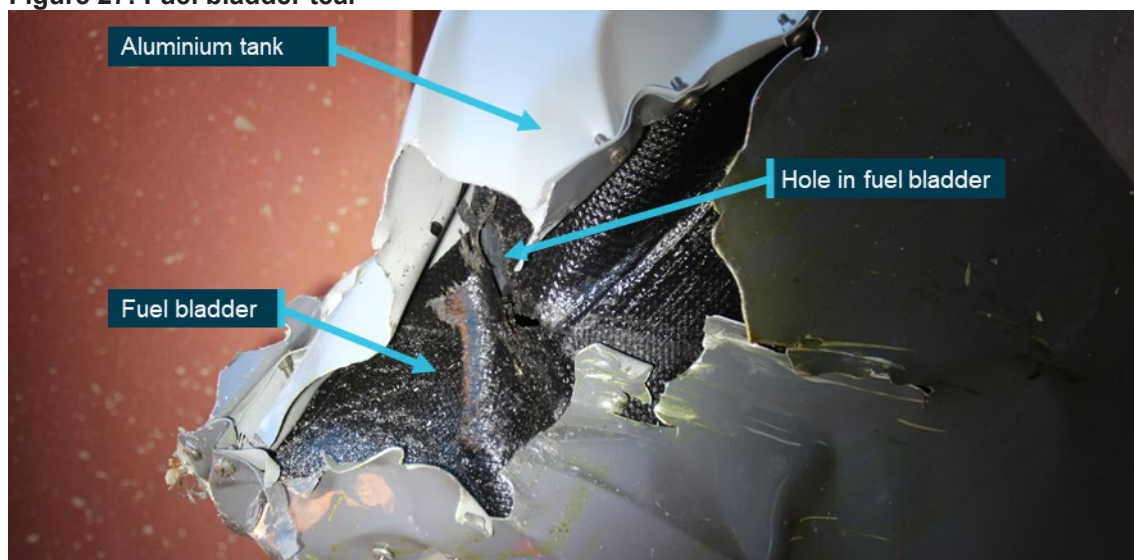
Figure 27: Fuel bladder tear

The puncture allowed the release of fuel, but at a low rate (Figure 27). An unknown quantity of fuel leaked from the bladder and attending fire services contained the spill. About 30 L of fuel remained in the helicopter. Given the previously-observed rupturing of aluminium fuel tanks during significant impact, without the fuel bladders, the risk of a post-crash fire would probably have been significantly higher.

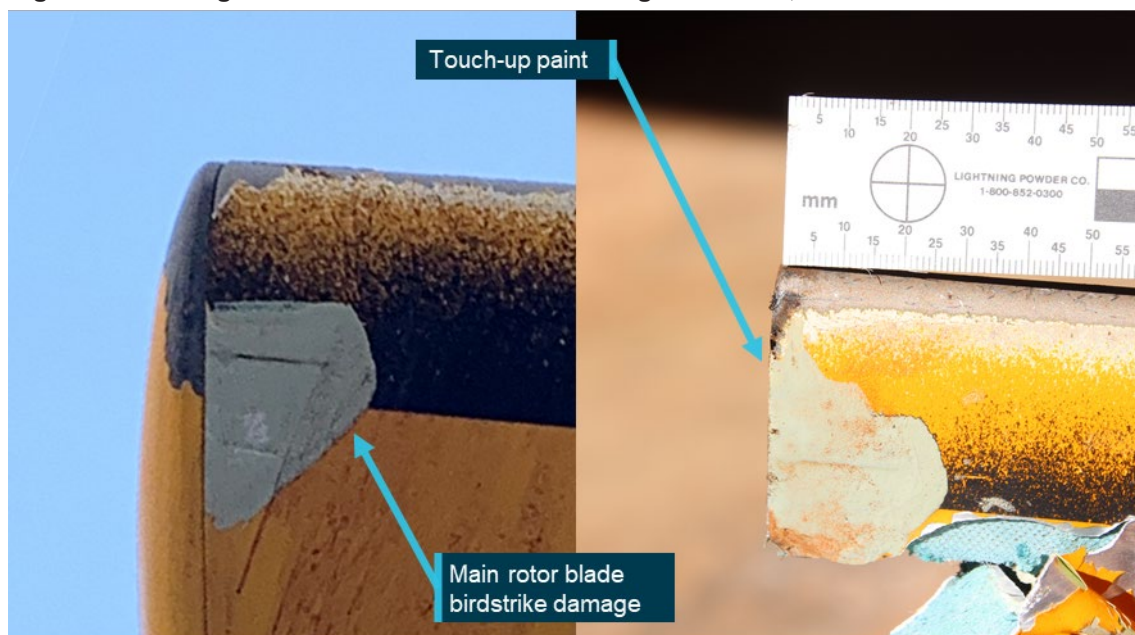
Figure 29: Damage to VH-NBY main rotor following bird strike, and blade at accident site

The main rotor blade tip was painted at some point after this event. There is no mention of inspection or repair in any of the helicopter logbooks or maintenance releases.

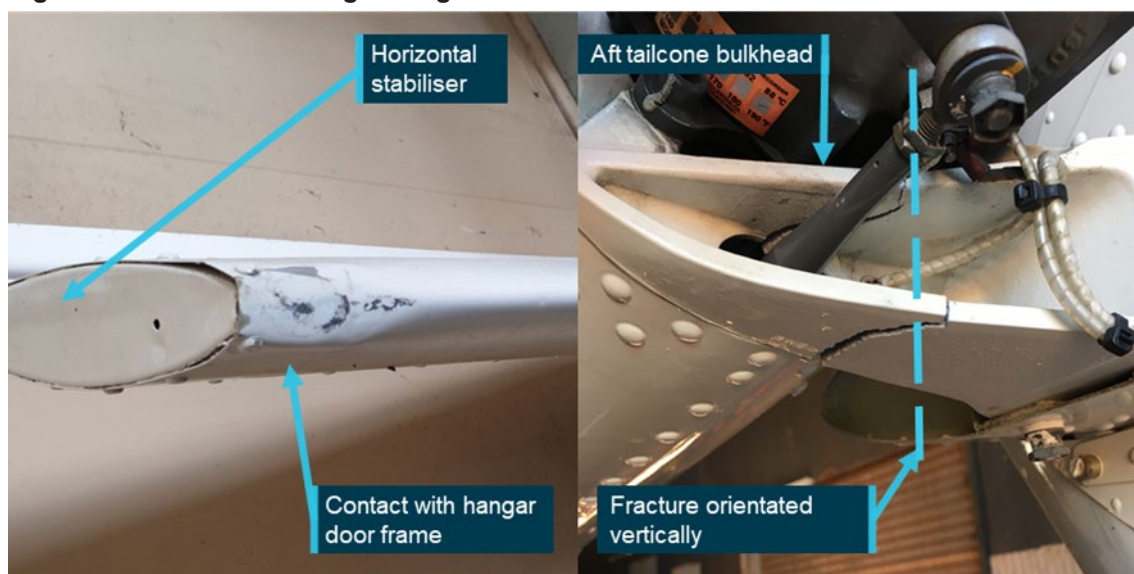
Figure 33: Ground handling damage to an R44

Three casting fractures were identified one in each of R22, R44 (Figure 33) and R66. Each was the result of contact of the horizontal stabiliser with a fixed object while ground handling the helicopter.

These failures were a known issue and the manufacturer had published service letters for each type on 11 March 2020.
