# Engine failure involving de Havilland Canada DHC-2 Beaver, VH-AAX

Moruya Airport, New South Wales, on 4 April 2022

Aviation Occurrence Investigation (Short)

AO-2022-025

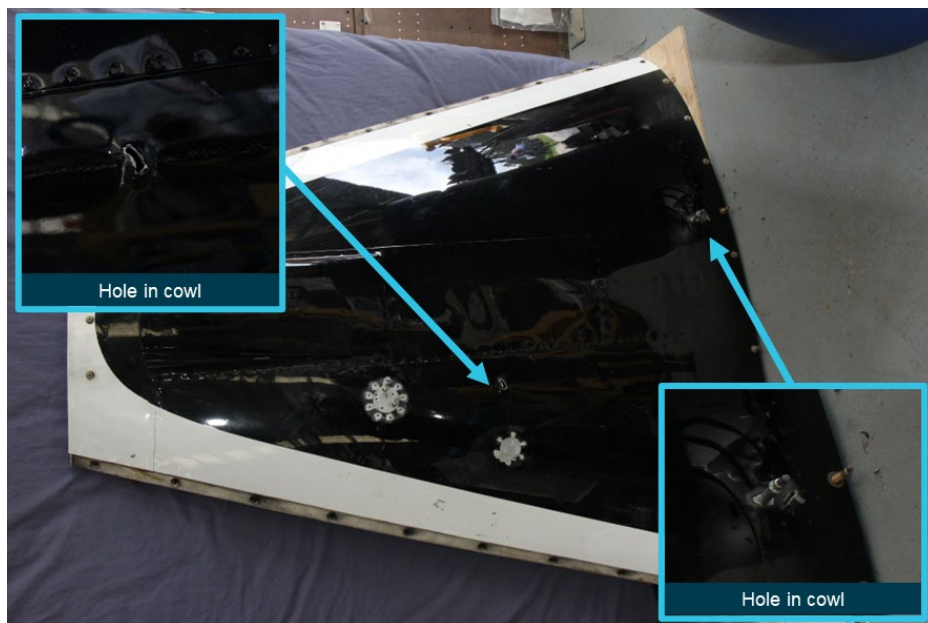
**Figure 2: Damage to upper engine cowl of VH-AAX**

A post-flight examination of the aircraft revealed holes in the cowling above the engine compartment (Figure 2). Examination of the engine identified a perforation of the external wall of the combustion chamber, holes through the exhaust assembly, failure of the main shaft and the torsion shaft,<sup>5</sup> damage to the turbine section, and loss of the 2nd and 3rd-stage turbine wheels (Figure 3).

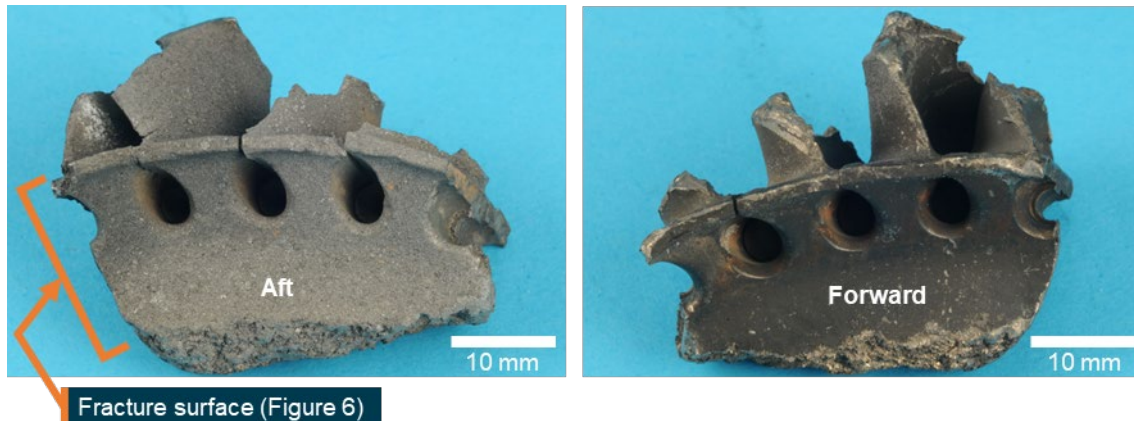
**Figure 5: Recovered fragment of 3rd-stage turbine wheel found lodged in the combustion case viewed from the aft (left) and forward sides (right)**

- there was evidence of rotational instability in the engine while the engine was running
- the main shaft and the torsion shaft had fractured
- a fragment of turbine wheel was lodged in the outwards rupture of the combustion case; this fragment (Figure 5) was consistent with the specified material of the 3rd-stage turbine wheel. No other parts of the 3rd stage turbine wheels were found in the engine
- evidence of low-cycle fatigue cracking<sup>7</sup> was identified on the fragment of the 3rd-stage turbine wheel found lodged in the combustion case (Figure 5 and Figure 6)
- the 2nd stage turbine wheel was not present
- the aft turbine bearing and bearing support, aft sump scavenge pump, aft bearing support struts, turbine nut, and tail cone were missing
- there was ‘no uncontainment’ of the combustion case.<sup>8</sup>

Both Honeywell and the National Transportation Safety Board concluded that the most likely reason for the engine failure was a low-cycle fatigue failure of the 3rd-stage turbine wheel.

When a low-cycle fatigue crack on the 3rd-stage turbine wheel, grew to a critical size, a fragment of the wheel was liberated under load, which initiated the engine failure. The fragment impacted the combustion case and became lodged. The separation of this wheel fragment resulted in significant rotational imbalance, which led to fracturing of the main and torsion shafts. Detached turbine section components then exited the engine, damaging the exhaust assembly. There was no evidence that any turbine wheel fragments exited through the combustion case with sufficient energy to cause a hazard to the aircraft. As such, the failure was deemed to be contained.

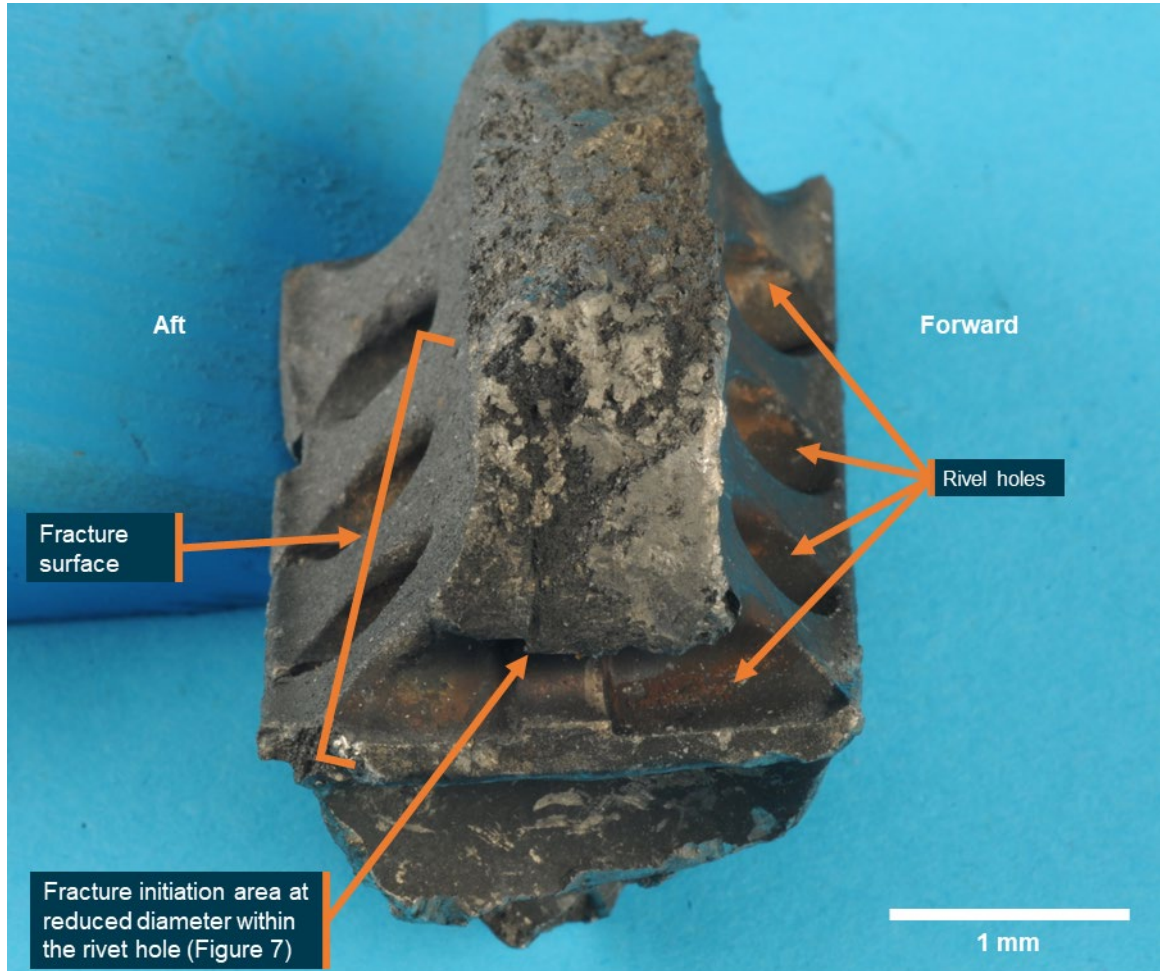
**Figure 6: Fracture surface on the 3rd-stage turbine wheel fragment**

The photograph in Figure 6 shows the fracture surface on the 3rd-stage turbine wheel fragment. The fracture surface is in the radial plane located at a rivet hole. The crack initiation area has been indicated.

The cumulative effect of the errors meant that the 3rd-stage turbine wheel had accrued 477.6 equivalent cycles more than the reported value. Consequently, at the time of the engine failure, the 3rd-stage turbine wheel had exceeded its component life-limit by 357.6 equivalent cycles. The operator had planned to replace the 3rd-stage turbine wheel upon reaching the life-limit (as recorded in the engine logbook). If the equivalent cycles had been correctly recorded, the part would have been replaced before an engine failure occurred.

- They have conducted an audit of the calculations of engine cycles and engine component total equivalent cycles for the in-service turbine engines they maintain, and any errors were corrected.
- They introduced new procedures for the calculation of engine cycles and engine component total equivalent cycles. The procedures included an independent check of input variables and calculation results. In addition, the maintainer will conduct 6-monthly internal audits of calculations.

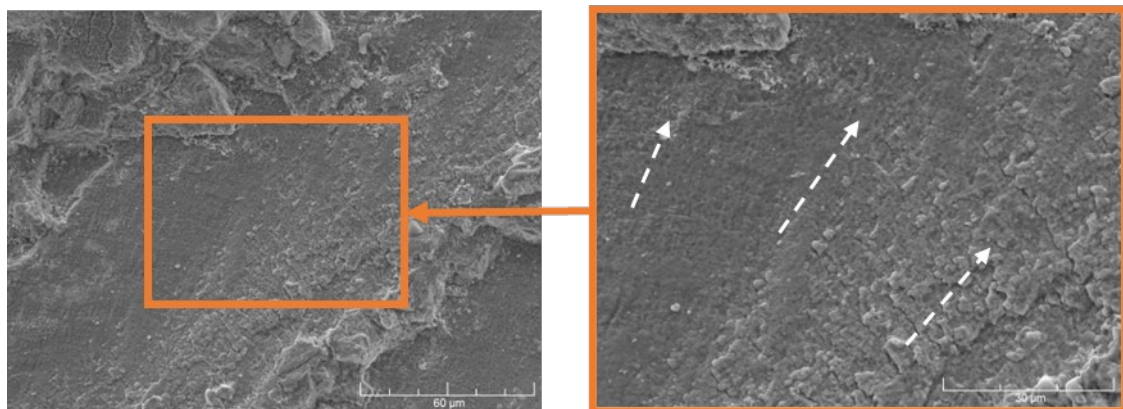
**Figure 7: Microscopic fracture surface features adjacent to the fracture initiation area indicating fatigue crack growth**

The scanning electron microscope image in Figure 7 taken of the fracture surface, showed features consistent with fatigue cracking. The direction of crack growth (white dash arrows), informed by the striations, indicated that the crack originated from the reduction in diameter of the rivet hole.
