Runway excursion involving De Havilland Canada DHC-8, VH-QQB

at Chinchilla Airport, Queensland on 23 May 2022

ATSB Transport Safety Report

AO-2022-031

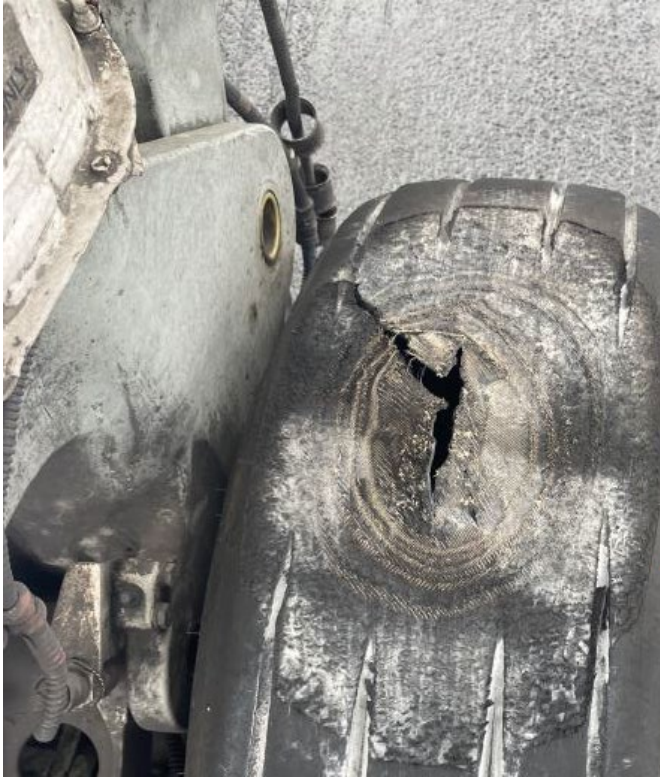
landing gear was deflated, with a flat spot that extended fully through the tyre (Figure 1). There was also mud on the left wheels.

Figure 1: Deflated outer right tyre

Engineers visually inspected the right landing gear following the incident and did not identify any defects with the brake pack or axle that would have led to the outer wheel lock up. Both right wheels were subsequently replaced. Significantly, the operator identified that, as the ECU system and the brake system are not connected, the wheel lock up was almost certainly unrelated to the ECU failure.

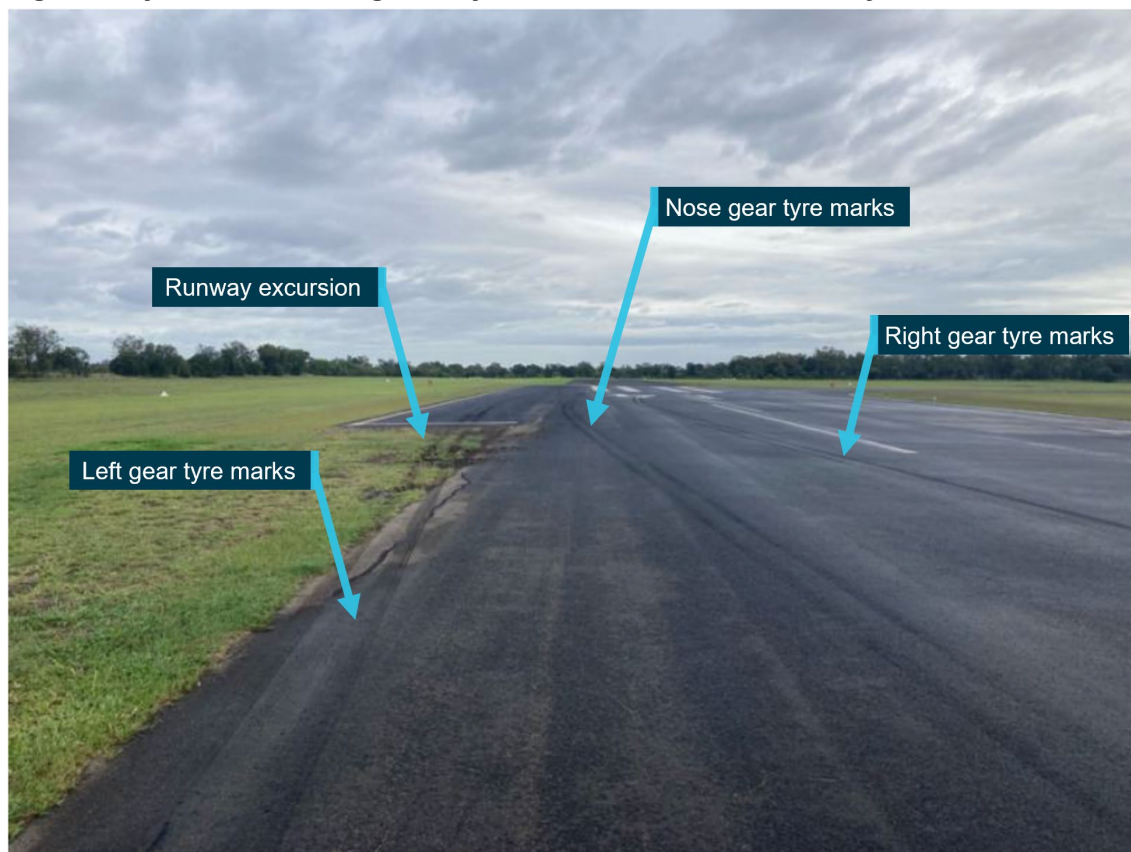
The PF then walked the length of the runway and saw tyre marks indicating that the aircraft had deviated off the left side of the runway just before the runway turning pad (Figure 2), and that the outer right tyre had 'dragged' on the runway from the point of touchdown.

Figure 2: Tyre marks showing runway excursion to the left of runway

The touchdown point could not be definitively determined however, the weight-on-wheels and squat switch parameters indicated the aircraft touched down approximately halfway down the runway (approximately 510 m beyond the runway 32 threshold). Further analysis of the data showed multiple vertical and longitudinal acceleration spikes along with GPS altitude reaching ground level coinciding with a large pitch rate oscillation approximately 4 seconds before that position. This indicated that touchdown may have occurred about 300 m beyond the runway 32 threshold. This was consistent with photographs of the main wheel skid marks on the runway.

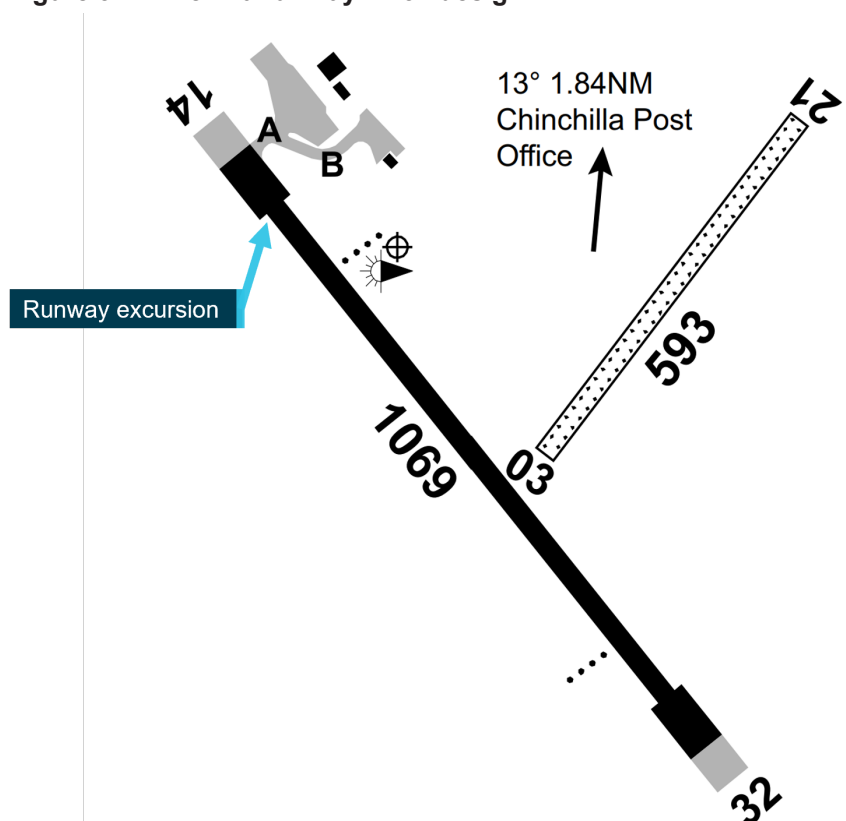
Chinchilla Airport is a certified non-controlled aerodrome located in south-eastern Queensland. The airport has 2 runways, one clay runway (runway 03/21) unsuitable for use by a Dash 8 aircraft, and one sealed runway 14/32. This runway was 1,069 m in length and 18 m wide with a turn pad at each end of the runway (Figure 3). Part 139 (Aerodromes) Manual of Standards (MOS) 2019 stated that 18 m was the minimum runway width for aerodrome design.

Figure 3: Chinchilla runway 14/32 design

Runway 14/32 had undergone rehabilitation works that included resurfacing in 2015. Technical documentation indicated that a symmetrical crown existed for the first 300 m of runway 32 with a 5 cm drop from the runway centreline to both runway edges. The remaining 769 m possessed a uniform 1.5% downward slope from left to right across the runway. This transverse slope was within the permitted range specified in section 6.08 of the Civil Aviation Safety Regulations - Part 139 (Aerodromes) Manual of Standards (2019), and opposite the direction of the runway excursion.
