Runway excursion involving GippsAero GA8, registration VH-TBU

Rat Island, Western Australia on 6 April 2023

ATSB Transport Safety Report

AO-2023-016

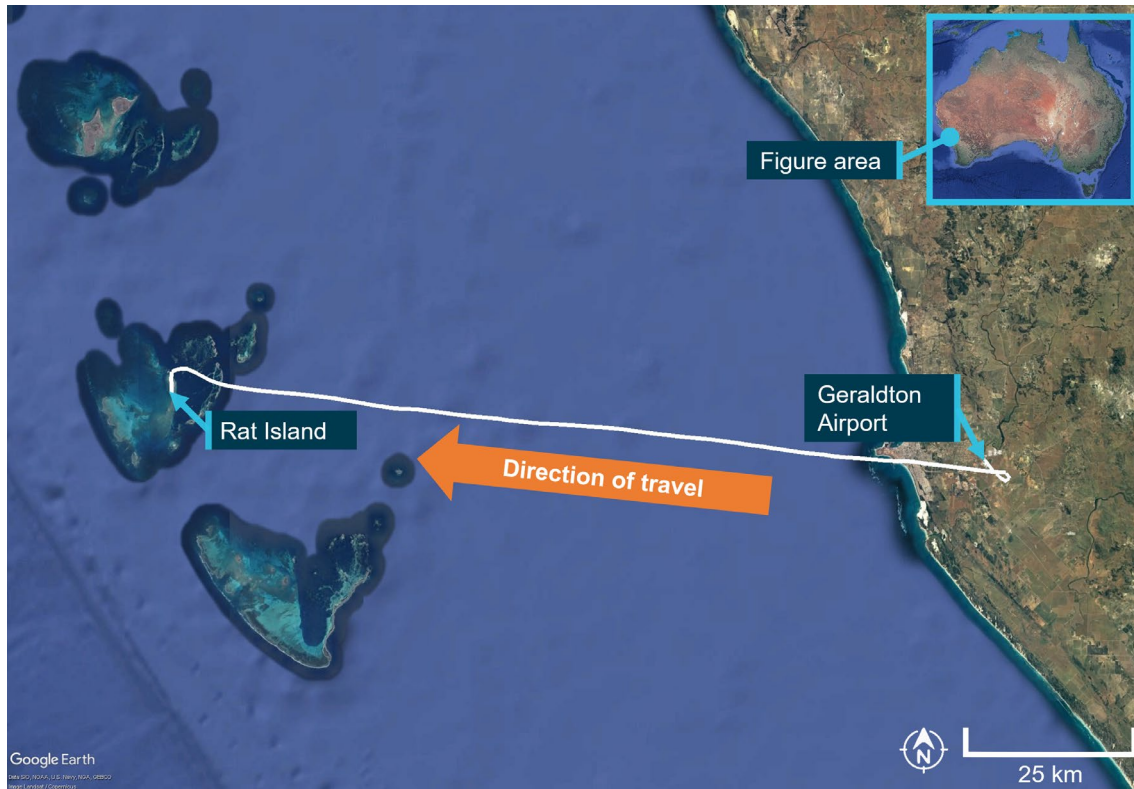
Figure 1. Flight track of VH-TBU

On 6 April 2023, a GippsAero GA8 Airvan registered VH-TBU and operated by Shine Aviation Services was being used on a chartered passenger flight. The aircraft departed Geraldton, Western Australia at 0814 local time on a flight to Rat Island in the Houtman Abrolhos Island chain, Western Australia (Figure 1). Onboard were the pilot and 6 passengers.

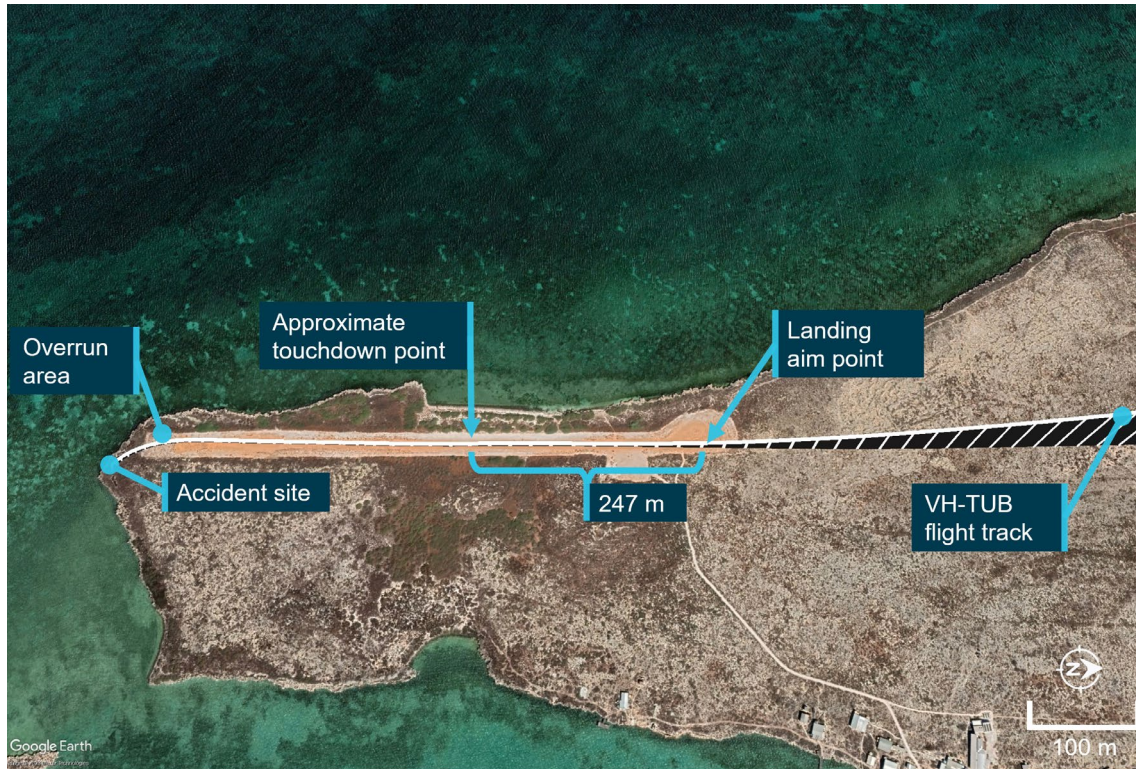
Figure 2 Rat Island runway and flight path of VH-TBU

During the landing, the aircraft floated significantly more than the pilot expected, with the aircraft touching down about 247 m beyond the threshold (Figure 2). The pilot recalled 'jumping on the brakes' as soon as they touched down, and then realised that the aircraft could not be stopped before the runway end. In response, they applied left rudder in an attempt to avoid entering the water in the overshoot. The aircraft traversed the runway overshoot area, coming to rest on the island's edge, before tipping forward into shallow seawater at about 0841 (Figure 3).

At 50 ft altitude on final, and about 70 m from threshold, the aircraft was travelling at a groundspeed of 88 kt. At the runway threshold (about the landing aim point), the aircraft was about 21 ft above ground level (AGL) and was travelling at a groundspeed of 86 kt. After the flare, the aircraft floated for about 170 m, and touched down approximately 247 m beyond the threshold, travelling at a groundspeed of 77 kt. It was at this point that the pilot reported that the airspeed was slightly below the aircraft's V_{ref} speed of 70 kt. The aircraft exited the overrun area at a groundspeed of about 43 kt. Full flaps remained deployed during the landing sequence.

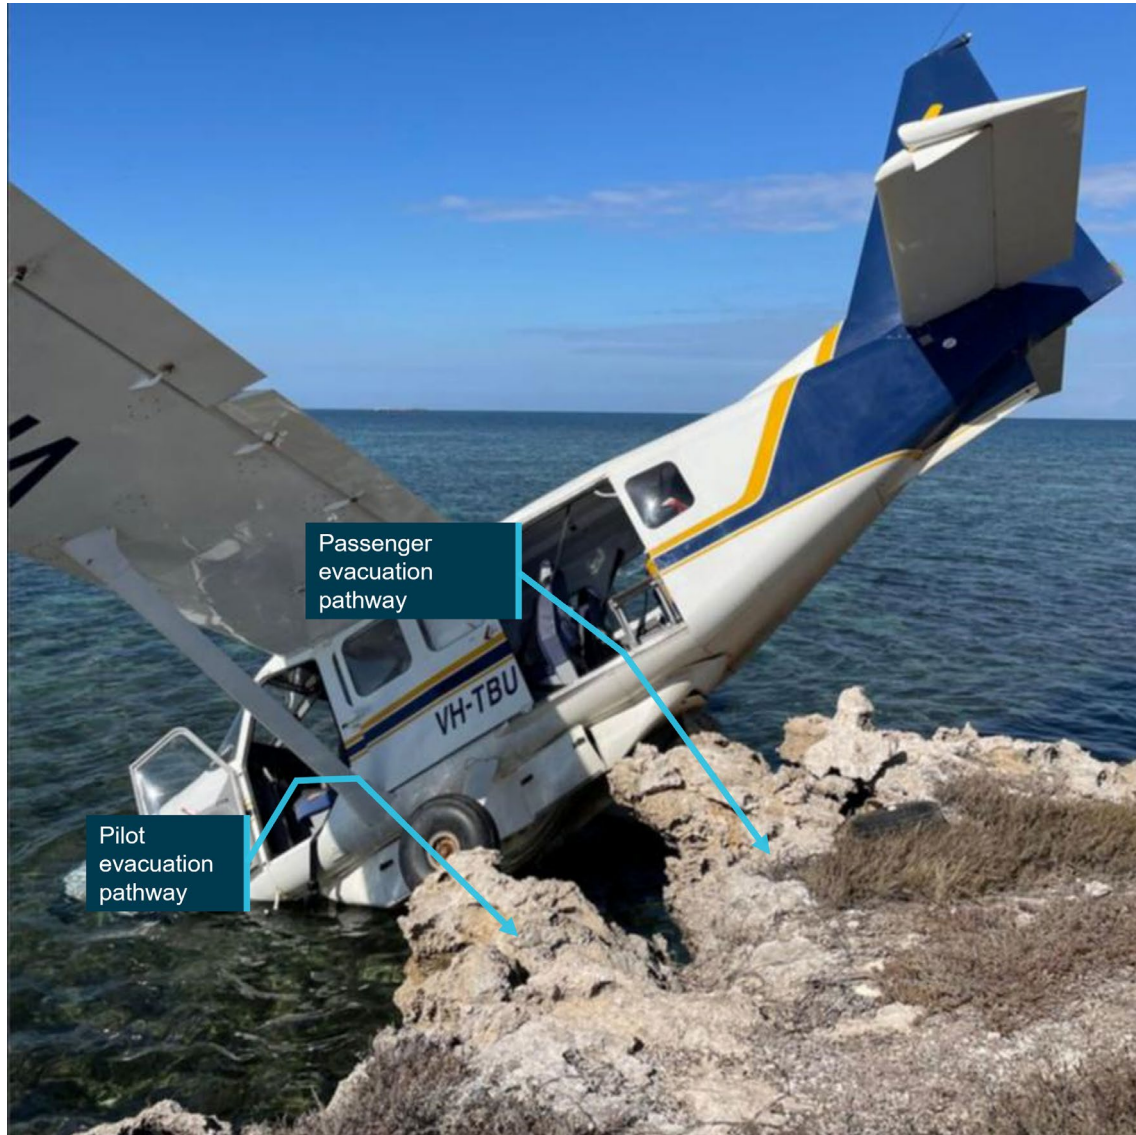
Figure 3 VH-TBU accident site

Water entered the cockpit to about 'shin-height' and the passenger seated in the rear left seat opened the emergency exit upon recalling the instructions from the safety briefing. All 6 passengers evacuated the aircraft through the rear left door. The pilot evacuated through the left cockpit door, walking across the wing strut onto land (Figure 3).

Neither the pilot nor 6 passengers were injured during the landing or evacuation. The aircraft sustained substantial damage to the nosewheel, propellor, right landing gear and cargo pod, and remained partially submerged for several days before being airlifted back to Geraldton.
