# Fuel exhaustion and collision with terrain involving Robinson R44 II, VH-IDW

King River, Northern Territory on 28 February 2022

ATSB Transport Safety Report Aviation Occurrence Investigation (Systemic) AO-2022-009 Final – 22 November 2023 Cover photo: Dallas Presser

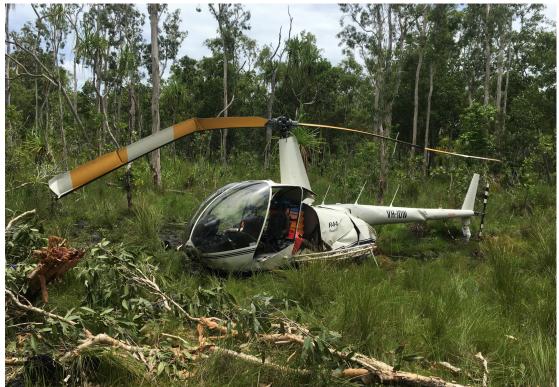
#### Figure 3: VH-IDW accident site

At 1036, they located the accident site closest to the first planned nest and landed nearby. They found the sling person (egg collector) fatally injured. VH-IDW was located 44 m beyond the sling person, substantially damaged having collided with trees and terrain (Figure 3). The accident pilot had sustained serious injuries and was found lying beside the helicopter. After providing reassurance to the pilot of VH-IDW, the other pilot returned to their helicopter and briefly became

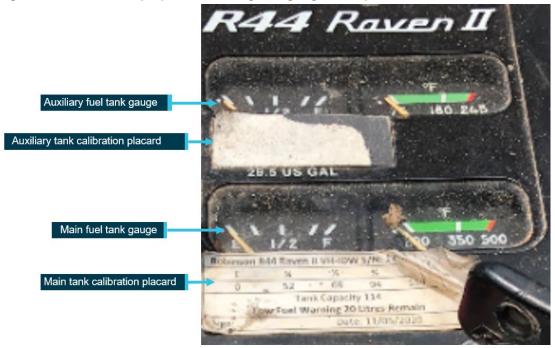
#### Figure 6: VH-IDW cockpit photo showing fuel gauges and placards

Calibration of the main and auxiliary tank fuel gauges was required every 48 months. The last calibration was conducted by a CASA-authorised maintainer in May 2020. The calibration is shown in Figure 5. The associated placards for the main and auxiliary tank gauge calibration were affixed in the cockpit, but the auxiliary tank placard was damaged and illegible (Figure 6).

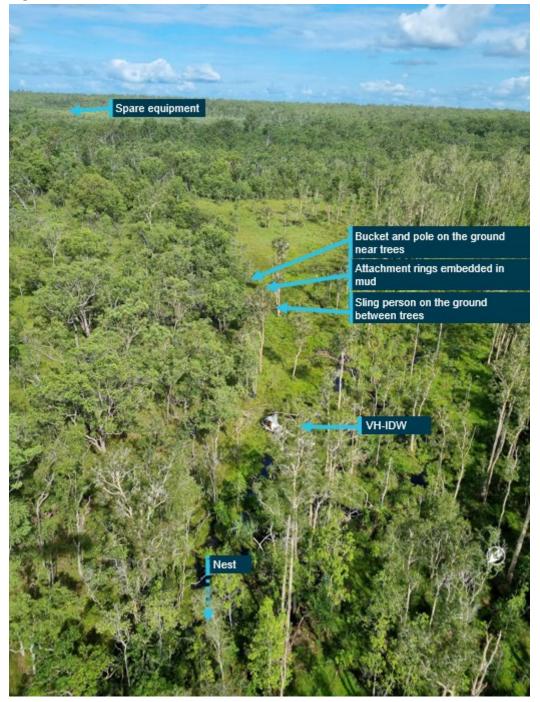
Figure 14: Accident trail

Assuming a direct transit from the clearing towards the first nest, the trees between where the helicopter probably took off, and where the egg collector was released, were 12–15 m tall. The trees in the vicinity of the target crocodile nest were at least 18 m tall. The bucket and pole were reported to have been found on the ground between trees about 4 m prior to the long line attachment rings. The egg collector was located about 8 m beyond the attachment rings and between 2 trees (Figure 14). On the first tree in the direction of flight, a section of bark had peeled away, about 4–5 m above the ground. While this may have been evidence of possible recent impact, no associated bark was found on the equipment or egg collector.

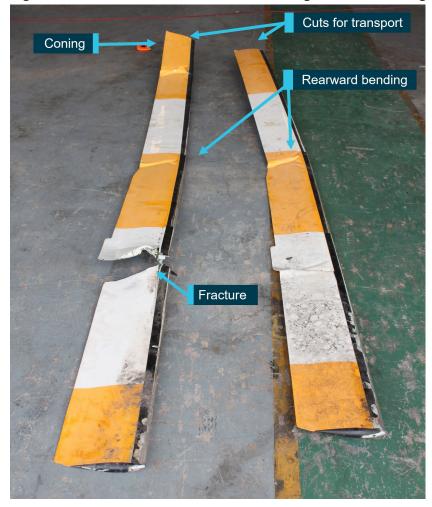
Figure 16: VH-IDW's main rotor blades showing rearward bending and fracture

The main rotor head droop stops were undamaged with no evidence of excessive teeter or mast bumping. Both blades exhibited rearward distortion about mid-span, with some mild upward

coning, indicative of low energy during the descent and tree strikes (Figure 16). The fractured pitch link failed in overstress at the upper rod end thread. The corresponding rod end was secured to the pitch horn, with a slight inboard deflection consistent with the rotor strike and blade fracture. The associated fractured blade had more pronounced coning near the hub, and impact marks and deformation on the lower surface, consistent with the blade being able to rotate about the pitch axis (up) following the pitch link failure. The blade tip was likely liberated at the stump strike.

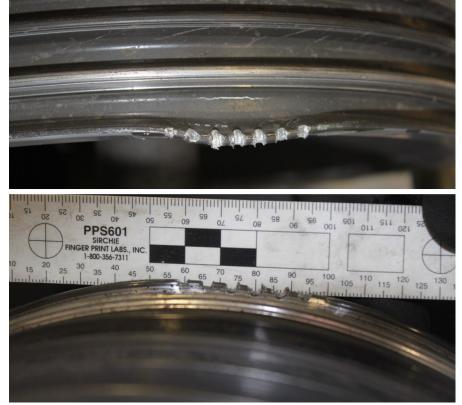
Figure 17: Upper sheave damage from impact with non-rotating starter ring gear

Significantly, impact damage and bending to the upper sheave forward end, lower surface was consistent with impact with the starter ring gear, and showed defined teeth impact marks, with no smearing (Figure 17).

This strongly supported the ring gear being stationary (engine stopped) when the helicopter collided with terrain.

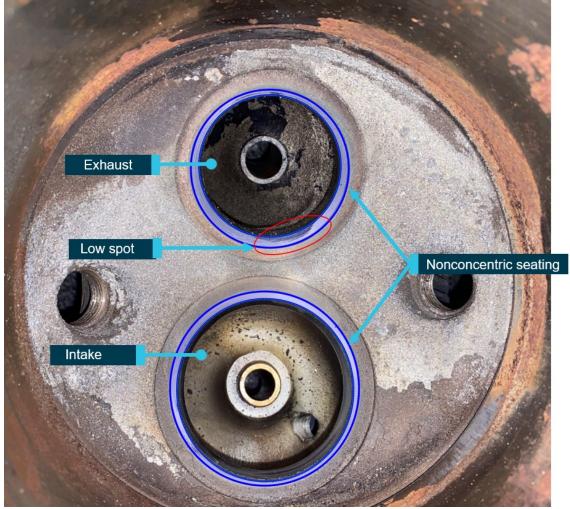
Figure 18: No. 6 cylinder intake and exhaust seats showing nonconcentric valve seating and low spot

The cylinders were then removed from the engine and subjected to a second, differential compression check on a test bench. During testing, the valves were tapped to ensure any debris was not preventing a good seal. All cylinders then reached or exceeded 70/80 except cylinder No. 6, which only attained 5/80. The leak from cylinder No. 6 was visually identified as coming from both valve seats.

The valves from cylinder No. 6 were removed and the seating surface contact was examined. The seating faces were uneven (nonconcentric), particularly on the intake, and the exhaust seat had a low spot consistent with the valve not sealing properly (Figure 18). The poorly seated valves would have accounted for the low compression although the valves appeared in good condition with no evidence of carbon build-up. The No. 6 cylinder had been overhauled in 2016 and a vacuum pressure test was reportedly conducted at the time to check for leaking, however the results weren't recorded. After overhaul, the cylinder was stored until installation in VH-IDW in 2022.

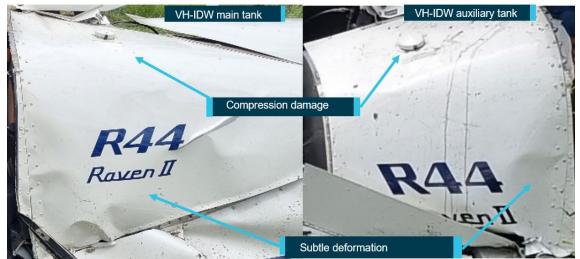
Figure 19: VH-IDW's auxiliary and main tanks showing subtle deformation and compression damage

(Figure 19 and Figure 20). Robinson assessed that the deformation of the fuel tanks was consistent with 'lower fuel quantity' but could not determine whether the deformation was due to impact damage, bulging of internal contents, or a combination of both. Robinson provided an image of an auxiliary tank that was known to have been nearly full at impact for comparison, which presented severe bulging over the entire tank (Figure 20). When compared with the exemplar image, the damage to VH-IDW's fuel tanks was assessed as representative of the high vertical impact resulting in severe distortion to the airframe around the tanks, with little or no fuel within. This was also consistent with an ATSB investigation into a previous Robinson R22 accident, in which the tank was half-full on impact and displayed distinctive bulging from the internal contents that was not evident in the deformation of VH-IDW's tanks.

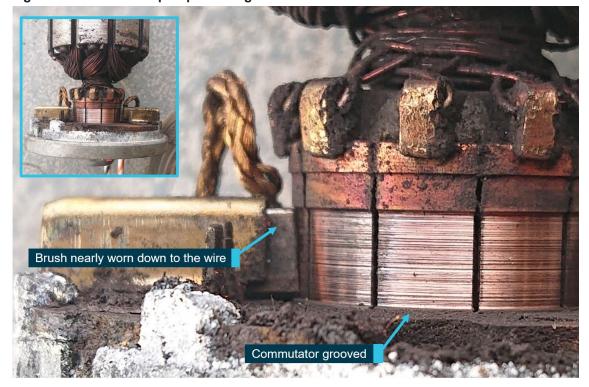
Figure 21: Electric fuel pump showing worn brush and commutator

The electric fuel pump was connected to a power source and operated. The pump was then disassembled, and the pump vane could be rotated manually. The electric motor was worn, with brushes almost down to the leads and the commutator grooved (Figure 21).

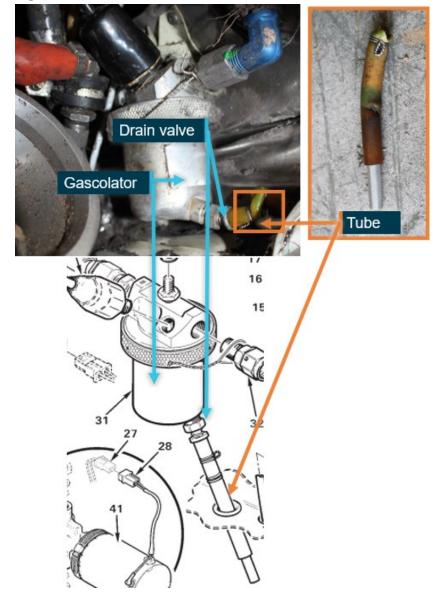
Figure 22: Gascolator, drain valve and tube, and R44 II Illustrated Parts Catalog extract

The fuel lines, flow divider and gascolator were all clean, and empty of fuel. The gascolator drain valve was found depressed against the firewall when examined at the Darwin hangar but reset when manipulated. Upward forces during impact distorted the aircraft structure around the drain assembly resulting in the drain extender tube, used to compress the drain valve, bending and splitting (Figure 22).

Following removal from the accident site, yellow sand was observed in the end of the tube, which was consistent with the site where the helicopter was set down during the wreckage retrieval. The sand likely entered the tube as the skids were removed prior to extrication of the wreckage from the swamp, leaving the tube as the lowest point below the fuselage. The gascolator bowl was dry and the filter screen was clear. Examination of the cowls did not identify any discolouration or staining that would be associated with leaking fuel, either prior to, or after the accident.

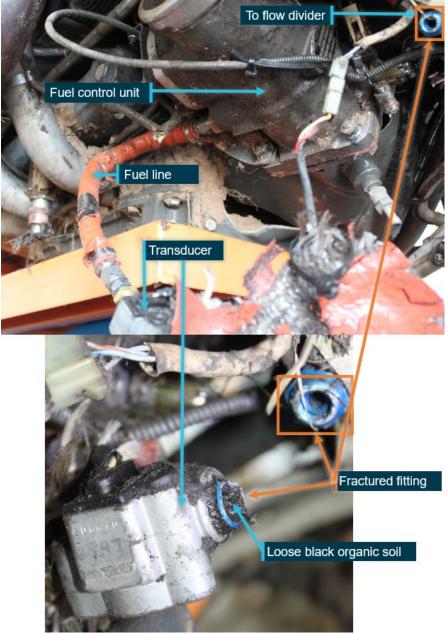
Figure 23: Fractured fitting between transducer and flow divider

The fuel flow transducer, positioned between the fuel control unit and flow divider, had a fractured outlet fitting. The fracture surface was consistent with impact damage, with no evidence of pre-existing fatigue. On behalf of the ATSB, Robinson conducted a test by removing the fuel line (and transducer) from the FCU outlet with the fuel valve open, mixture full rich and throttle full open. Robinson found that due to gravity, the fuel flowed out at a significant rate and would eventually empty the tanks. Loose black organic soil consistent with the accident site filled the transducer end of the fractured fitting (Figure 23), which likely would have been dislodged at the fuel flow rate demonstrated by Robinson.

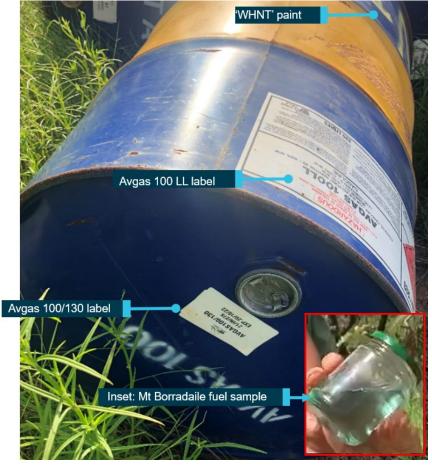
Figure 24: WHNT fuel drum at Mount Borradaile showing distinct paint and labels. Inset: Fuel sample

The WHNT fuel drums at Mount Borradaile contained green-coloured 100/130 'leaded' fuel.<sup>16</sup> The same person who rolled out the 2 fuel drums for the R44 pilots to refuel on the accident day, subsequently identified those drums and provided samples to the ATSB for testing. The person identified that as the drums had been reused, they had old 100 LL labels on the side, and the current 100/130 fuel labels on the top (Figure 24). WHNT was also clearly painted on the drums. The person checked the labels and seals, and recalled that the fuel in the drums was green.
