# Wirestrike and collision with terrain involving Robinson R44 II, VH-WLH

Bingegang, Queensland on 4 April 2023

**ATSB Transport Safety Report**

AO-2023-014

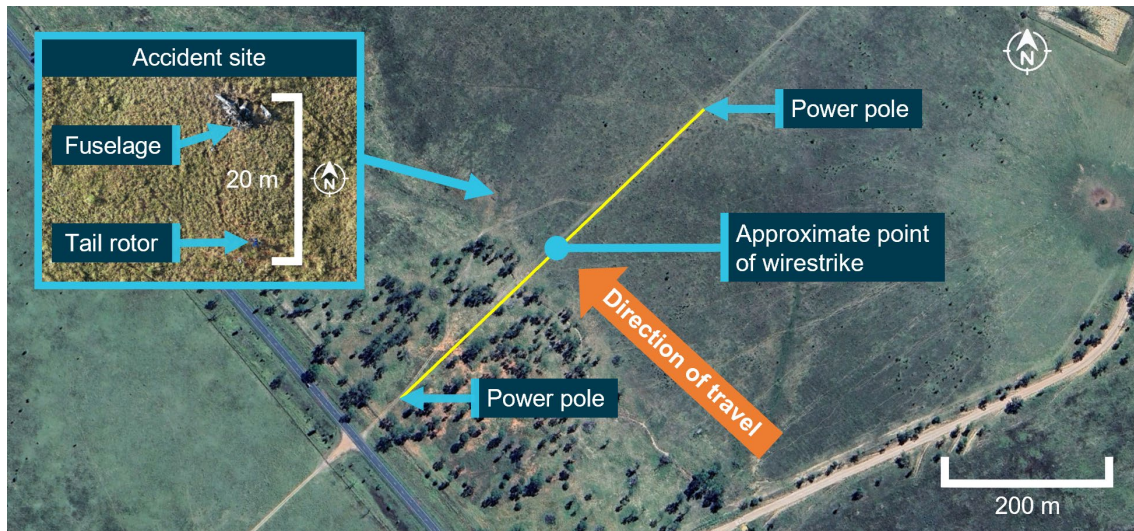
**Figure 1: Accident site**

Figure 1 shows an overview of the accident site. The powerline, a single-wire earth return (SWER) wire that ran across the property, was not marked and there was no requirement within the applicable aviation regulations, Australian Standards or elsewhere to do so. The wire was estimated to be at a height of 5.6 m at the point of impact.

The terrain was clear to the right of the helicopter's flightpath, and there were trees taller than the wire height that would have obscured the wire and pole on the left side.

The helicopter impacted terrain left side down and yawing to the right about 90 m beyond the point of contact with the wire and facing back towards the wire. There was insufficient evidence available to determine the angle and speed of impact with the ground.

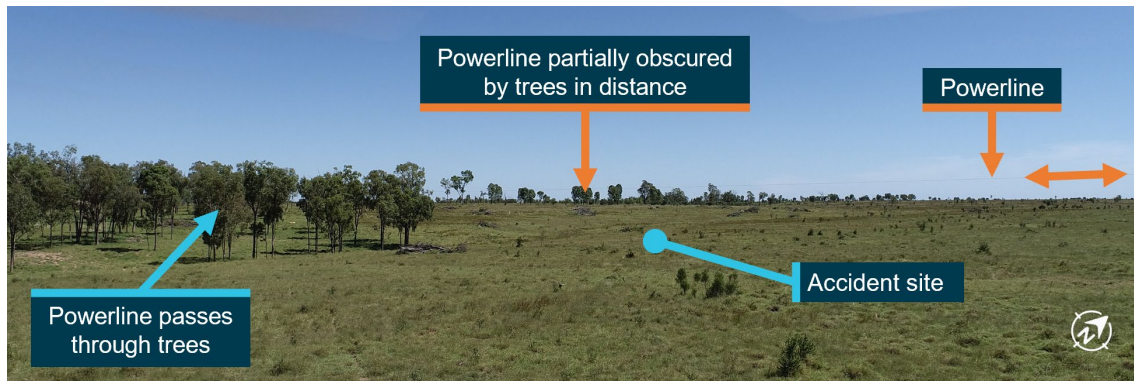
**Figure 2: RPAS simulation of flight path**

Queensland Police officers later returned to the accident site to conduct a simulation using a remotely piloted aircraft system (RPAS) of the helicopter's approximate flight path and height prior to striking the powerline assuming that it had not turned. The simulation was conducted in conditions similar to those on the day of the accident. Images from the RPAS simulating what the pilot would have seen when approaching the wire showed the wire was difficult to distinguish from the background and the left pole was obscured by trees (Figure 2).

- The powerline was partially obscured by trees and terrain, depriving the pilot of critical visual cues as to its presence.
