# Fuel starvation and ditching involving Piper PA-28, VH-FEY

15 km north-west of Jandakot Airport, Western Australia on 20 April 2023

## **ATSB Transport Safety Report**

AO-2023-021

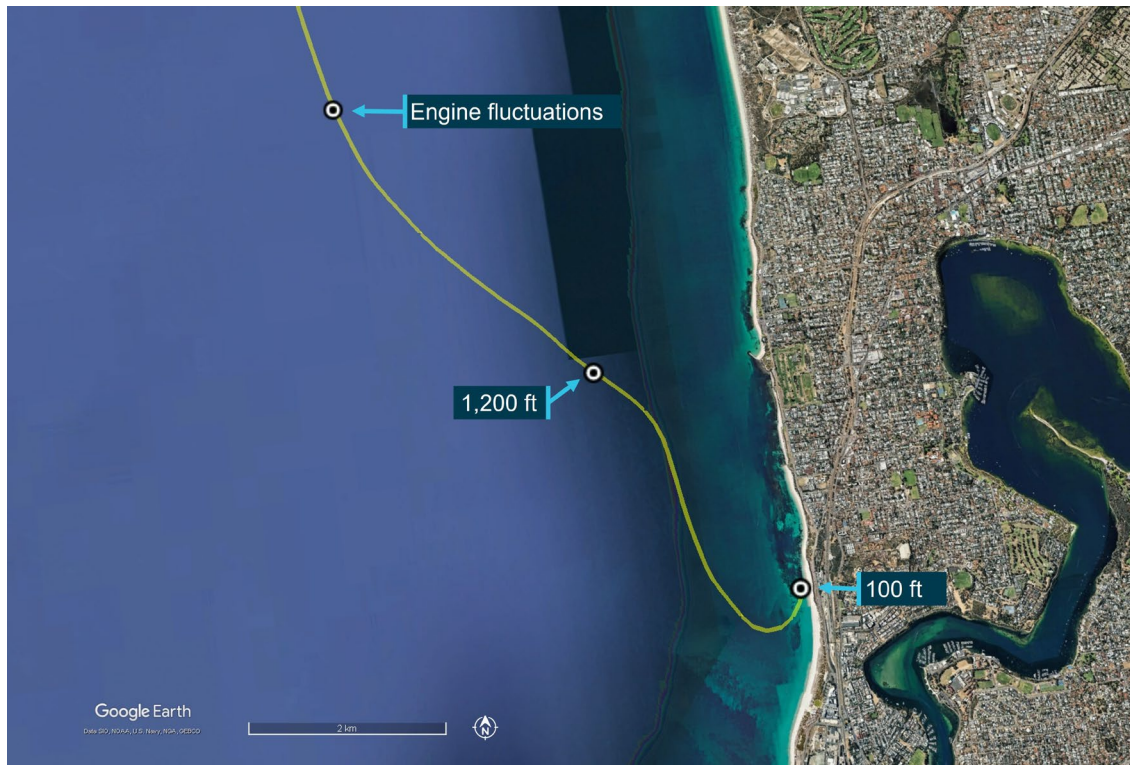
**Figure 1: Aircraft track from engine fluctuations to ditching**

Now at about 1,000 ft, the pilot observed that they were not far from Leighton Beach. Considering that the surface wind was coming from the north-east, the pilot decided to turn into wind and land on the beach (Figure 1). During the turn however, the pilot noticed there were people all over the beach and that the plan was unworkable.

By the time the turn had been completed, at about 300 ft, the engine had completely lost power and the propeller stopped turning shortly afterwards. The last data point was recorded at 1709.

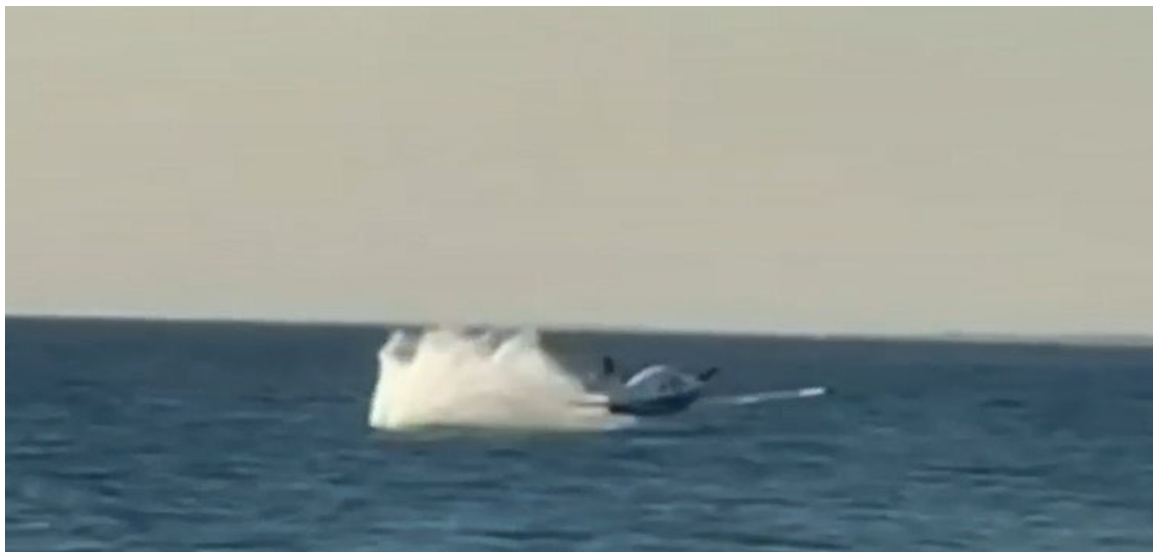
**Figure 2: VH-FEY ditching touchdown**

With the stall warning still going, a main wheel contacted the water and the aircraft skipped along the surface for a few seconds. Then the right wing dropped rapidly consistent with a stall and dug into the water, quickly stopping the aircraft. Water gushed up over the front of the aircraft and windscreen.

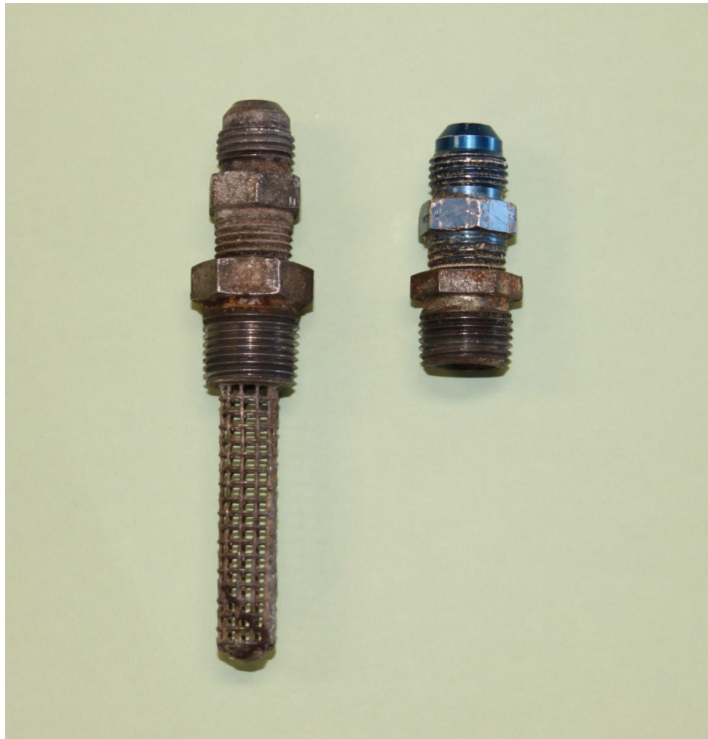
**Figure 3: VH-FEY Fuel tank outlet fittings - left with finger strainer and right without finger strainer**

Examination of the aircraft fuel system was focussed on the right fuel tank assembly and fuel line to the selector. The right tank outlet fitting did not incorporate a 'finger' strainer, which was a non-conformance with the fuel system data in the PA-28 parts catalogue. This outlet fitting was a different type to the conforming left tank outlet. No foreign object or evidence of contamination was found in the right tank.

The ATSB considered the absence of a finger strainer in the only outlet from the right tank increased the risk of foreign object obstruction to fuel flow from the tank. This scenario would require an object of about the size of the internal diameter of the outlet fitting, which was stepped from 10 mm to 7 mm. Given there were no foreign objects found in the tank and no openings in the tank that would allow migration of any objects post-ditching, this scenario was considered highly unlikely. In addition, the aircraft manufacturer advised that there were no service difficulty reports or occurrences associated with the finger strainer (72091-000).
