Level crossing collision between passenger train E820 and road vehicle

Wynnum West, Queensland, on 26 February 2021

ATSB Transport Safety Report

RO-2021-005

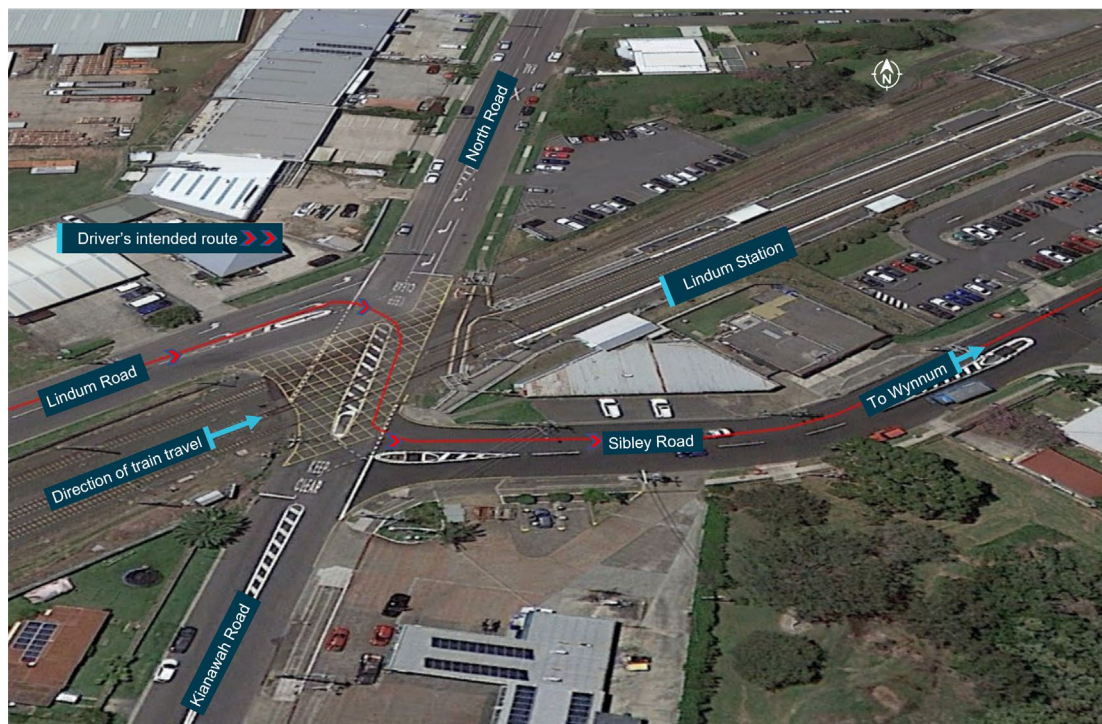
Figure 1: Road user's likely intended route from Lindum Road through the level crossing

As the driver of the motor vehicle travelled along Lindum Road, in an easterly direction, they approached the intersection of Lindum Road and North Road, which was located on the northern side of the Kianawah Road level crossing. As illustrated in Figure 1, the likely intention of the driver was to turn right at the intersection and pass through the level crossing enroute to Wynnum. A friend reported to the Queensland Police Service they did not know if the vehicle driver had been through this intersection previously, but assumed they would have been using a navigation system to assist with directions.

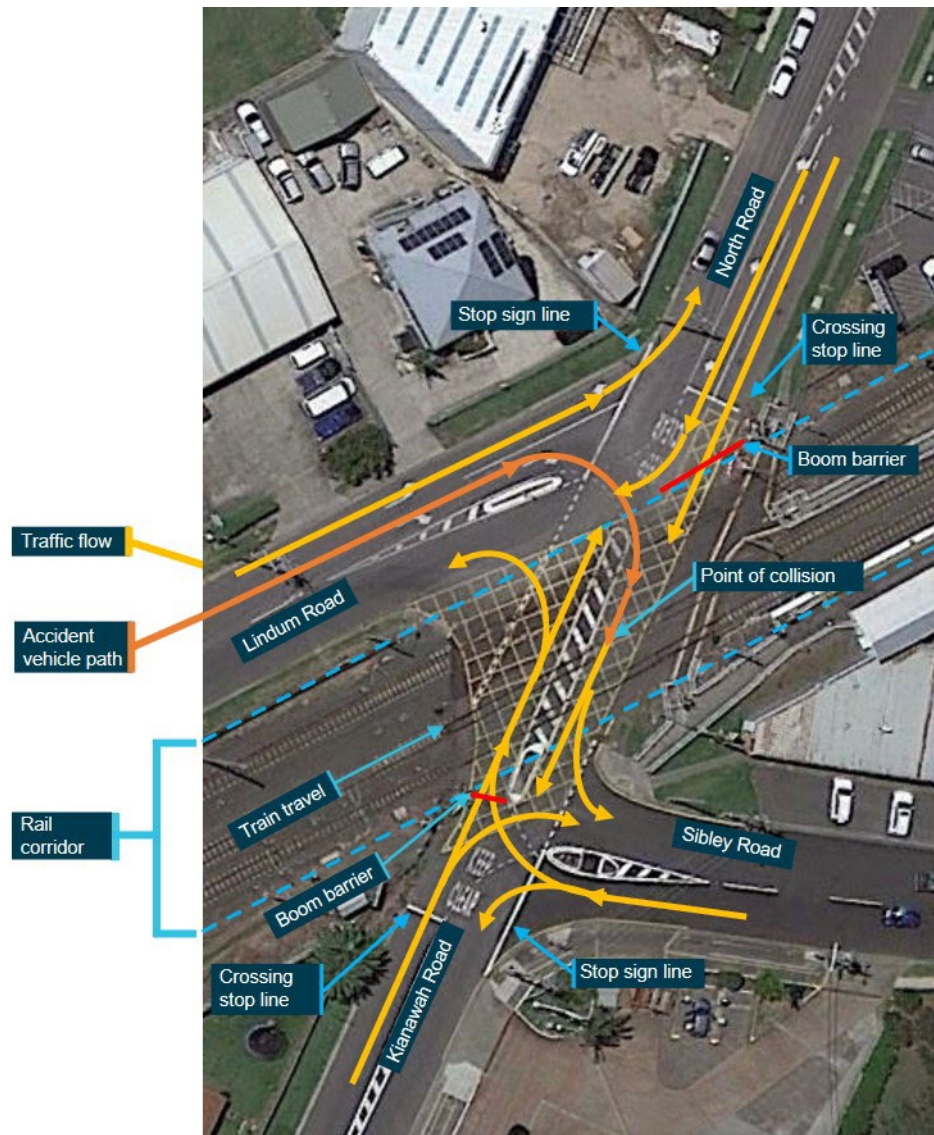
Figure 3: Kianawah Road level crossing showing intersections and general traffic flow

Depicted in Figure 3 are the potential variations in road vehicle travel through the level crossing (yellow). The path of the motor vehicle involved in the accident (orange), the direction of the train's travel, and the point of the collision are also shown.

Problems that existed for motorists using the Lindum Road turn-right lane was that it merged with North Road, Kianawah Road and the rail corridor at the level crossing. This created a condition where traffic from Lindum Road approached the entrance to the level crossing at a 40° angle, forming a significant 12 m wide entrance to the level crossing, as illustrated in Figure 3. This, and traffic activity connecting the various access roads at the intersection created complexity for road users. To reduce the complexity and driver confusion, turn line markings were painted on the road pavement connecting the stop line and the painted median island guiding road users from Lindum Road through the level crossing.
