# VFR into IMC and controlled flight into terrain involving Cessna R182, VH-EHM

36 km north-west of Archerfield Airport, Queensland on 29 August 2022

## ATSB Transport Safety Report

AO-2022-041

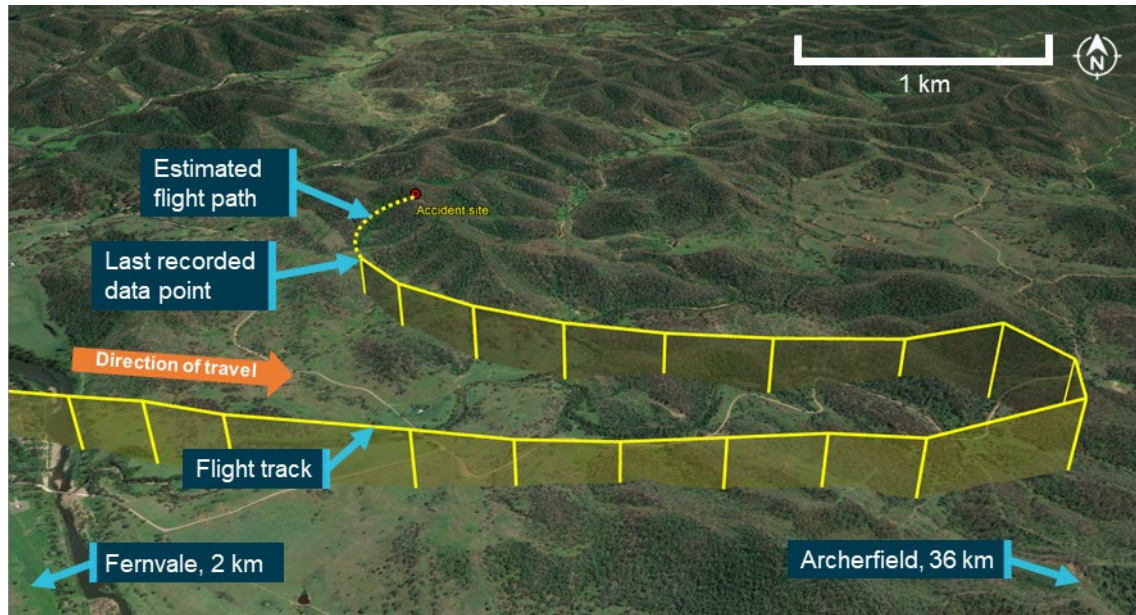
**Figure 3: Final flight track segment and accident site**

After passing Fernvale, the flight progressed down a valley before completing another 180° turn while climbing to 1,200 ft (1,000 ft AGL). After completing the turn, the aircraft was then descended to 800 ft (600 ft AGL) before turning right, back towards the D'Aguilar Range (Figure 3) and towards observed low cloud. During this turn, at 1007, the aircraft impacted terrain at an elevation of about 650 ft. The aircraft was destroyed, and the occupants were fatally injured.

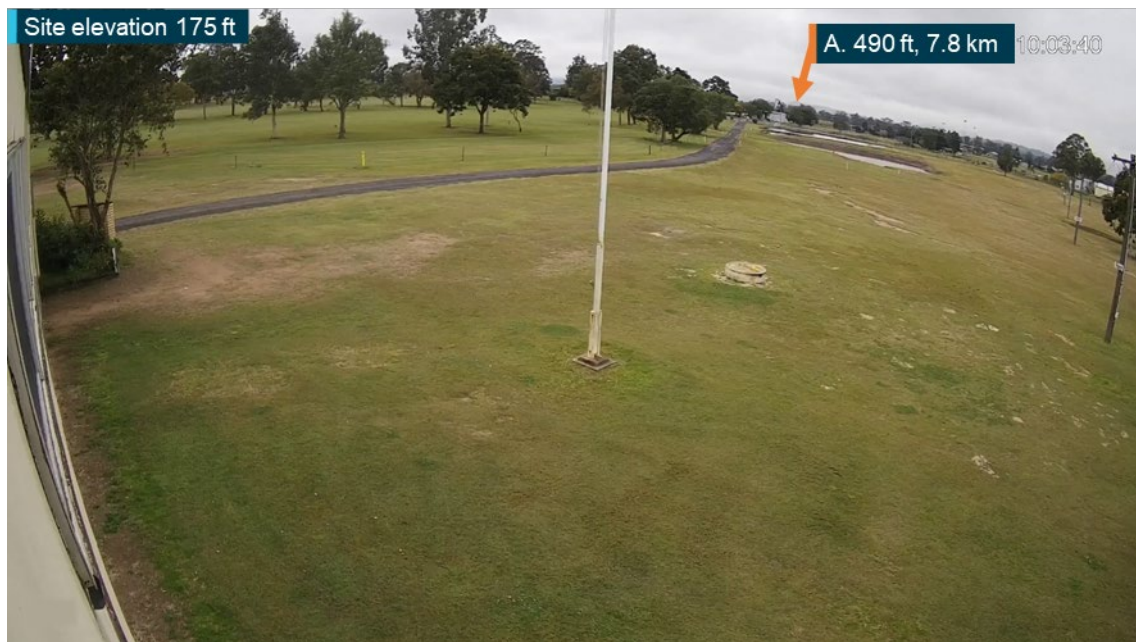
**Figure 9: Image from Lowood towards D'Aguilar Range at the time of flyover**

The surveillance video camera from Lowood, located about 10.5 km west-south-west of the accident site, captured the aircraft flying overhead below a low-level cloud layer about 4 minutes before the accident. No abnormal engine or propeller sounds were noted. A mountain peak (A) about 7.8 km from the camera location was just visible (Figure 9).

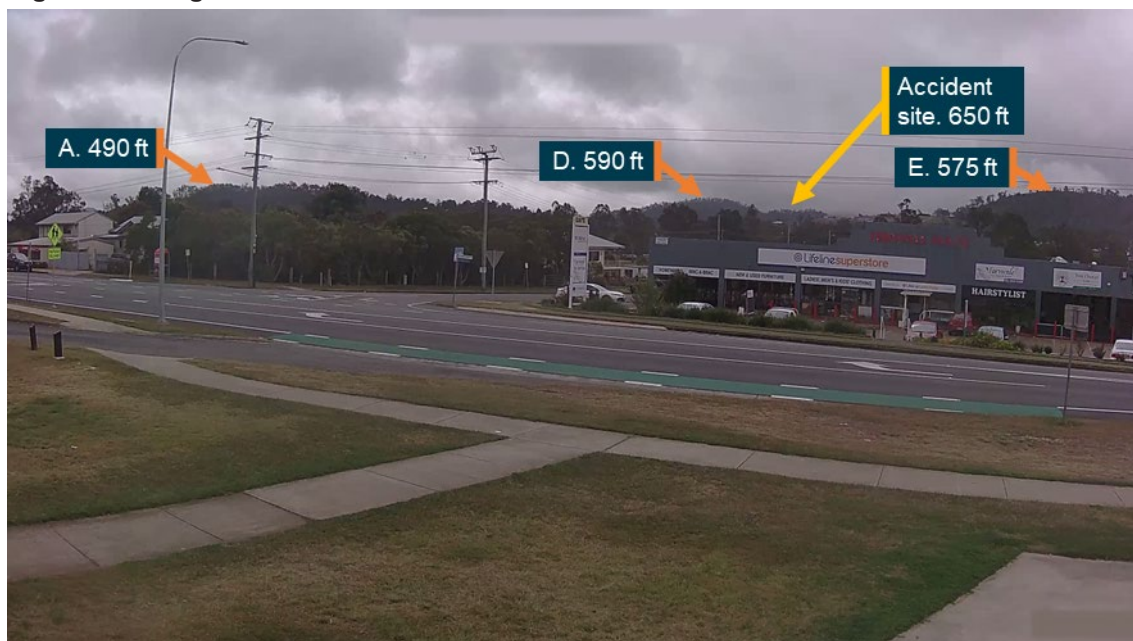
**Figure 11: Image from Fernvale around the time of the accident**

Video footage of the conditions around the time of the accident<sup>22</sup> (Figure 11) showed low level cloud over the area of the D'Aguilar Range, with mountain peaks B and C, and the accident site, obscured by cloud. The aircraft could not be seen in the footage.

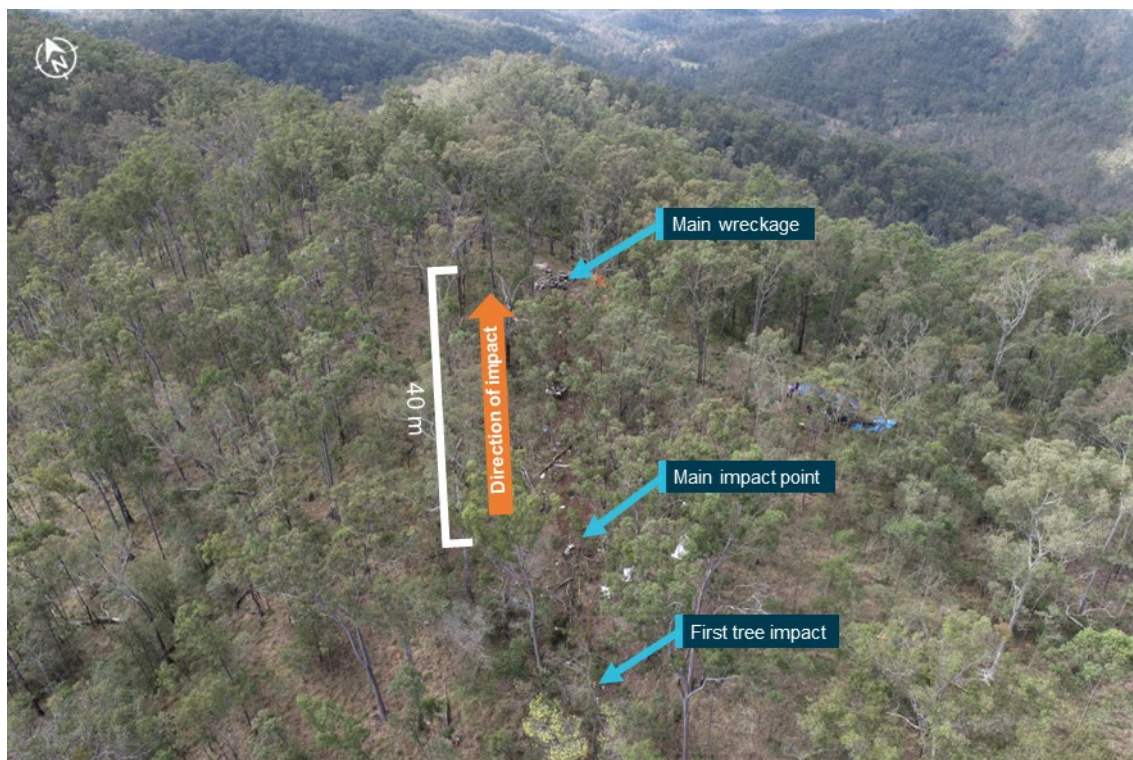
**Figure 14: Accident site**

The accident site was located within the D'Aguilar Range on a steep section of mountainous terrain covered with trees (Figure 14).

The aircraft impacted terrain at 650 ft AMSL, about 28 ft vertically below the top of the ridge. The wreckage trail extended about 40 m from the initial impact point to the top of the ridge where most of the wreckage, including the engine, was located. The propeller was located about 10 m forward of the main impact point.

On-site examination of the engine did not reveal any pre-impact mechanical damage, while damage to the propeller indicated that the engine was providing high power at impact. The landing gear and flaps were retracted and there was no evidence of an in-flight break-up or a pre-existing defect with the aircraft. Due to extensive damage, the serviceability of the flight instruments, auto-pilot, and associated systems could not be determined. The pressure altimeter subscale QNH<sup>30</sup> setting was appropriately set. The fuel tanks ruptured on impact, and an odour of fuel was present at the site. No fuel samples were available for recovery.

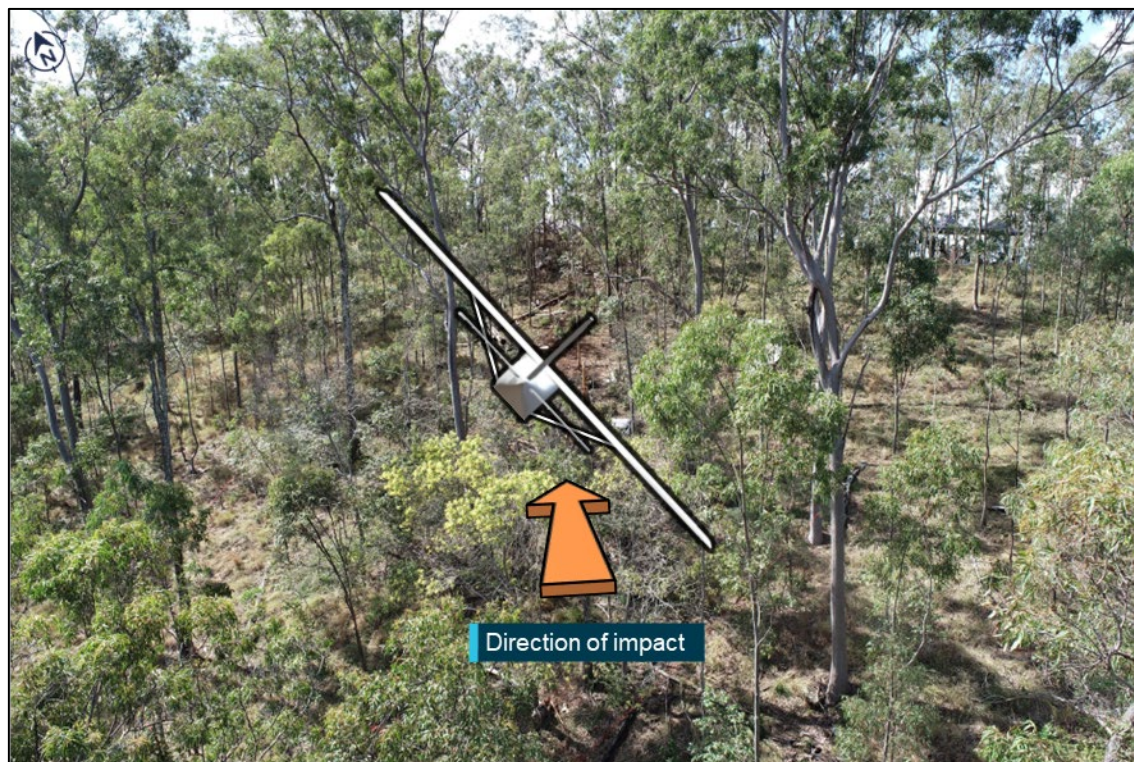
**Figure 15: Representation of the aircraft's attitude at time of impact with trees**

There were several initial impact points with numerous trees before the aircraft impacted the ground. These indicated a final flight path descent angle of about  $2^\circ$ , in about a  $47^\circ$  right bank (Figure 15).
