# Collision with terrain involving Stoddard Hamilton Aircraft Glasair Super II FT, N600

Near Wedderburn aircraft landing area, New South Wales, on 26 December 2022

Aviation Occurrence Investigation (Short)

AO-2022-068

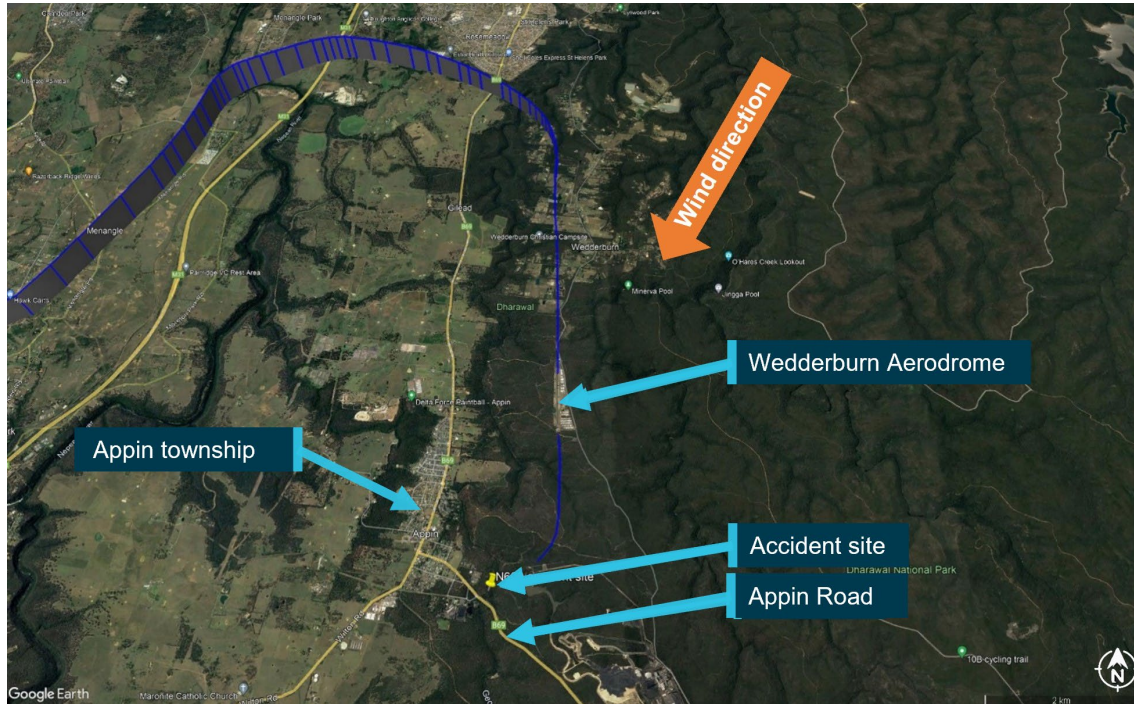
**Figure 2: ADS-B Exchange flight data showing the landing and go-around at Wedderburn aircraft landing area and the location of the collision with terrain**

Witnesses at Wedderburn observed the aircraft in a shallow climb, climbing just enough to clear rising terrain and trees at the end of runway 17. After clearing the trees, the aircraft disappeared from view below the ridgeline. About 2 minutes later, N600 collided with terrain about 2.7 km from the end of the runway, and about 150 m from Appin Road (Figure 2), about 1.4 km to the south-east of Appin township.

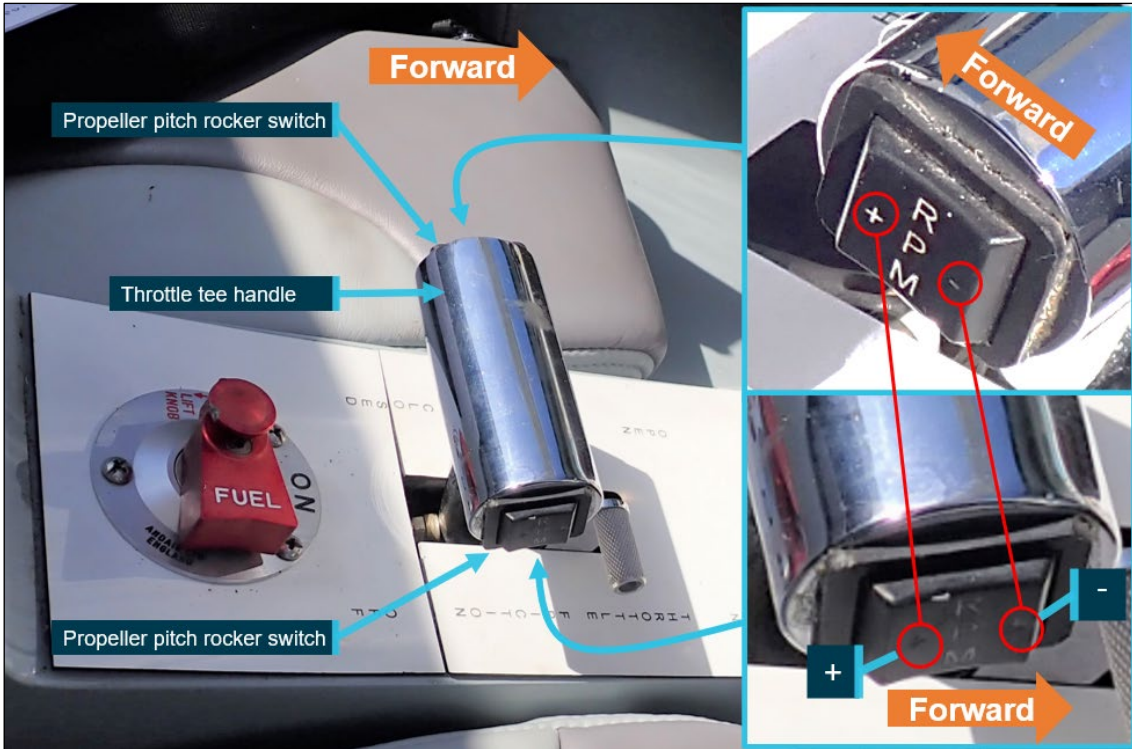
**Figure 3: Engine throttle tee-handle lever showing propeller rocker switches mounted to each side**

It was also found that N600 was fitted with propeller pitch change rocker switches on the left and right side of the throttle which were reversed in orientation for each flight crew member. This increased the risk that a pilot flying from the right seat could operate the propeller pitch change opposite to the intended selection.

Propeller pitch change control (Figure 3) was achieved with two rocker switches (one for each crew seat) mounted on either side of the throttle tee-handle lever, activating the electric pitch change motor. It took about 10 seconds to cycle between the course and fine pitch stops. The rocker switches were identical in their design and operation, in that when viewed directly on, the left side of the switch had the increase pitch selection (+), and the right side had the decrease pitch selection (-). This meant that if the switches were wired in accordance with the ‘+’ and ‘-’ labelling, the switches would be actuated in opposite directions relative to each pilot’s seated position to achieve the desired propeller pitch change. The switch orientation and wiring was confirmed by the original aircraft builder as being wired correctly to the switch orientation when the aircraft was constructed.

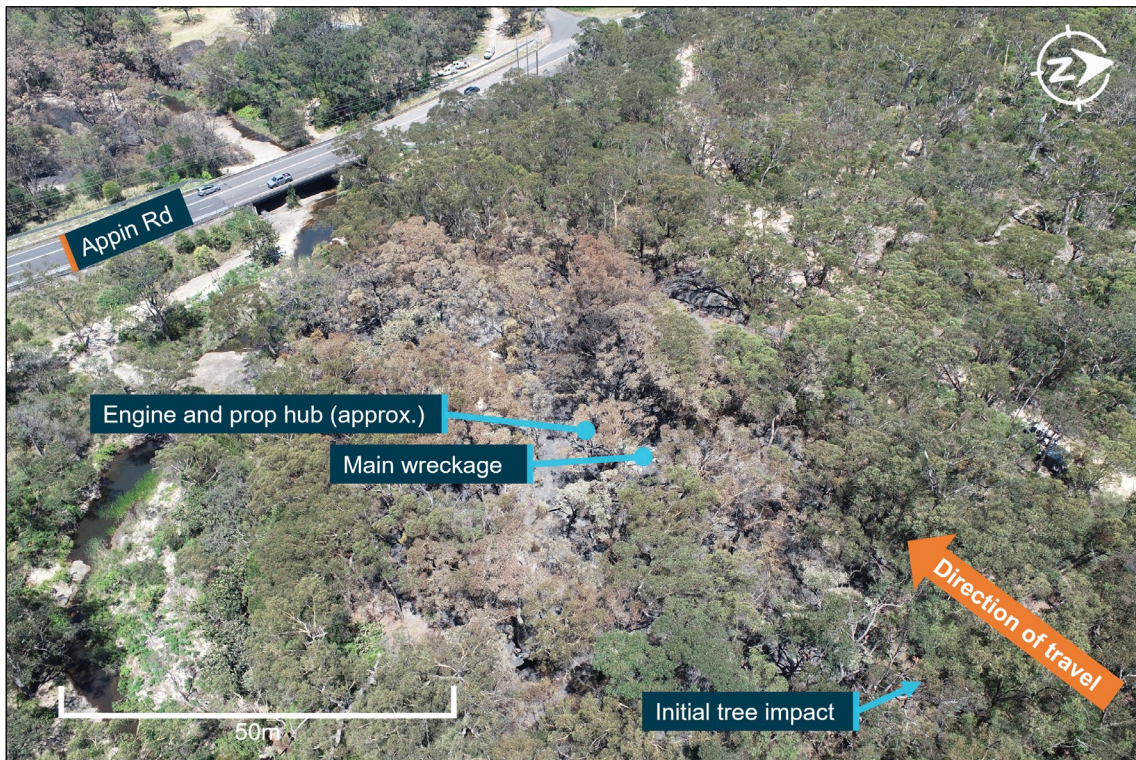
**Figure 4: Accident site**

The accident site was located about 1.2 km to the south-east of Appin township (Figure 4).

N600 entered trees on an approximate heading of 237° and the first tree impact was about 50 ft above ground level (Figure 4) at 833 ft above mean sea level. The left-wing tip (fuel tank) was located to the left of that tree, and a piece of the upper left wing was to the right of the direction of travel, most likely as a result of initial tree impact. The aircraft then continued for about 45 m, hitting further trees, before impacting a large rock. The airframe was upright and facing opposite the direction of travel. The main wreckage was spread along a path of about 90 m and was heavily disrupted and fire affected.

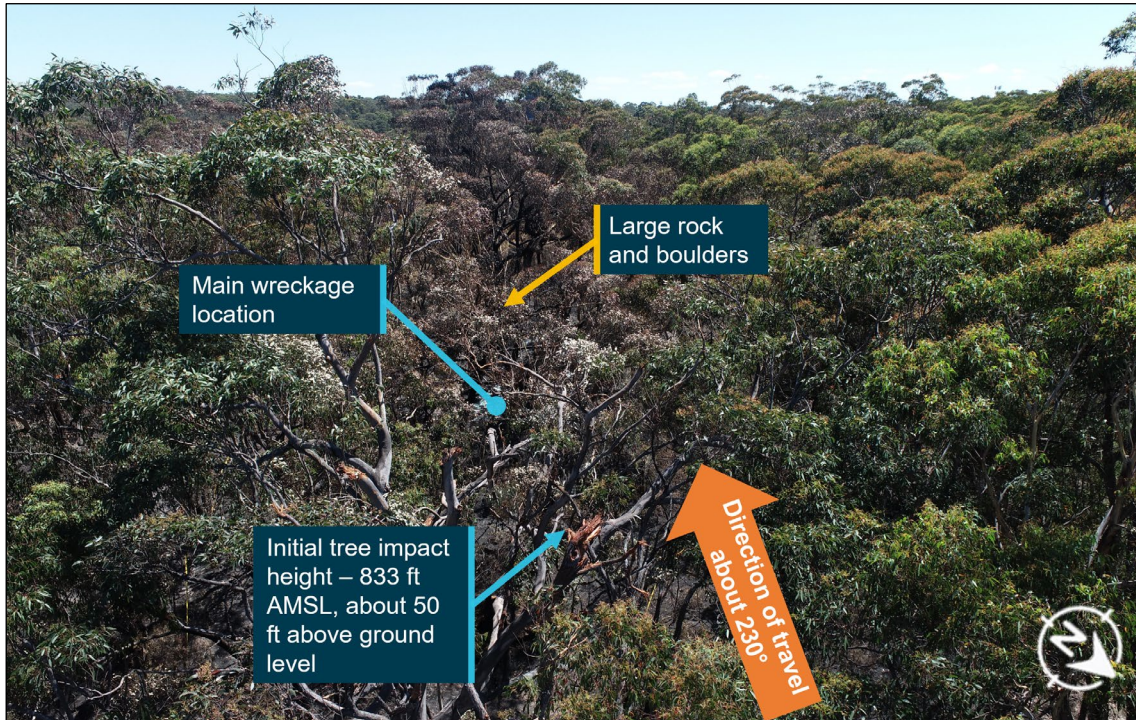
**Figure 5: Direction of travel N600**

During the accident sequence, the engine and propeller assembly had detached from the airframe and came to rest about 10 m further in the direction of travel, and was heavily affected by fire. Initial propeller contact with trees led to both blades separating from the hub. Most of the wreckage was contained within the fire zone with a small fragment of unburnt propeller blade located about 100 m from the initial tree impact point to the right of aircraft direction of travel.

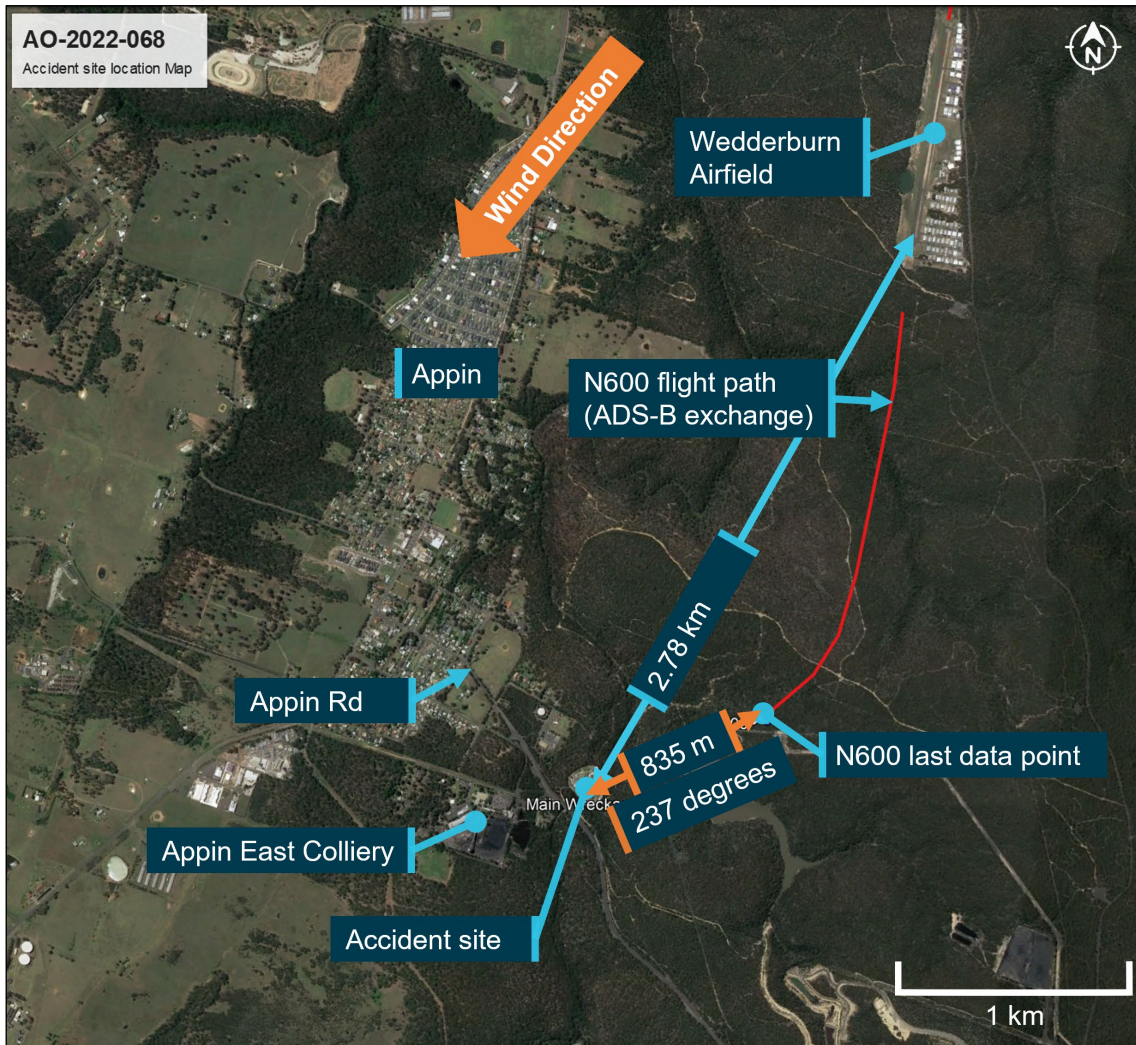
Figure 6: Final track N600

CCTV at Wedderburn showed the aircraft in a shallow climb, enough to just clear rising terrain and trees at the end of runway 17. After clearing the trees in the vicinity of the airfield, the aircraft then disappeared from CCTV view. Recorded data indicated that about 2 minutes later, N600 collided with terrain about 2.7 km from the end of the runway, about 150 m from Appin Road (Figure 6).
