Hard landing involving Boeing 737, VH-YQR

Sydney Airport, New South Wales on 10 March 2023

AO-2023-010

Final – 8 December 2023

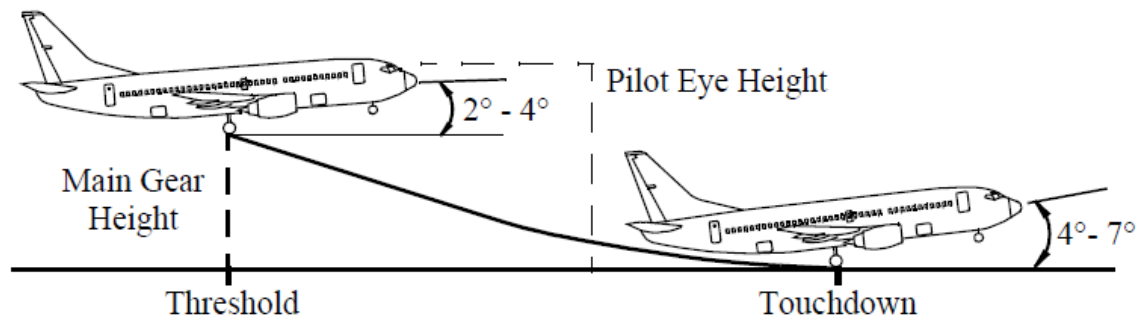
Figure 1: Flare profile

... initiate the flare when the main gear is approximately 20 feet above the runway by increasing pitch attitude approximately 2–3°. This slows the rate of descent.

After the flare is initiated, the pilot is required to smoothly retard the thrust levers to idle and make small pitch attitude adjustments to maintain the desired descent rate to the runway. A smooth thrust reduction assists in controlling the natural nose-down pitch change associated with thrust reduction. Hold sufficient back pressure on the control column to keep the pitch attitude constant. A touchdown attitude as depicted in the figure below is normal with an airspeed of approximately VREF. Ideally, main gear touchdown should occur simultaneously with thrust levers reaching idle.

It also stated that the 'typical landing flare times ranged from 4 to 8 seconds...'

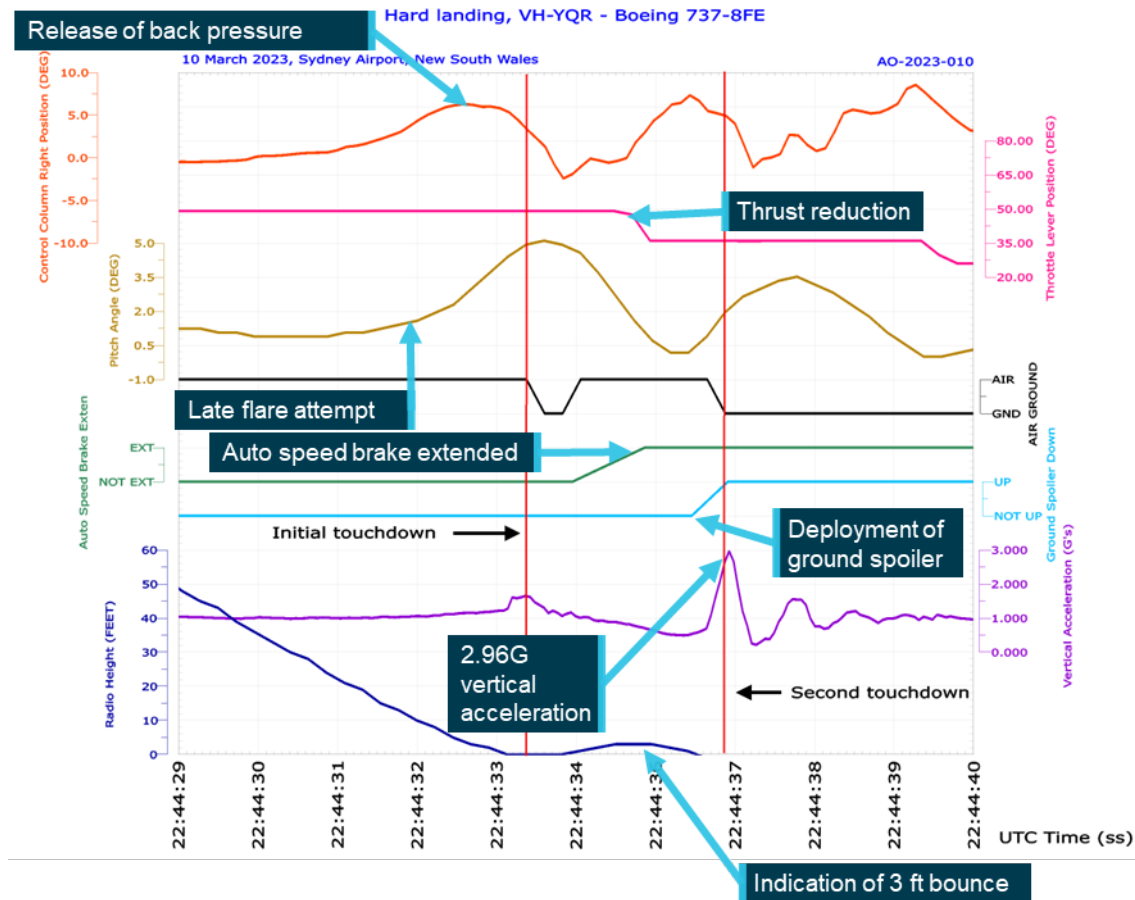
Figure 2: VH-YQR aircraft flight data

The quick access recorder (QAR) data indicated that the aircraft was within the stable approach criteria during the approach and prior to the initial touchdown. However, the flare was initiated late at between 10-15 ft, and very quickly the attitude reached a maximum of 5° before the back pressure on the control column was released. Thrust was not reduced prior to the touchdown and as the aircraft touched down, it had a roll of 0.70°, a pitch of 5.09, and a vertical acceleration of 1.25 G. The ground spoilers did not activate, and the aircraft bounced 3 ft.

During the bounce, the thrust was reduced, however, not to idle, and the speedbrakes deployed automatically. Just prior to the second touchdown, the ground spoilers deployed, significantly reducing lift. As the aircraft touched down, it had a roll of 1.54°, a pitch of 2.11° and a G force of 2.96 G. Thrust was reduced to idle, 3 seconds after the second touchdown.

Both the occurrence landing and the 5 April 2023 landing showed very similar characteristics. In both cases, the initial bounced landing was the result of a combination of a late flare and a higher than idle thrust being maintained through initial touchdown. In addition, during the bounce, both the speedbrakes and ground spoilers deployed while the aircraft was still in the air, significantly reducing the amount of lift, which led to the hard landings during the second touchdown.

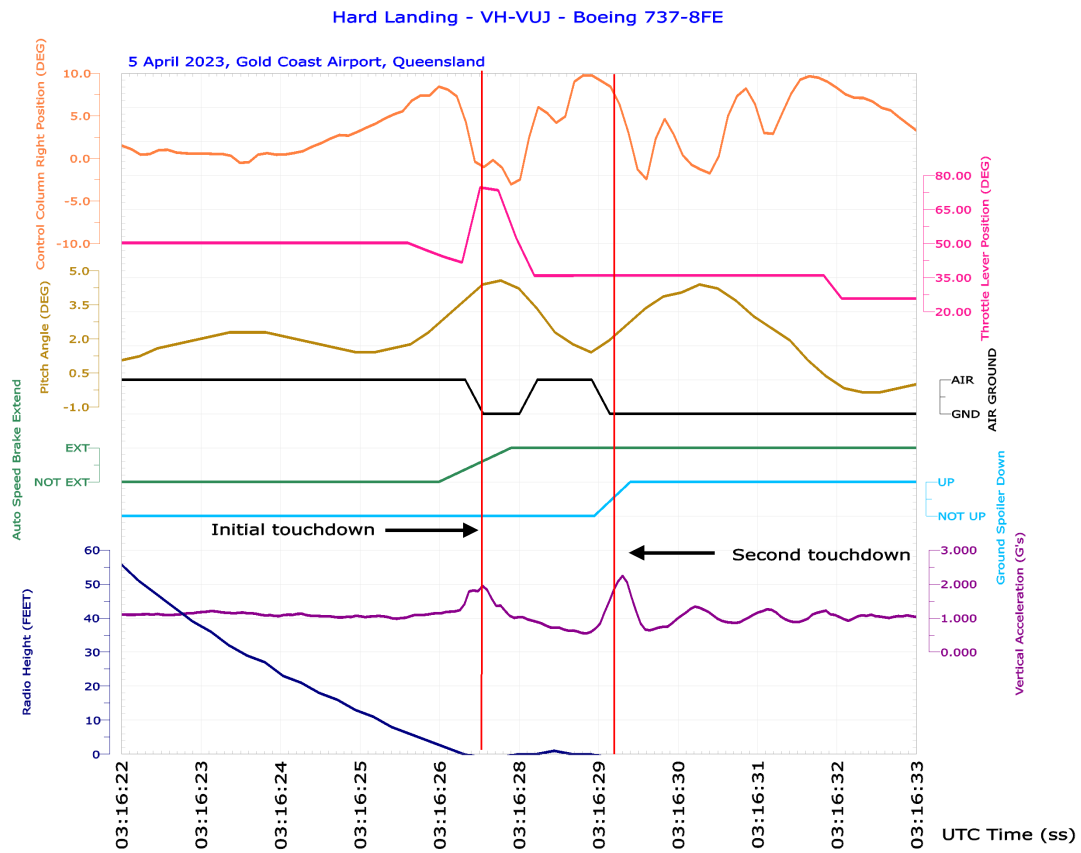
Figure 3: VH-VUJ aircraft flight data

The ATSB received the flight data for the second flare-related hard landing. This landing, which occurred on 5 April 2023, was conducted by a different FO under line training. It had similar characteristics as the occurrence flight. On this flight, the flare was also initiated at approximately 10 ft and quickly increased to approximately 5°, before back pressure was released, thrust was reduced slightly but not to idle. The aircraft touched down with a roll of 1.42°, a pitch of 4.4° and a G force of 1.94 G (Figure 3). The speedbrakes deployed during the touchdown, however, the aircraft bounced approximately 2 ft.

During the bounce, the thrust was reduced, again not to idle, and the ground spoilers activated while the aircraft was still airborne resulting in a G force during the second landing of 2.2 G. The throttle was reduced to idle approximately 3 seconds after the second touchdown.
