Grounding of pilot launch *PV Corsair*

Port Phillip Heads (near Point Lonsdale) Victoria, on 5 October 2023

ATSB Transport Safety Report
Marine Occurrence Investigation
MO-2023-003
Preliminary – 22 December 2023

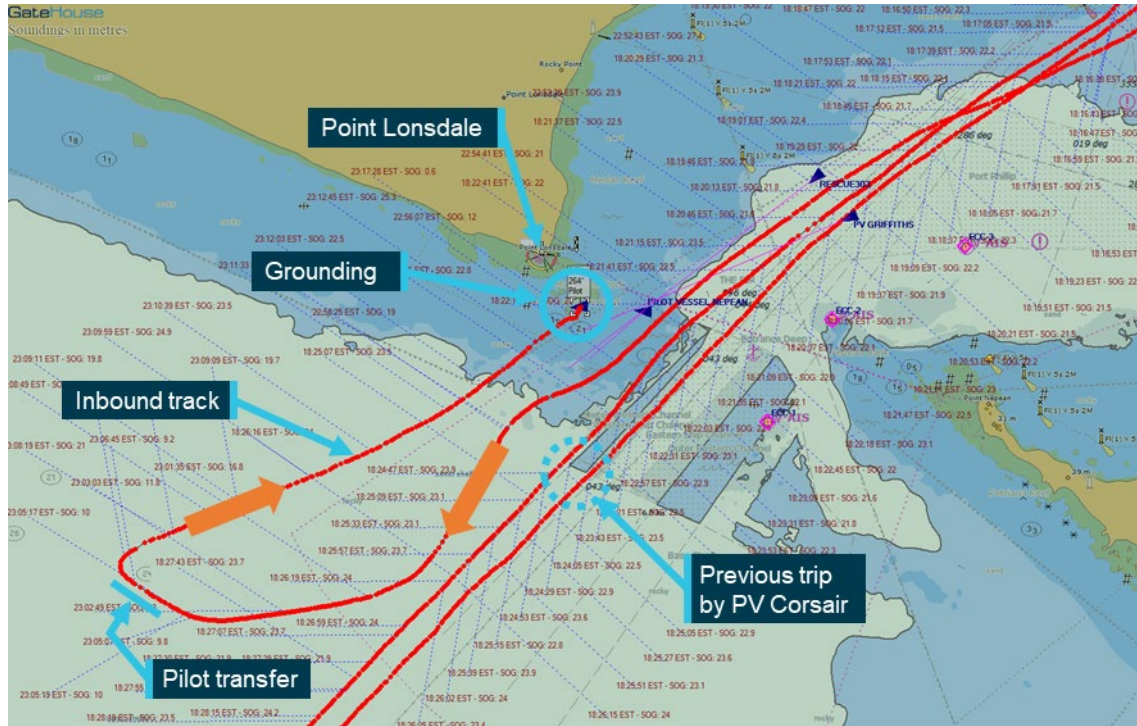
Figure 1: The track of PV *Corsair* for pilot transfer from *Rio Grande*

At about 2306, the pilot disembarked into the pilot launch and soon after, from a position about 2.3 NM south-west of Point Lonsdale, *Corsair* commenced heading back to the entrance on a course of about 070°⁸ and at a speed of about 24 knots (Figure 1).⁹

The figure also shows the tracks of PV *Corsair* through the Heads on its previous trip.
Source: Ports Victoria with annotations by the Office of the Chief Investigator

At about 2310, *Corsair* was about 1.4 NM south-west from Point Lonsdale when it commenced a slow alteration in course to port. At about 2312, when about 205° and 0.54 NM from Point Lonsdale, the launch steadied on a course of about 051° and its speed was still about 24 knots.

At about 2313 *Corsair* entered the shallow water surrounding the reef and ran aground. The launch came to rest in a rock pool about 500 m from Point Lonsdale.

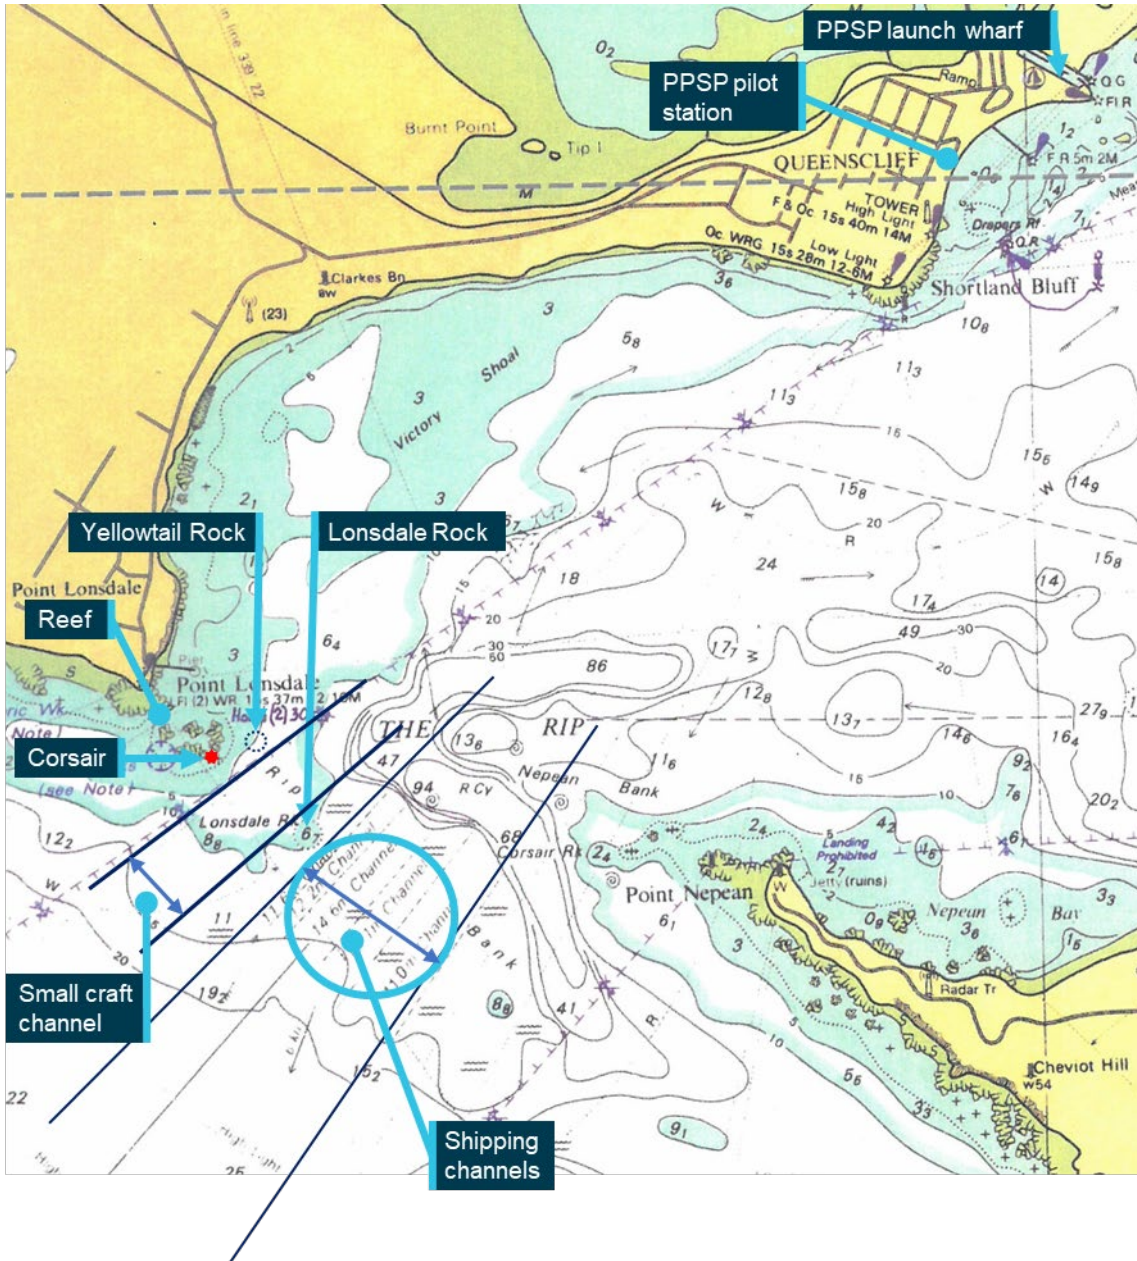
Figure 2: Port Phillip Heads and entrance channels

Port Phillip Heads, also known as The Heads or The Rip, is a narrow waterway that connects Port Phillip to Bass Strait and is the only access for ships visiting the ports of Melbourne and Geelong (Figure 2).

West of the Outer West Channel lies the Small Craft Channel, which was used by smaller boats, fishing vessels and the pilot launches. The channel ran between Yellowtail Rock and Lonsdale Rock (Figure 2).¹⁰ The defined western edge of the channel was about 50 m off Yellowtail rock. The width of the channel at that section was about 300 m and its depth between 5 and 10 m.

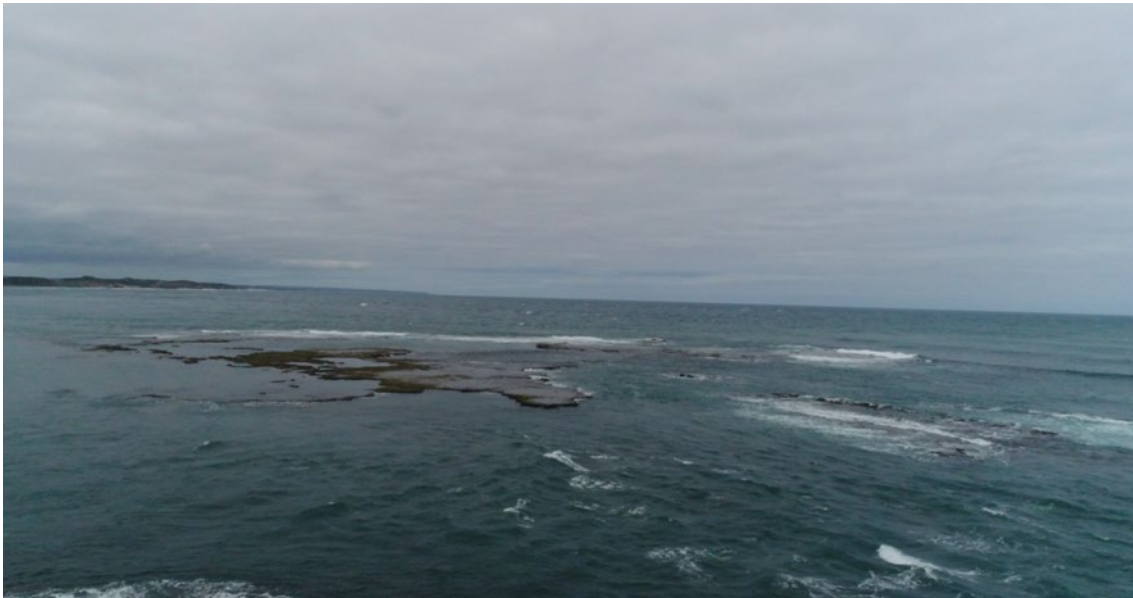
Figure 3: Point Lonsdale Reef

Point Lonsdale Reef is an outcrop of flat-topped rocks extending up to about 540 m south-east of Point Lonsdale (Figure 3). The extent of the reef’s exposure and its visibility varies with tide and sea conditions.

Point Lonsdale Reef photographed from Point Lonsdale the day after the grounding.
 Source: Elstone Diving Services Pty Ltd

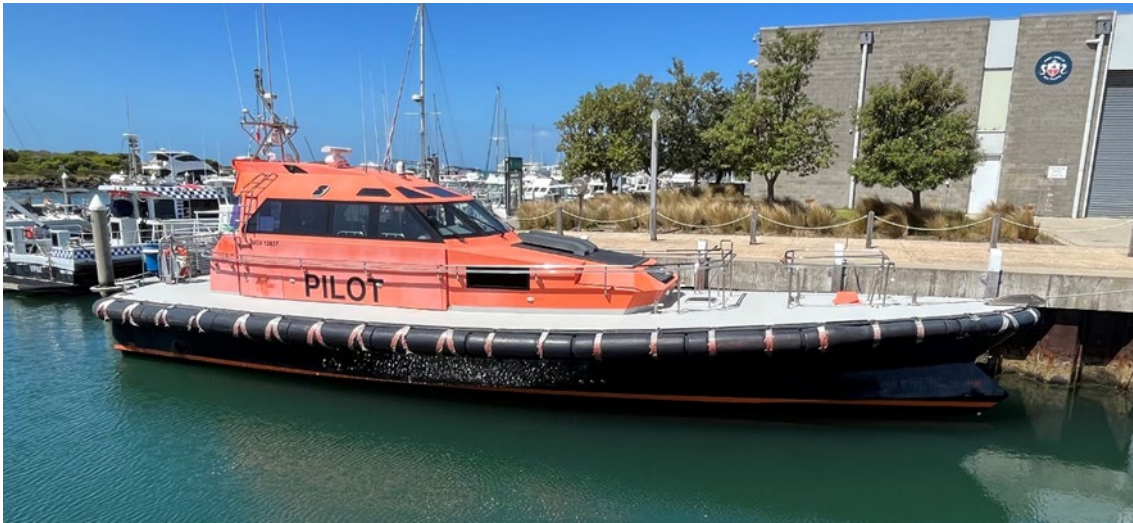
Figure 4: *PV Nepean*, the sister vessel of *PV Corsair*

The pilot launch *Corsair* was a dedicated pilot transfer vessel of monohull design constructed in 2014 by Hart Marine in Mornington, Victoria (Figure 4). It had an overall length of 18.55 m, breadth of 5.5 m, depth of 2.3 m and a loaded draught of about 1.55 m. Propulsion was by two Cummins QSK 19-M marine diesel engines of 597 kW at 2100 rpm, each driving a fixed pitch propeller. The launch had a maximum speed of about 30 knots.

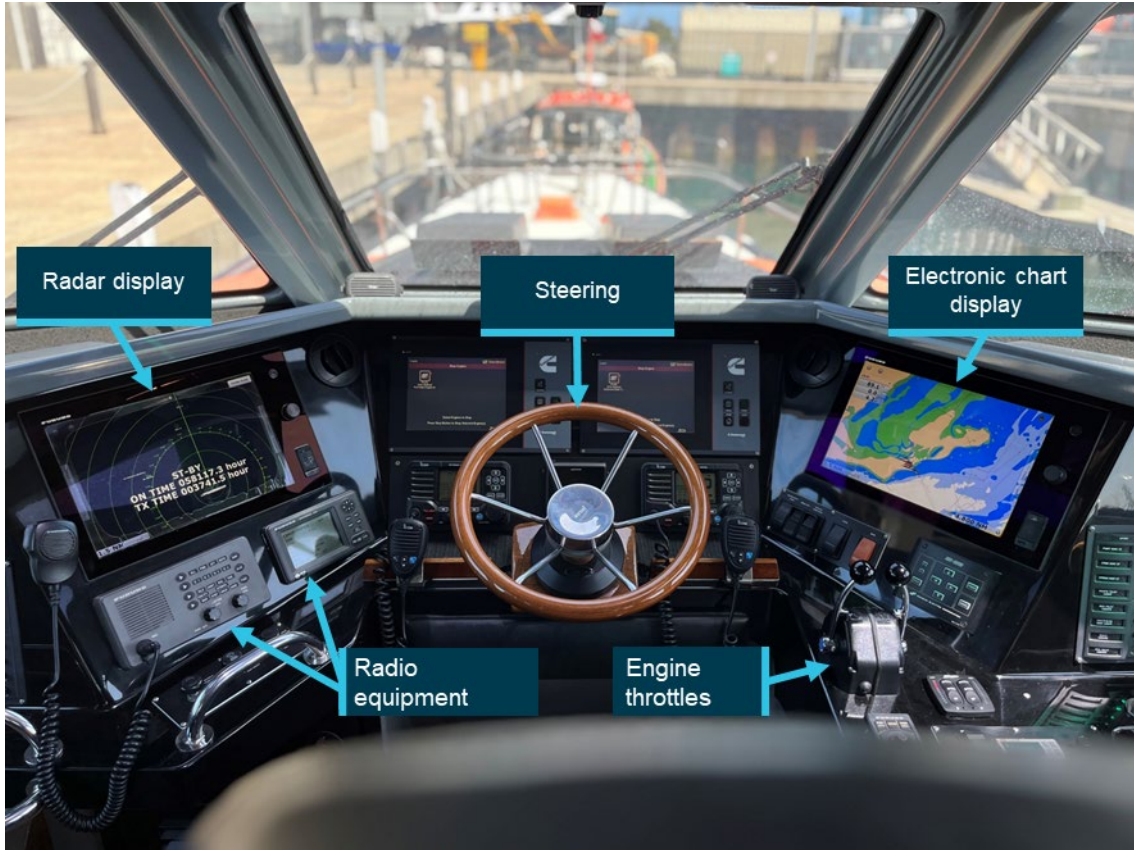
Figure 5: *PV Corsair* navigation equipment demonstrated on *PV Nepean*

The launch was fitted with a central navigational console with two navigation screens, one on each side of the conning position (Figure 5). The screen to the right of the conning position was set to display the electronic charting system and the screen to the left had the radar display. The depth sounder was connected to the charting display. All navigational equipment was reported to be operational at the time of the incident.
