Fuel imbalance and engine shutdown involving Boeing 737, VH-VZT

135 NM south of Kalgoorlie-Boulder Aerodrome, Western Australia, on 25 October 2021

ATSB Transport Safety Report

AO-2021-043

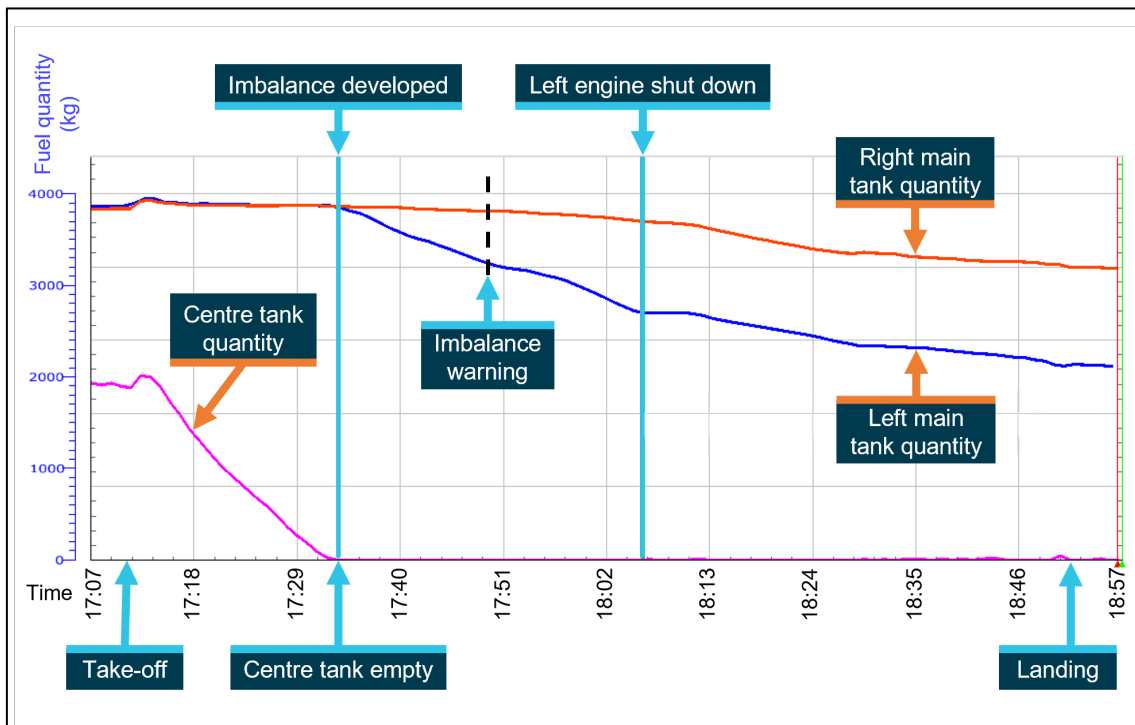
Figure 1: Fuel quantities on the occurrence flight

Flight data (Figure 1) showed that after the fuel in the centre tank had been consumed, an imbalance between the left and right main fuel tanks began to develop and was maintained for the remainder of the flight.
