Collision with terrain involving Cessna 172, VH-JUA

1 km north-east of Murwillumbah, New South Wales on 15 October 2023

AO-2023-048

Final – 14 February 2024

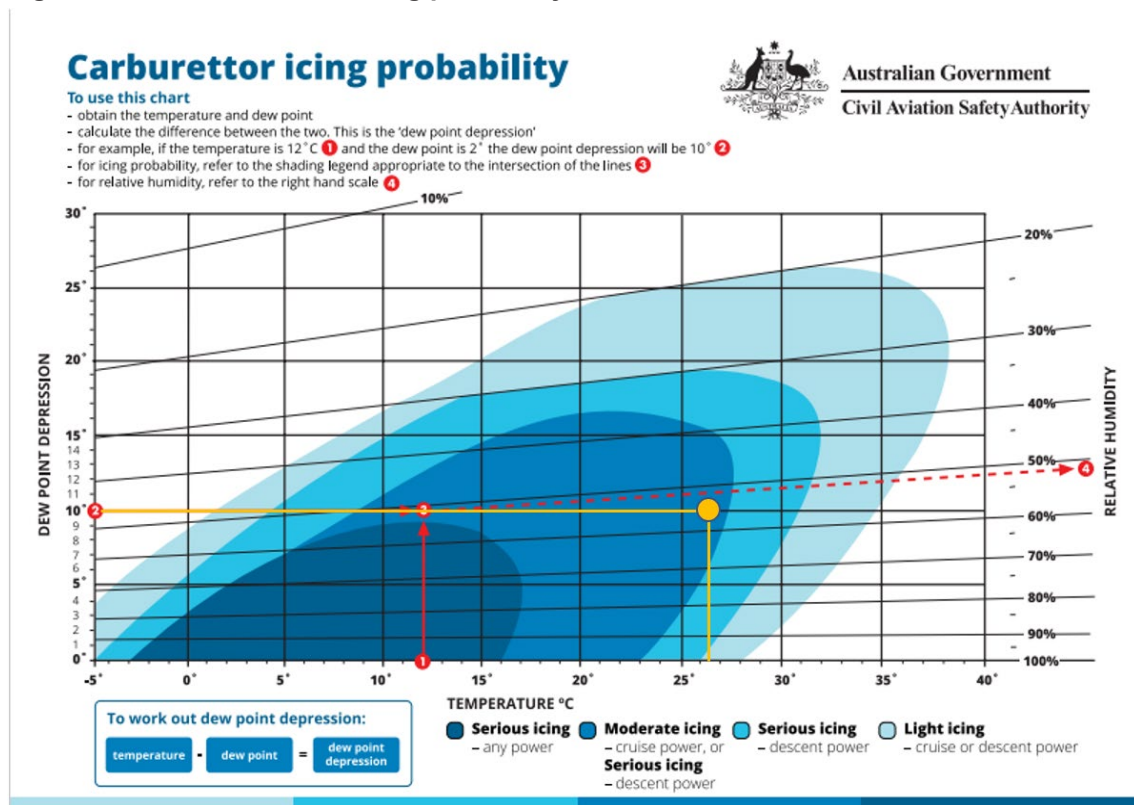
Figure 1: CASA carburettor icing probability chart

The CASA carburettor icing probability chart predicted that serious carburettor icing at descent power was probable (Figure 1). The pilot stated that the engine was performing as expected throughout the approach. However, any loss of power associated with carburettor icing may not have been noticed at low power settings during an approach.

However, as the aircraft was able to maintain speed and height across the runway and subsequently climb with full flap, and no faults were found during the engine inspection, it is unlikely that the engine had any mechanical issues or any significant carburettor icing.

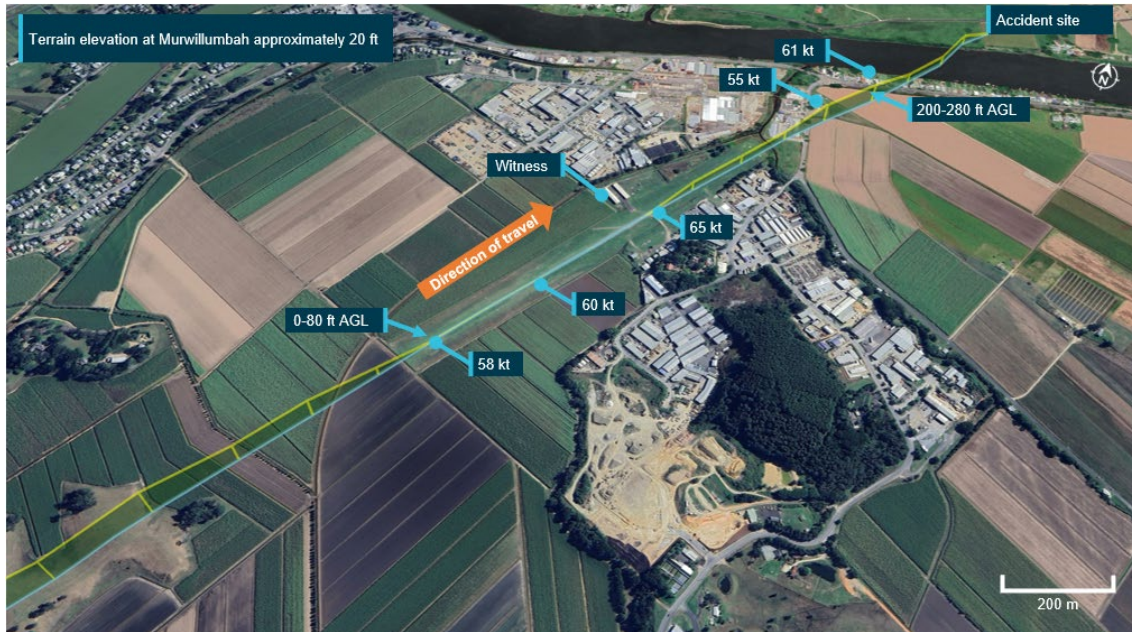
Figure 2: VH-JUA go-around at Murwillumbah Runway 01

Taking into account the terrain elevation, the data showed the aircraft crossing the threshold below 80 ft above ground level (AGL) at 58 kts ground speed. The aircraft maintained approximately the same speed and altitude until about halfway down the runway.

The aircraft then commenced a climb, to a maximum height of between 200–280 ft, maintaining approximately 60 kts, before descending towards the cane field (Figure 2).

The data further indicates that the aircraft started climbing, consistent with the commencement of a go-around, about half-way down the runway rather than over the threshold as recalled by the pilot.

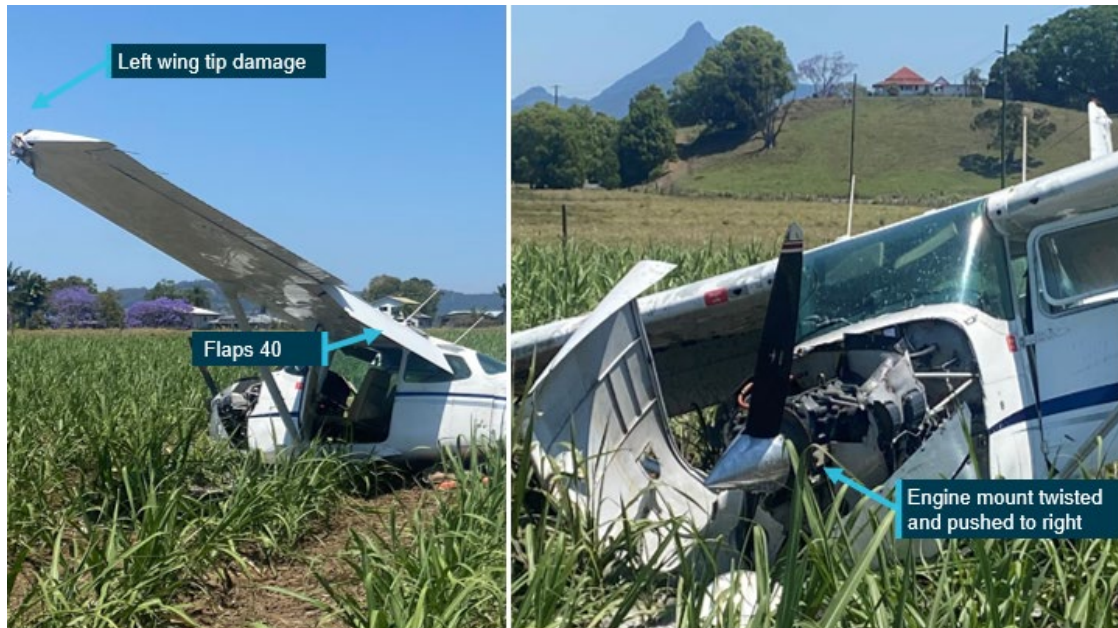
Figure 3: Photos of the aircraft at the accident site

- QNH subscale was set to the 1017 hPa
- flaps extended to approximately 40 degrees
- damage to the left wingtip, fuselage and right wing
- nose and right main landing gear collapsed
- engine pushed to the right
- a nose-wheel steering towbar on the front right seat of the aircraft

It is likely that the pilot’s decision to maintain full flap (40 degrees), which creates a large amount of drag and impaired climb performance, resulted in the pilot’s perception that the engine was not performing adequately.

- During the go-around, it is likely the aircraft was incorrectly configured resulting in reduced climb performance.

- updated quick reference handbooks (QRH) to be clearer on balked landings (go-around) procedures.
- issued an information circular to students and private hire pilots reminding them of the importance to secure cockpit cargo.
- updated the private hiring agreements with regard to tighter recency requirements.

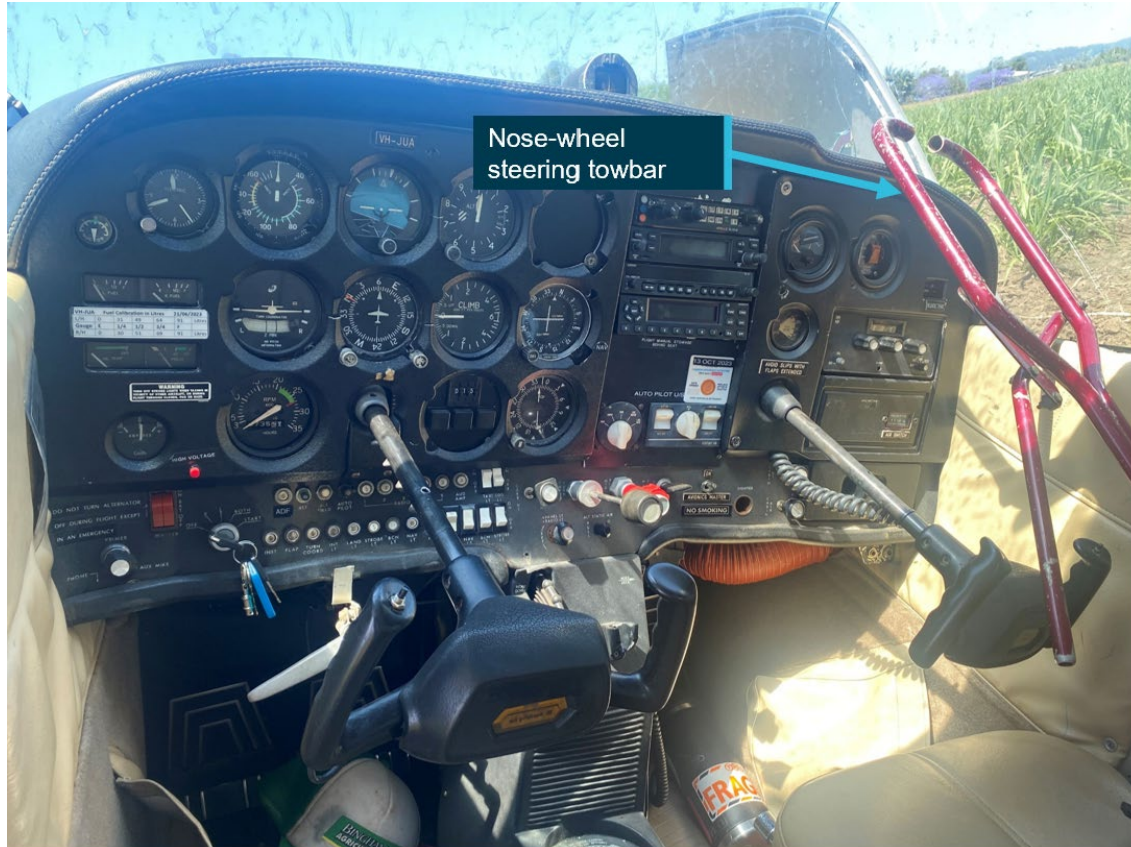
Figure 4: Nose-wheel steering towbar unrestrained in the cockpit

Photograph of the inside of the aircraft after the accident showed the nose-wheel steering towbar on the front passenger seat.
Source: NSW Police annotated by ATSB

The Civil Aviation Safety Regulations 91.600 state that ‘cargo must not be carried in a place where the cargo may damage, obstruct or cause the failure of a control or obstruct or restrict access to an emergency exit’.

While it could not be determined where the towbar was stored prior to the commencement of the flight, the operator’s standard procedure is to put the tow bar under the seat or to be covered by the net in the rear baggage compartment.

While the nose-wheel steering towbar did not adversely affect the flight or injure the pilot, loose items in the cockpit or baggage area can jam flight controls and become dangerous projectiles and may cause serious injuries during an abrupt stop, turbulence or an accident sequence. Further, they can hinder an emergency evacuation.

- The unrestrained object in the aircraft increased the risk of serious injury to the pilot.
