Fuel starvation and collision with water involving Rockwell International 114, VH-WMM

1 km north of Redcliffe aircraft landing area, Queensland, on 19 December 2021

ATSB Transport Safety Report

AO-2021-053

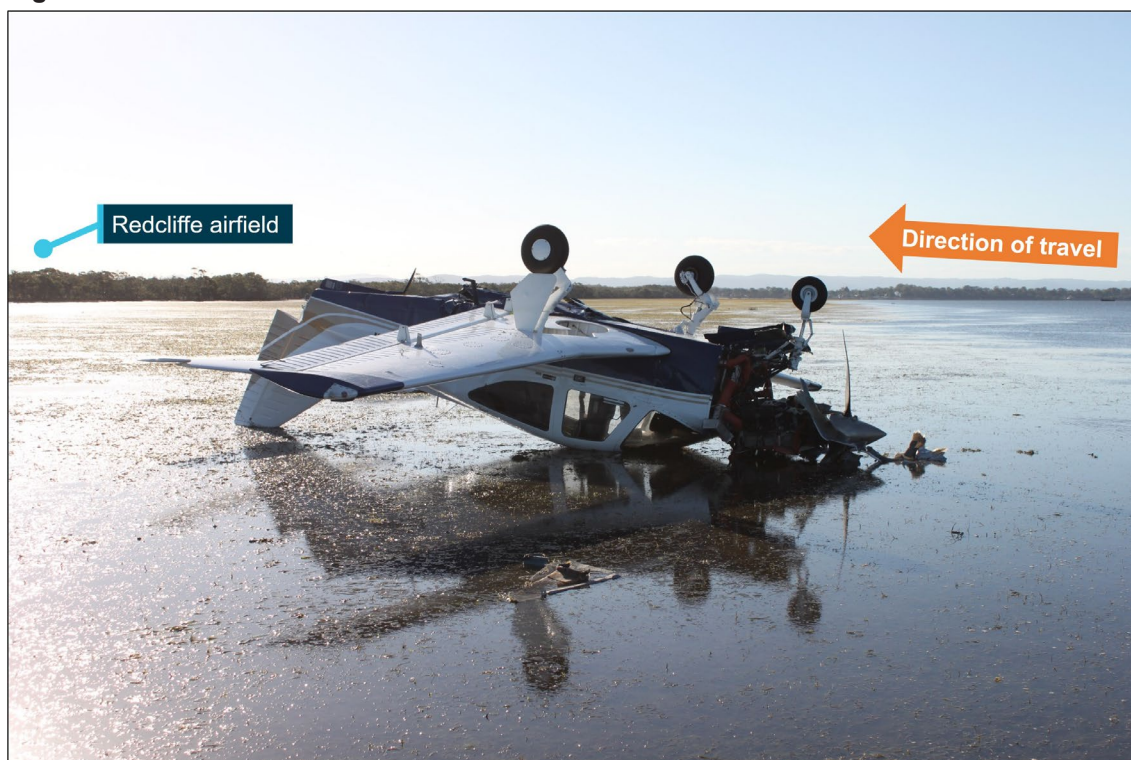
Figure 3: VH-WMM accident site at low tide

Ground scars observed on the tidal flat indicated that after entering the water, the aircraft nose wheel and propeller contacted the seabed leading to the aircraft overturning, resulting in sudden deceleration and the aircraft coming to rest inverted. Witnesses described the water directly around the aircraft to be murky due to the mud and silt seabed having been disturbed by the aircraft impact. The left door (pilot door) was in a closed and latched condition when the ATSB arrived onsite. The right door was found by police divers to be slightly ajar, and difficult to open during the recovery operation.

The aircraft fuselage underside and right wing showed evidence of hydraulic⁹ compression from impacting the water surface, and the engine had separated from the aircraft. The impact to the fuselage underside damaged the fuselage skins forward and aft of the wing main spar carry-through, resulting in a large hole. The engine firewall had been punctured by the engine and the left rear side window was broken. The identified damage would have allowed water ingress into the fuselage. Fuel was visibly leaking from the right underwing fuel vent, and a strong fuel smell was evident at the site.

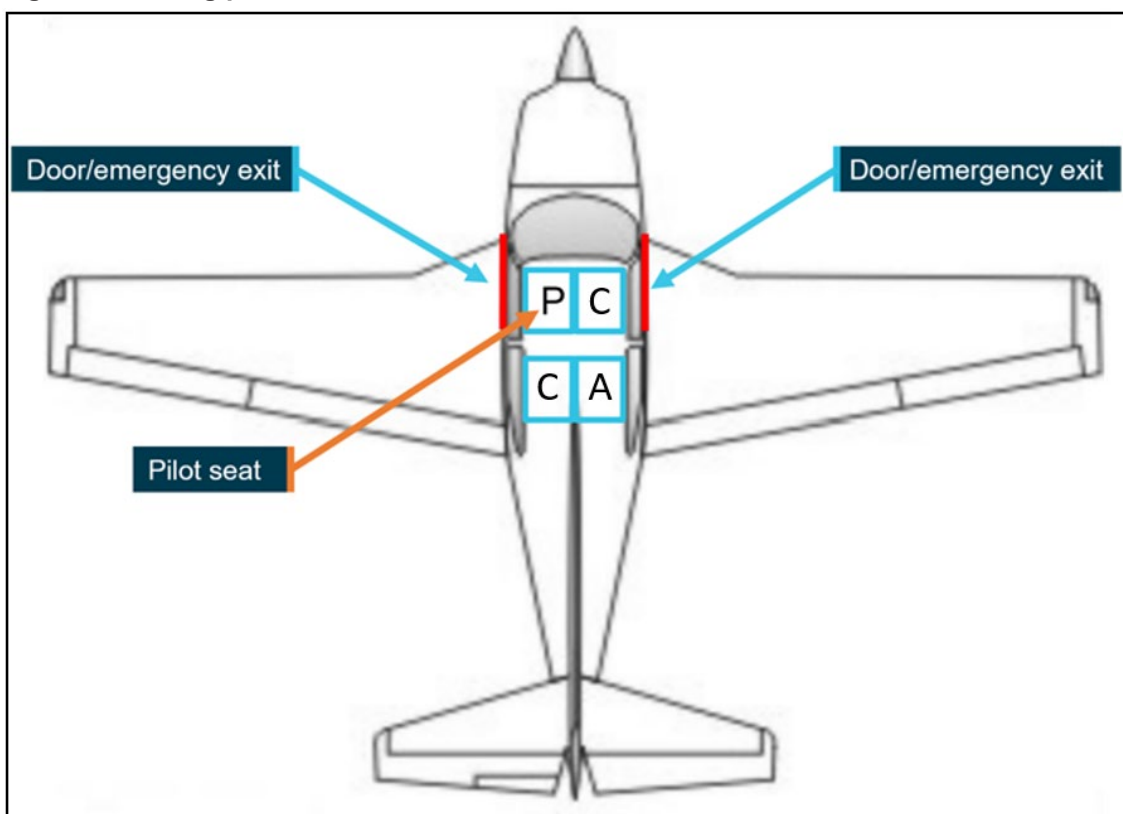
Figure 5: Seating positions

The pilot (P) was seated in the front left seat location. The 3 passengers consisted of an adult and 2 children.¹² One child (C) was seated in the forward right seat next to the pilot and another child (C) was seated in the left-rear behind the pilot. The adult (A) passenger was seated in the rear-right (Figure 5). Both aircraft doors were at the front row.

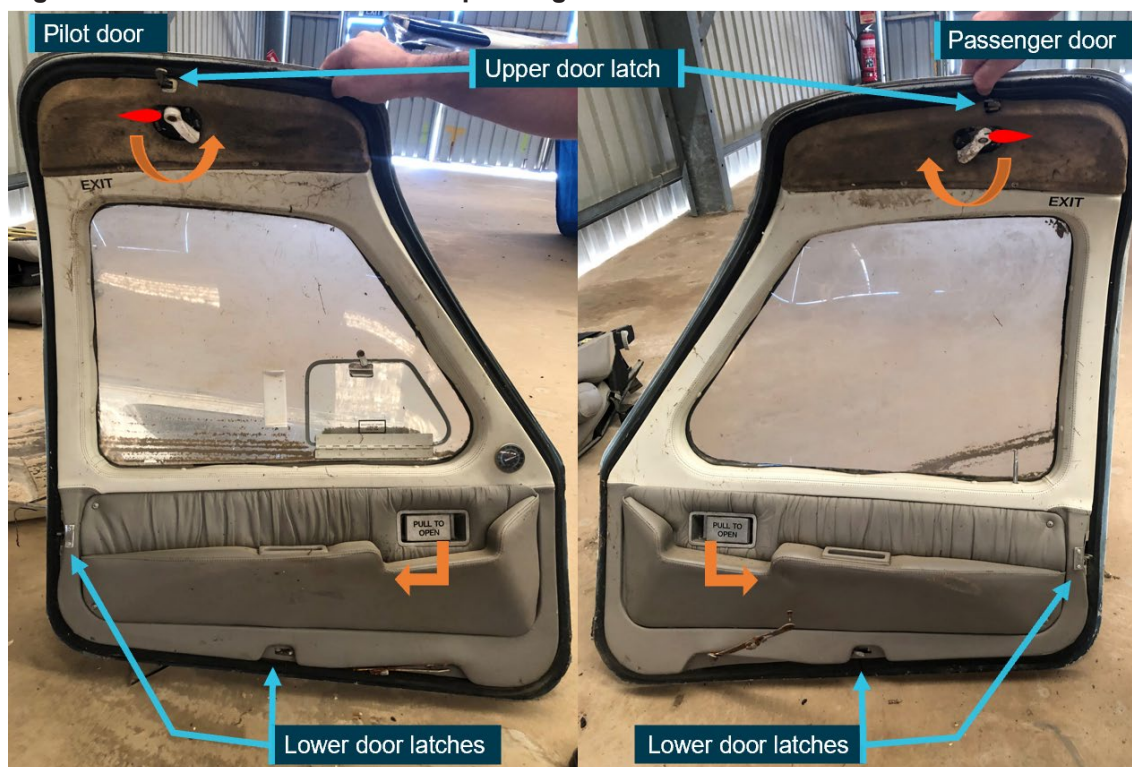
Figure 6: Location of door interior operating handles

Figure 6 shows the aircraft doors, which were designed as both normal and emergency exits. Both doors had the same operation, which required 2 opening mechanisms to be manipulated, both when operating from inside or outside. One handle was located above the passenger/pilot head that needed to be rotated downwards to unlatch. The second handle was fitted to the forward lower part of the door and was a lever type arrangement, which was required to be pulled inwards to unlatch the 2 lower latches. Each door needed to be pushed outwards to open. There was no emergency jettison mechanism.

After the accident, police divers were unable to open the pilot's left door, and only opened the other (right) door with difficulty. For the injured pilot and right front seat occupant of VH-WMM, who was a child, it is highly unlikely they would have had the post-accident capability to open the doors. The right door was observed unlocked and ajar by police divers following the collision, suggesting the possibility that an attempt had been made to open the door.
