# Loss of control and collision with terrain involving Cirrus SR22, VH-XGR

Bankstown Airport, New South Wales on 17 March 2023

## **ATSB Transport Safety Report**

AO-2023-011

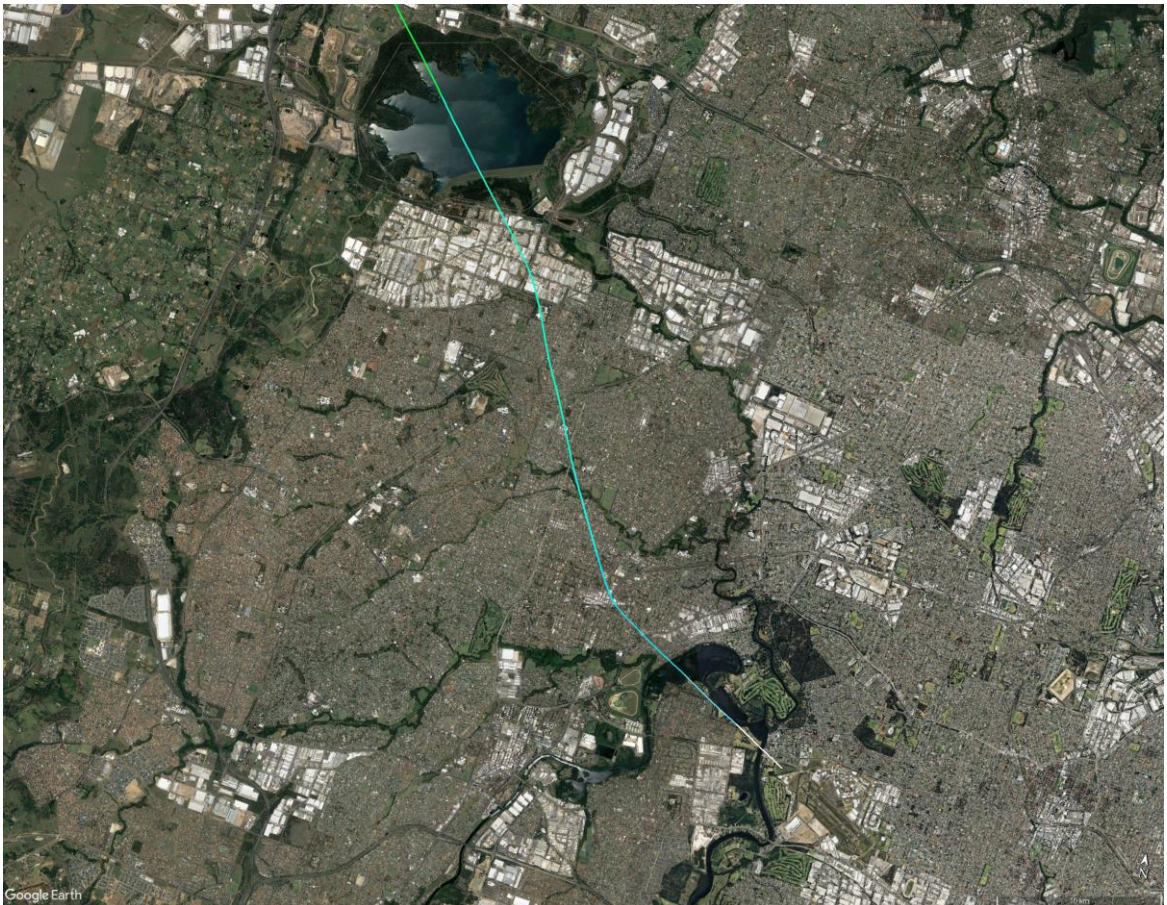
As the approach continued, the groundspeed continued to slow until reaching a groundspeed of 60 kt while on descent through 350 ft. The groundspeed varied between 60 and 63 kts until the last data point recorded at 100 ft.

**Figure 2: Track from Prospect reservoir to Bankstown Airport**

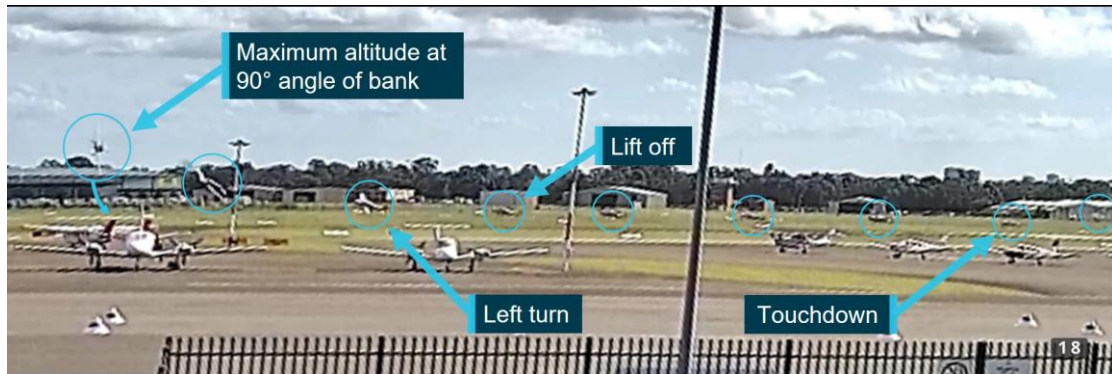
A camera mounted on the Bankstown Airport passenger terminal<sup>8</sup> recorded low resolution imagery of the accident sequence (Figure 3). It showed the aircraft sinking onto the runway, proceeding along the runway for about 5 seconds, then rapidly entering a steep climbing turn to the left. Having turned through 90° and reached a maximum height of about 40 ft, the bank angle exceeded 90° and the aircraft dropped onto the left wing and nose. This was also recorded by a camera in a different location.

**Figure 3: Bankstown Airport terminal CCTV showing sequence from initial touchdown to just before impact (right to left)**

In the CCTV imagery, the aircraft appeared to sink onto the runway and witnesses observed the aircraft bounce along the runway. After the initial bounce, the aircraft tail scraped on the runway, which was symptomatic of the unstable landing without any effect on the subsequent controllability of the aircraft.

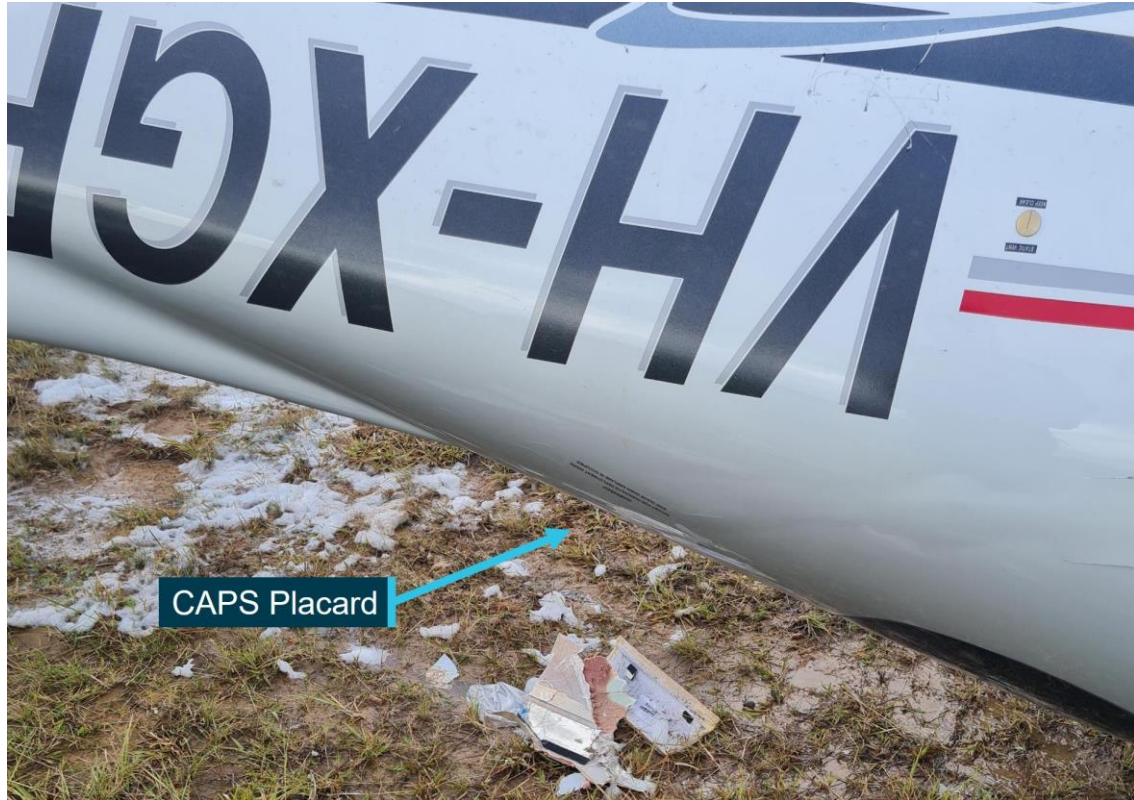
Depending on observer perspective, the CAPS warning placard was visible on the left rear inverted fuselage (Figure 7). Because of the tilt of the wreckage, the right-side placard was not as visible.

**Figure 7: Wreckage (inverted) at accident site showing CAPS warning placard on left rear fuselage**

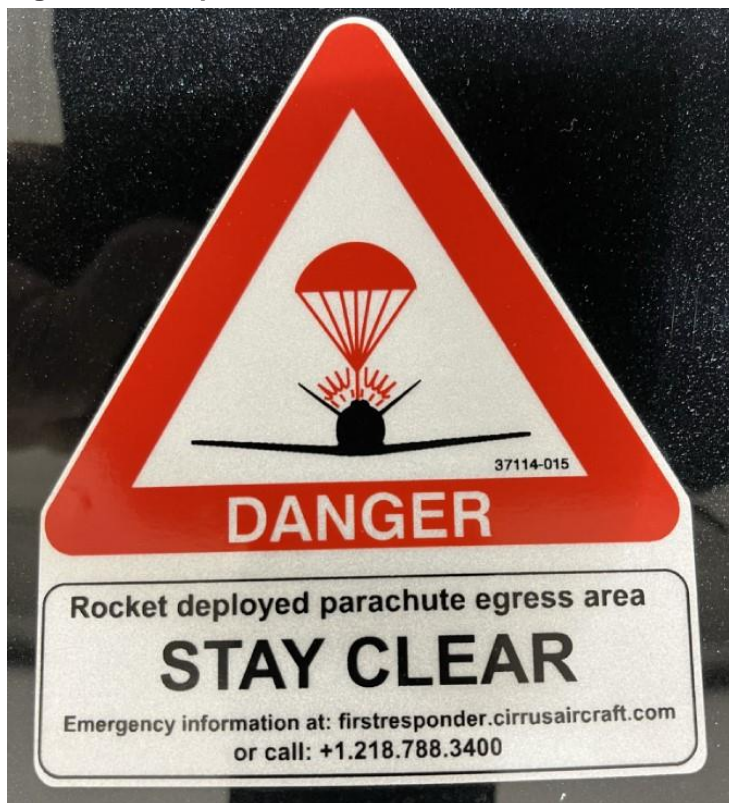
**Figure 8: Example of an ASTM Standard CAPS Placard used on the SF50 Vision Jet**

Cirrus Aircraft advised that they have enhanced the external CAPS placarding on 2 new models of aircraft (the SF50, and another in development) to align with current American Society for Testing and Materials (ASTM) standards (Figure 8). The SR2X series of aircraft (the SR20, SR22, and SR22T) were certified prior to the implementation of ASTM standards. At the time of writing, Cirrus was reviewing the possibility to enhance the placard that was certified with SR2X.
