Flight instrumentation failure and descent below glideslope involving Saab 340, VH-VEQ

9 km south of Sydney Airport, New South Wales on 24 October 2022

ATSB Transport Safety Report
Aviation Occurrence Investigation (Short)
AO-2022-050
Final – 23 April 2024

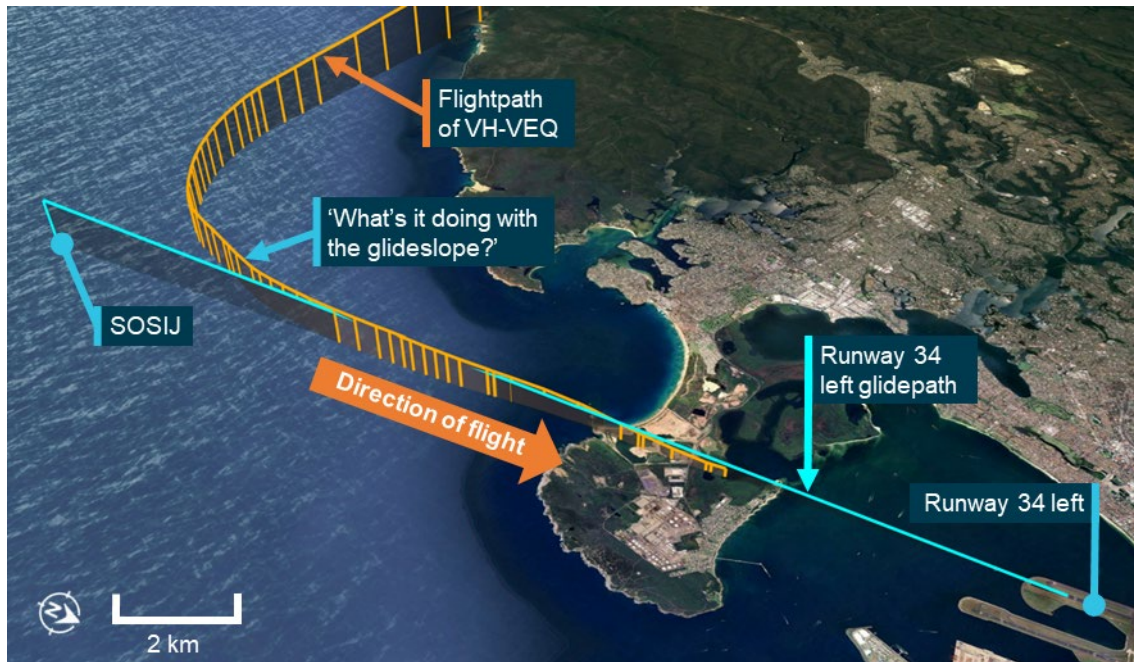
Figure 1: Flightpath of approach

The aircraft continued descending and at 1947:58, as the aircraft tracked to intercept the localiser, the cockpit voice recorder captured the first officer asking, 'What's it doing with the glideslope?' (Figure 1).

As the descent continued, the autopilot switched automatically to localiser mode and captured the ILS localiser at an altitude and distance from the runway that positioned the aircraft close to being on the glideslope for the approach. The autopilot subsequently captured the glideslope and the crew continued the approach using the autopilot approach mode. The crew observed that the aircraft did not commence descending as expected to maintain the glidepath, despite the EADIs indicating that the aircraft remained on glideslope. The captain assessed that there was probably some lag in the glideslope indication and its input to the autopilot capturing of the glideslope. To progress the aircraft's descent along the glideslope, the captain disengaged the autopilot and manually increased the descent rate.

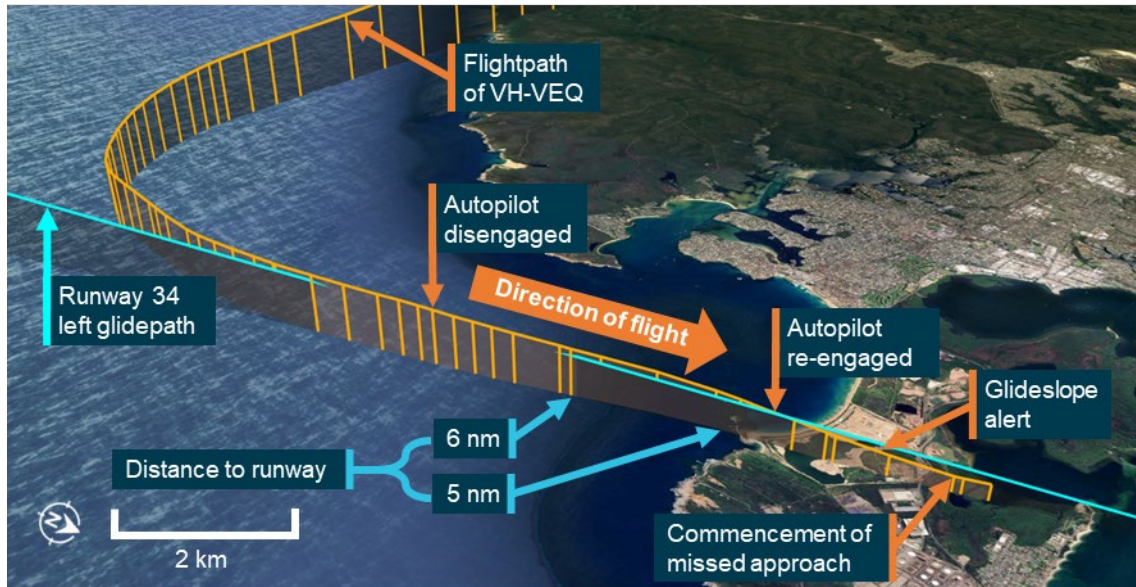
Figure 2: Flightpath of the descent below glideslope

The captain then called for the flaps to be extended, but the first officer did not complete the action as they were engaged in trying to resolve the conflicting glideslope indications. A second later, as the aircraft descended below 957 ft AMSL (about 380 ft below the glideslope – full-scale

deflection), the ground proximity warning system generated a ‘glideslope’ alert (see the section titled *Ground proximity warning system*) (Figure 2) and 7 seconds later, the crew commenced a missed approach. At 19:50:36, 10 seconds after the missed approach was commenced, air traffic control issued a safety alert to the crew advising them to check their altitude. The minimum height recorded during the missed approach was 586 ft.

As the aircraft descended below 1,000 ft AMSL while significantly below the glideslope, the aircraft penetrated the ground proximity warning system warning envelope and a ‘glideslope’ alert sounded. At about the same time, the first officer’s EADI began showing correct glideslope indications. At that point the crew recognised the approach was unstable and immediately commenced a missed approach.

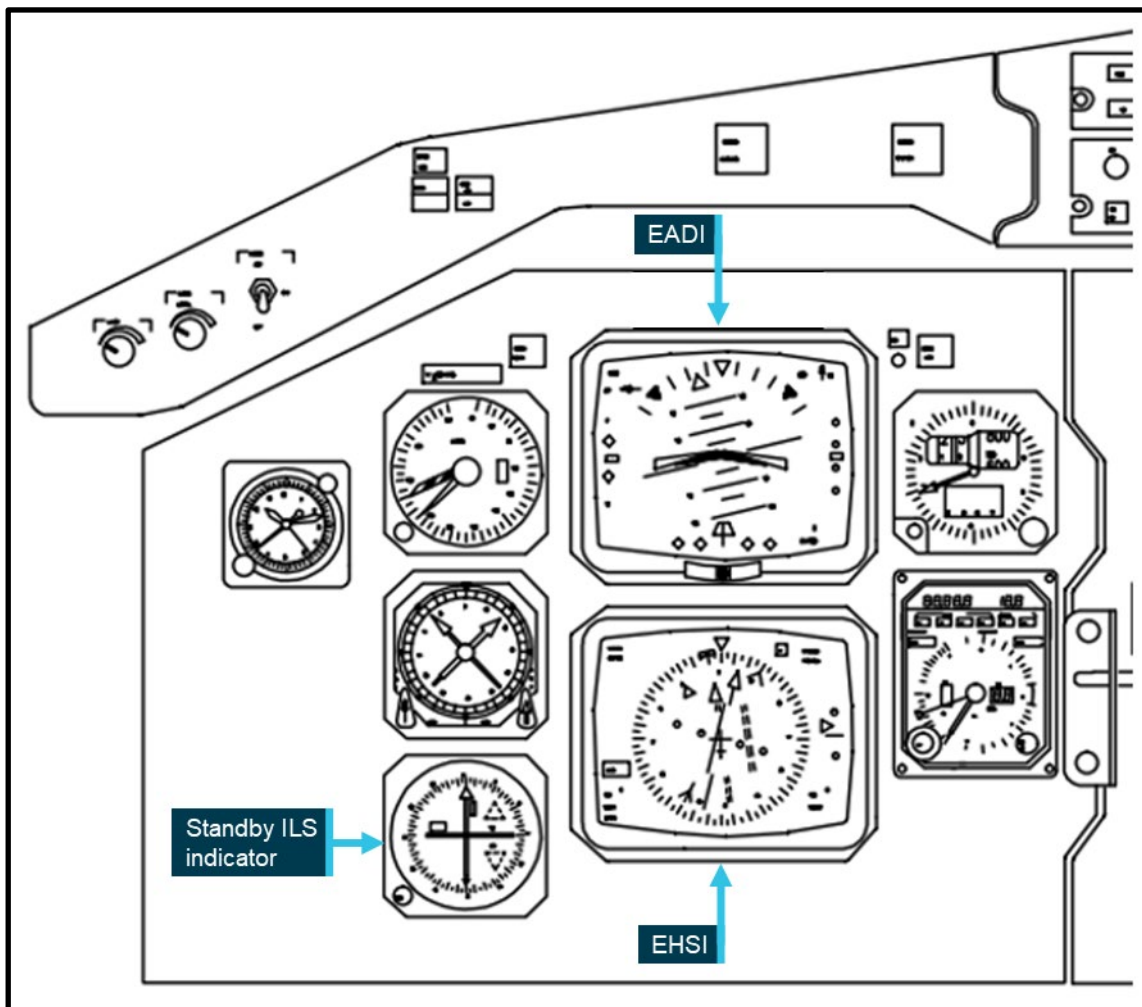
Figure 4: Saab 340 left (captain's) flight instrumentation

VH-VEQ was equipped with the Rockwell Collins Pro Line 4 electronic flight instrument system. This system used cathode ray tube displays to present flight and navigation information on the left (captain) and right (first officer) electronic attitude direction indicators (EADIs) and electronic horizontal situation indicators (EHSIs) (Figure 4).

The data presented on each side's EADI and EHSI was provided by a corresponding display processor unit (DPU). The DPUs received data from numerous aircraft systems, including the navigation radios³ and used the data to generate the required text and imagery for each display.

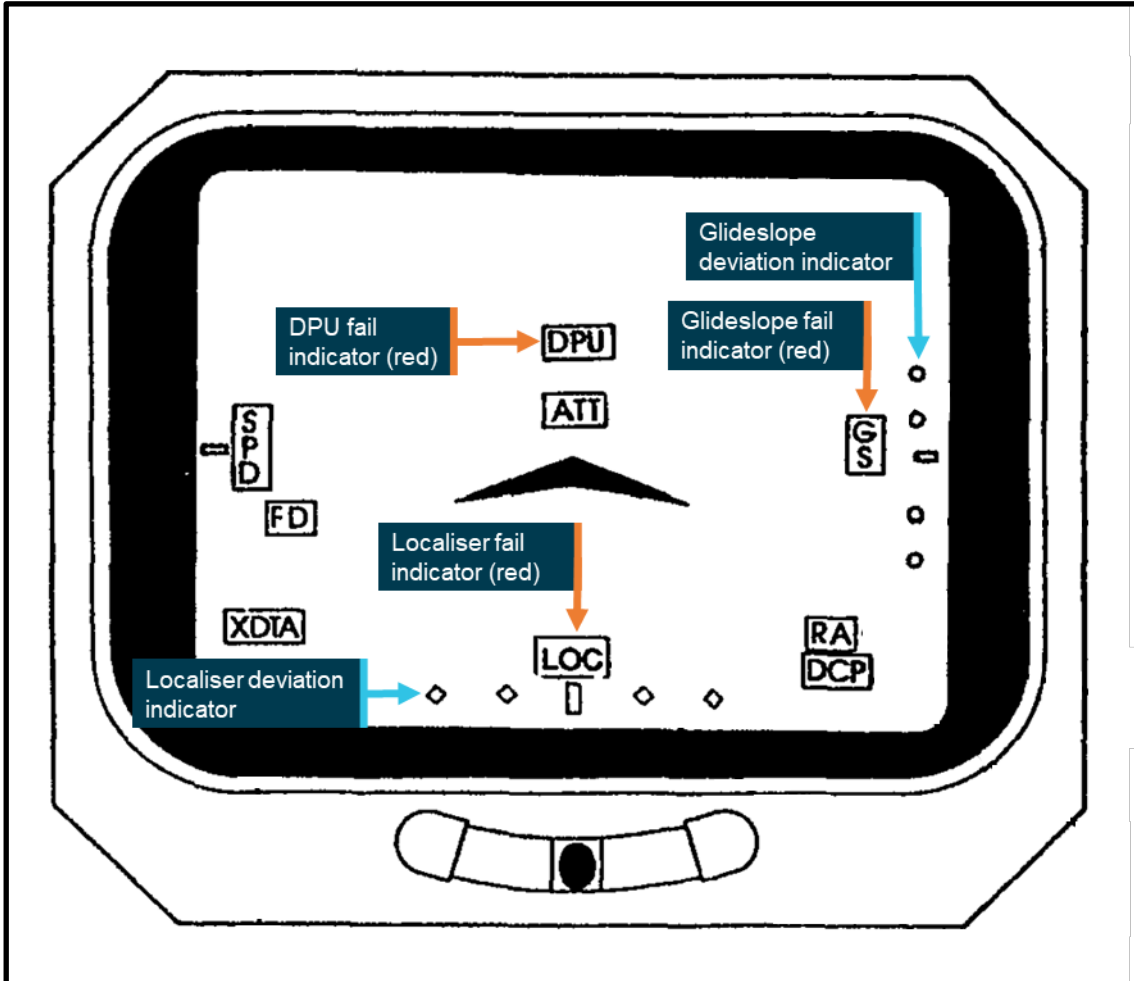
Figure 5: Electronic attitude direction indicator

The ILS glideslope indication was presented on the right side of each EADI as fly-up or fly-down commands on the glideslope indicator. Glideslope deviation was displayed with a centre marker

and deviation dots (Figure 5). Full-scale deflection equated to about 0.7° of angular deviation from the nominal glideslope.

While the precise source of the error could not be determined, it resulted in a constant on-glideslope indication on the captain's electronic attitude direction indicator (EADI) regardless of the aircraft's position relative to the glideslope. The indications were presented with no glideslope or DPU failure indication.
