ATSB TRANSPORT SAFETY INVESTIGATION REPORT

Additional Analysis of Left Engine Failure VH-LQH

6 March 2006

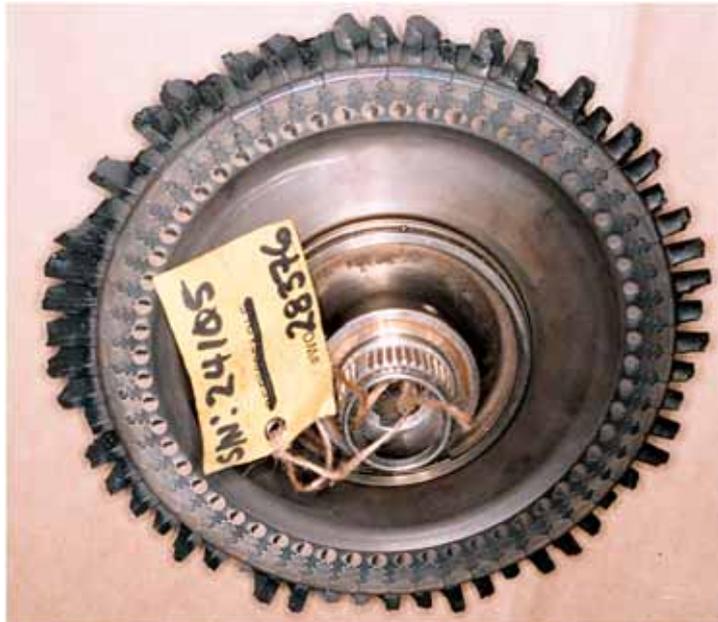
Figure 1: Compressor turbine, upstream side, left engine VH-LQH

Each compressor turbine blade had fractured during the engine failure sequence. Only the blade sections still attached to the turbine disc were recovered. It is evident that blade fracture occurred at varying locations along the blade span, the angle of the fracture plane varied with respect to the blade axis (it was not consistently perpendicular to the blade axis) and the macroscopic fracture surface features were dendritic in nature.

Dendritic fracture surface features in cast nickel based superalloys are created when a component is fractured by a single overstress condition. The preferred fracture path reflects the underlying dendritic nature of the microstructure created during casting.

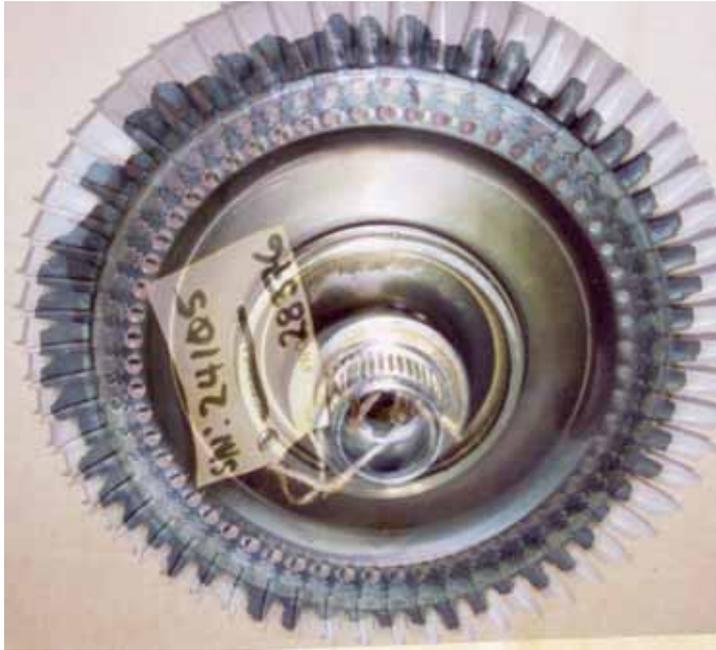
Figure 2: Composite photograph - compressor turbine, left engine VH-LQH, superimposed over an intact compressor turbine

Creep failure (stress rupture) occurs at a blade location that coincides with maximum temperature and increasing mechanical stress – typically around mid span. Failure is preceded by localised plastic deformation (necking) and surface microcracking. If all blades are manufactured from the same alloy, in the same heat treated condition, then all blades will show evidence of the final stages of creep preceding failure. There are sufficient blade remnants that allow the midspan region to be examined.

The known location for high cycle fatigue in turbine blades with no tip shrouds is at the base of the blade. No evidence of fracture surface features consistent with any stage of crack growth by the mechanism of fatigue was present.

No evidence of gross loss of blade cross-section through sulphidation was present.

The location of blade fracture, angle of fracture plane to the blade axis, and fracture surface features indicates that the blades were fractured as a result of a varying blade tip/shroud interference force.

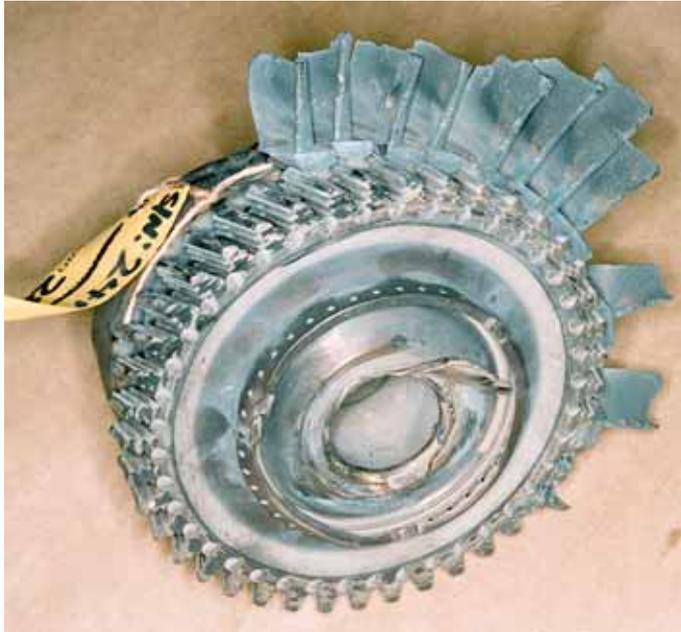
Figure 3: Power turbine, left engine VH-LQH

Only about one quarter of the power turbine blades were recovered from the accident site. Each blade had fractured and exhibited extensive leading edge wear through rotational contact with the displaced interstage baffle.

Despite the considerable amount of damage created by continued rotation after the initiating event one distinctive fracture feature was present in a number of blades. It was evident that crack growth had occurred from the blade trailing edge, around the midspan location, by a mechanism that created a 'faceted', 'crystallographic' fracture surface. This fracture surface feature contrasted with the dendritic features of all other fractures in the power turbine blades.

The evidence of crack growth extending from the trailing edge of several power turbine blades by a mechanism that creates a 'faceted', 'crystallographic' surface, and a crack path that is not perpendicular to the blade axis indicates that crack growth has occurred by the mechanism of thermal fatigue (see Appendices C and D).

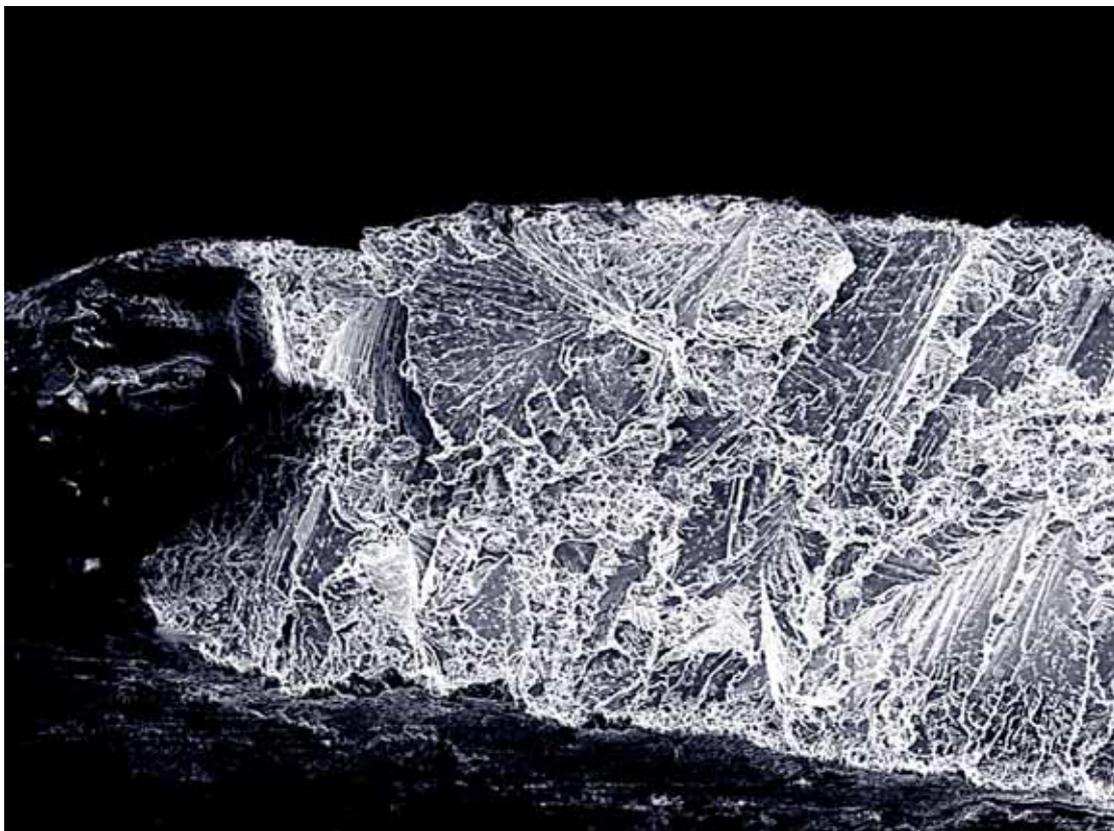
Region of crack growth with faceted 'faceted' features, arrowed (delineated by the blue heat tinting)

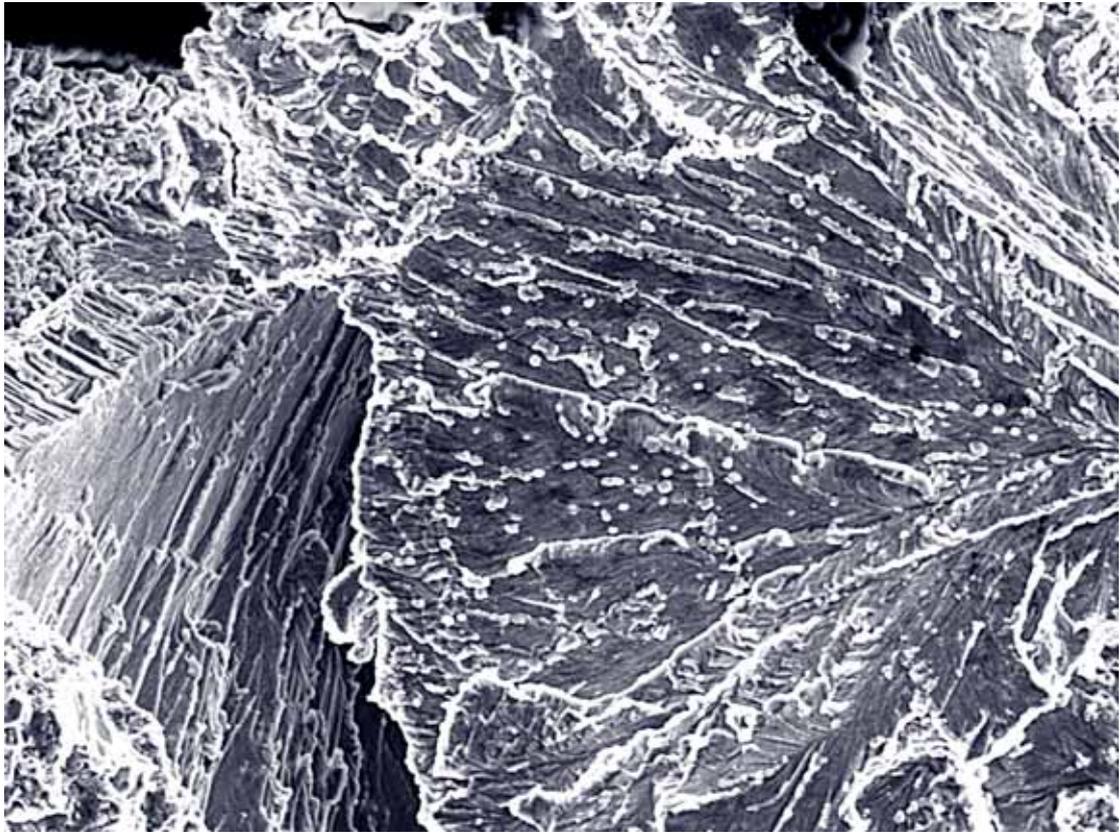
Scanning electron micrograph of the trailing edge crack, magnification 200X

Scanning electron micrograph at higher magnification of trailing edge crack, magnification 350X

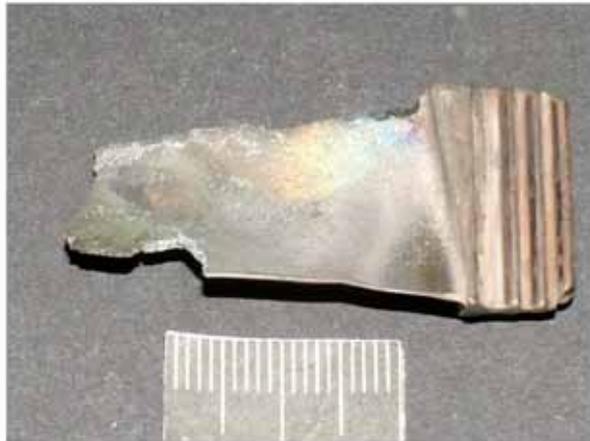
All available power turbine blades were re-examined with particular attention being paid to trailing edge cracks. No trailing edge cracks other than caused by impact damage with flying debris were found. One of the blades with a trailing edge crack undoubtedly caused by impact (Figures 1 and 2) was examined in the scanning electron microscope (SEM). This examination revealed fracture consistent with overstress. The fracture topography at the trailing edge (Figures 3 and 4) was comparable to that described in one of the attachments to your correspondence. It is therefore concluded that the trailing edge crack was a result of overstress situation rather than fatigue propagating under low alternating stress magnitude. The same blade described in the attachment was located and re-examined in the SEM. In our opinion, the fractographic features do not reflect a fatigue mode of crack propagation.

Figure 1 Power turbine blade with trailing edge crack.

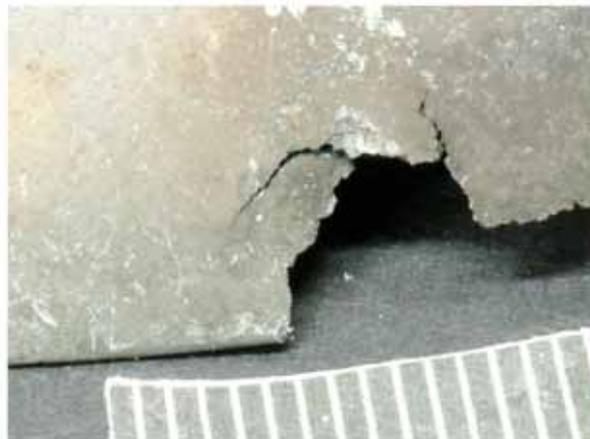
Figure 2 Close-up of the trailing edge crack.

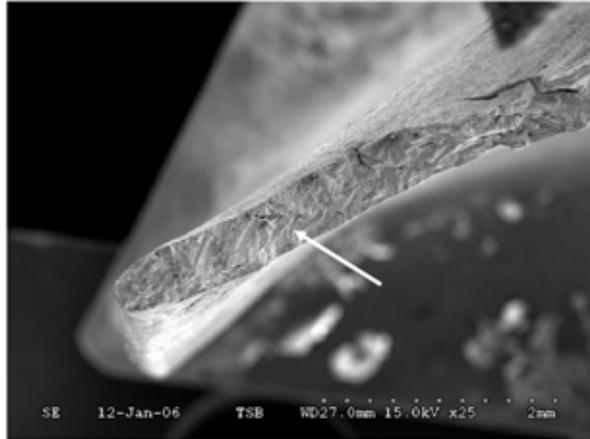
Figure 3 SEM image of the trailing edge fracture. Arrow identifies the area shown at higher magnification in Figure 4.

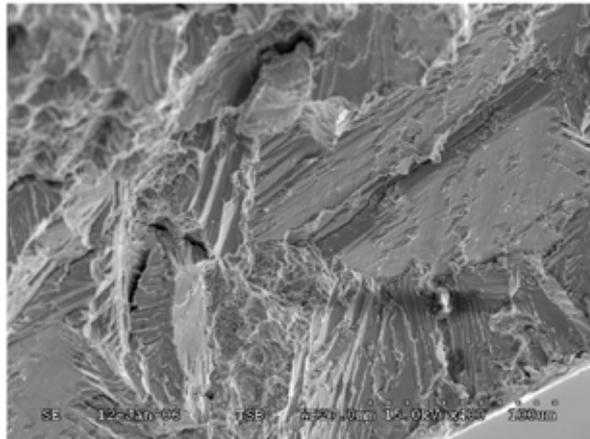
Figure 4 Area identified by arrow in Figure 3.

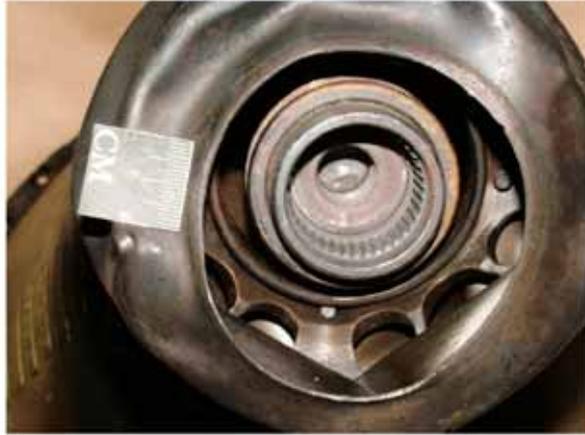
Figure 5 Separation of the power turbine shaft housing.

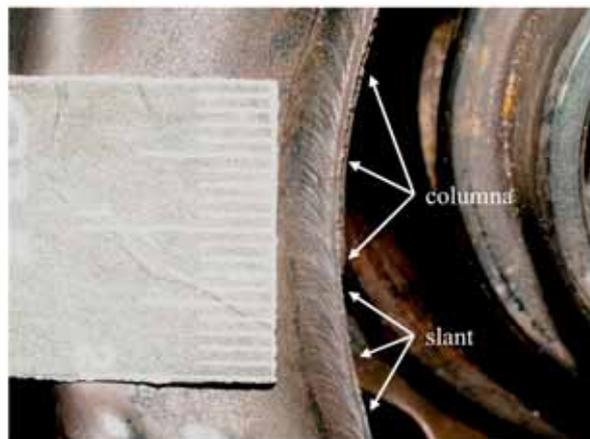
The following paragraph refers to Figures 6 and 7 that appear in the Pratt & Whitney Canada Report No. 01-119. Comparison of microstructures obtained from a section through a representative compressor turbine blade with those of reference microstructures for the applicable alloy indicated that the blade location shown in Figure 6 had reached 2050°F. The location represented by Figure 7 had been exposed to 2100°F. It is entirely possible that the temperature excursion to modify the gamma prime morphology occurred during the failure event. In fact, a loss of efficiency due to compressor blade loss frequently leads to an overheat condition.

Figure 6 Boundary between columnar and slant topography.

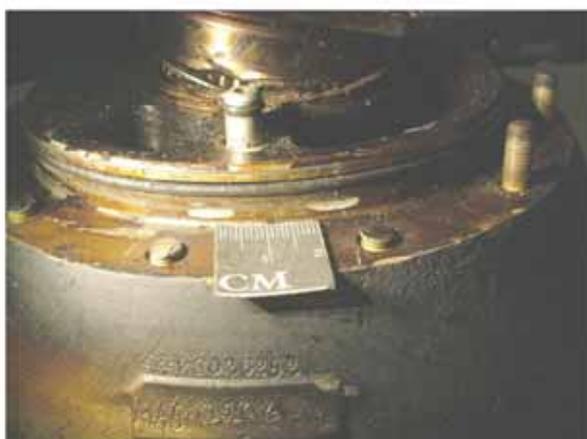
Figure 7 Attachment studs cut off with an abrasive cutter.

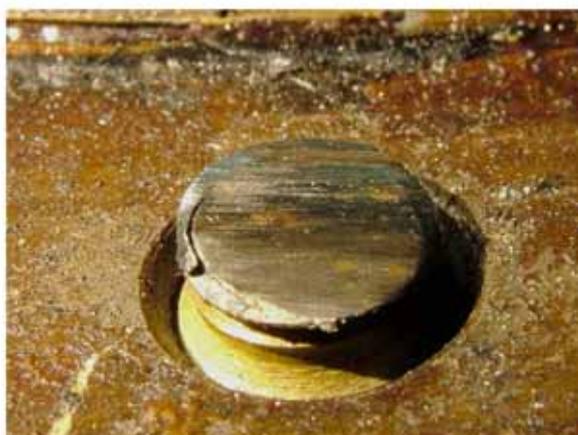
Figure 8 Close up of one of the studs.
