# In-flight break-up involving Robinson R22 Beta II, VH-RAS

13 km south-west of Koorda, Western Australia, on 2 October 2022

## **ATSB Transport Safety Report**

AO-2022-045

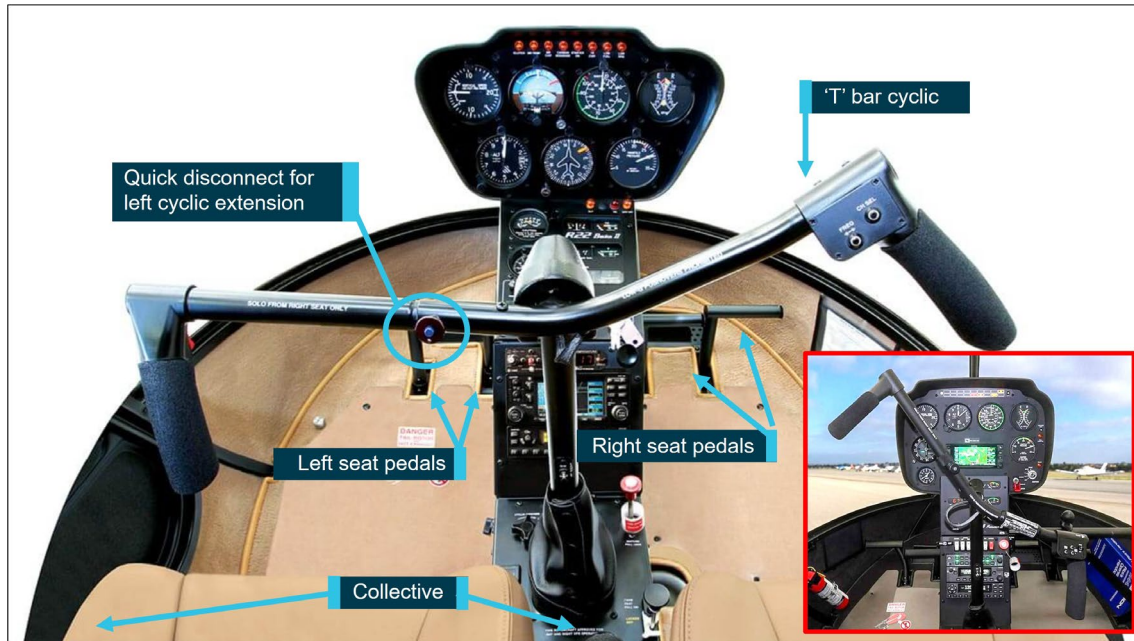
**Figure 4: Dual flight controls, with insert showing deflection when being operated from the right**

Both windshields had shattered, however, the bow (central pillar) was intact. The left seat quick-disconnect dual flight controls were installed. It was reported both doors were fitted when the helicopter departed Koorda.<sup>24</sup> The left door or its components were not identified in the wreckage at the site, nor in an extensive search of the surrounding area. It was possible it may have been destroyed during the main rotor blade strike to the cabin, but with the fragments unable to be identified or located in the loose muddy sand that was below the salt crust. There was no evidence of main rotor blade strike to any portion of the tailcone.

...remove left seat controls if person in that seat is not a rated helicopter pilot.

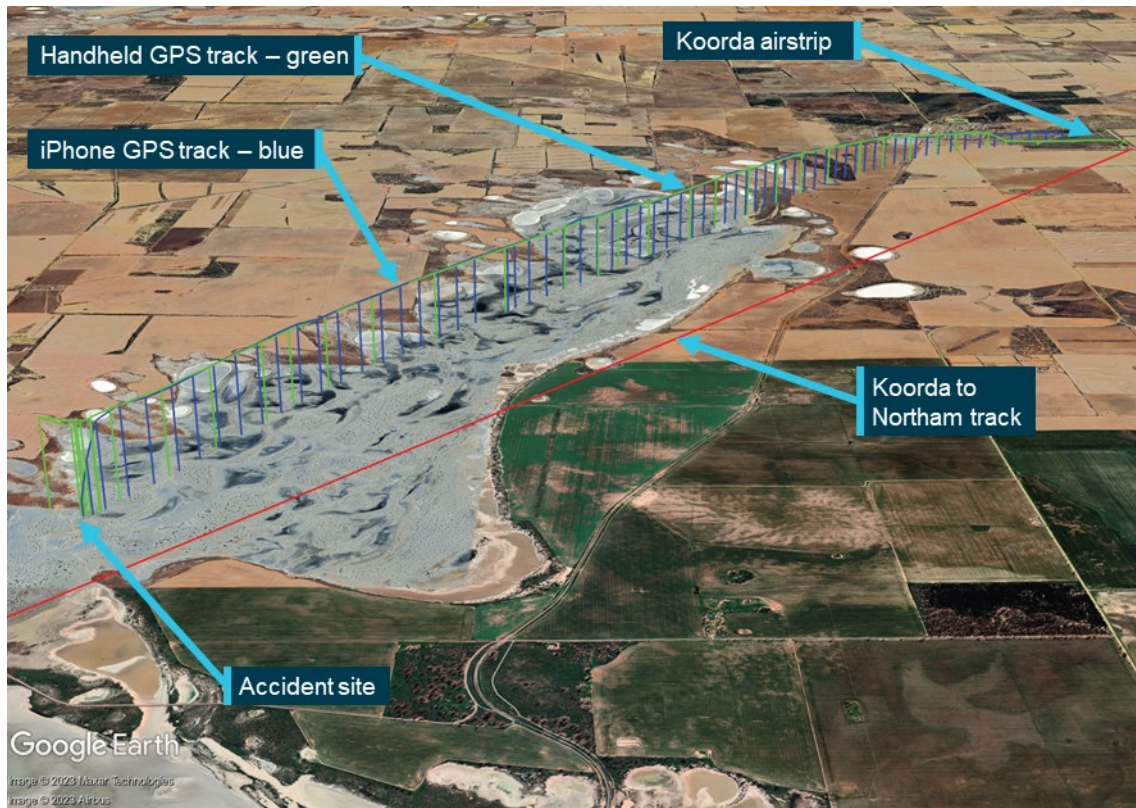
**Figure 5: Correlated track data for VH-RAS from Koorda to the accident site**

There was a close correlation between the 2 tracks and groundspeeds. The helicopter's airspeed during the initial stages of climb was estimated to be between 60 and 65 kt,<sup>20</sup> which was consistent with the helicopter manufacturer's recommended climb speed. The estimated airspeed increased progressively towards about 80 kt during the latter stages of the climb. About 3 minutes 40 seconds after take-off, the iPhone and GPS altitude stabilised at about 2,700 ft (refer *Appendix A* for graphed data).

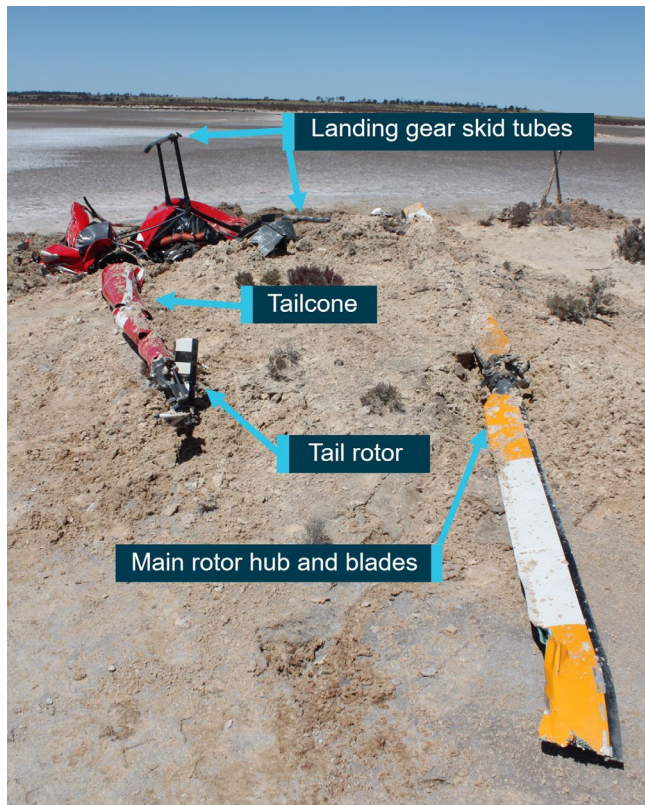
**Figure 7: Accident site and wreckage**

The helicopter collided with terrain inverted, on a dry salt flat, on an easterly heading. A small distance below the salt crust was loose muddy sand and the water table was close to the surface. The main rotor head, with blades attached, and the top portion of the mast had separated but were located alongside the fuselage (Figure 7). One main rotor blade had fractured, with the outboard section located about 3 m from the main rotor assembly. The tailcone, including the tail rotor assembly, was attached to the fuselage. The horizontal and vertical stabiliser assembly had separated and was located about 6 m from the tailcone. The auxiliary fuel tank bladder was intact, however, the main tank bladder had ruptured due to impact forces. There was no fire.

Distribution of the wreckage and ground scars were consistent with an almost vertical descent and little to no rotation of the main rotor blades. Both occupants were found secured in their respective restraints, however, due to the high descent rate and inverted orientation, the impact was not considered survivable.

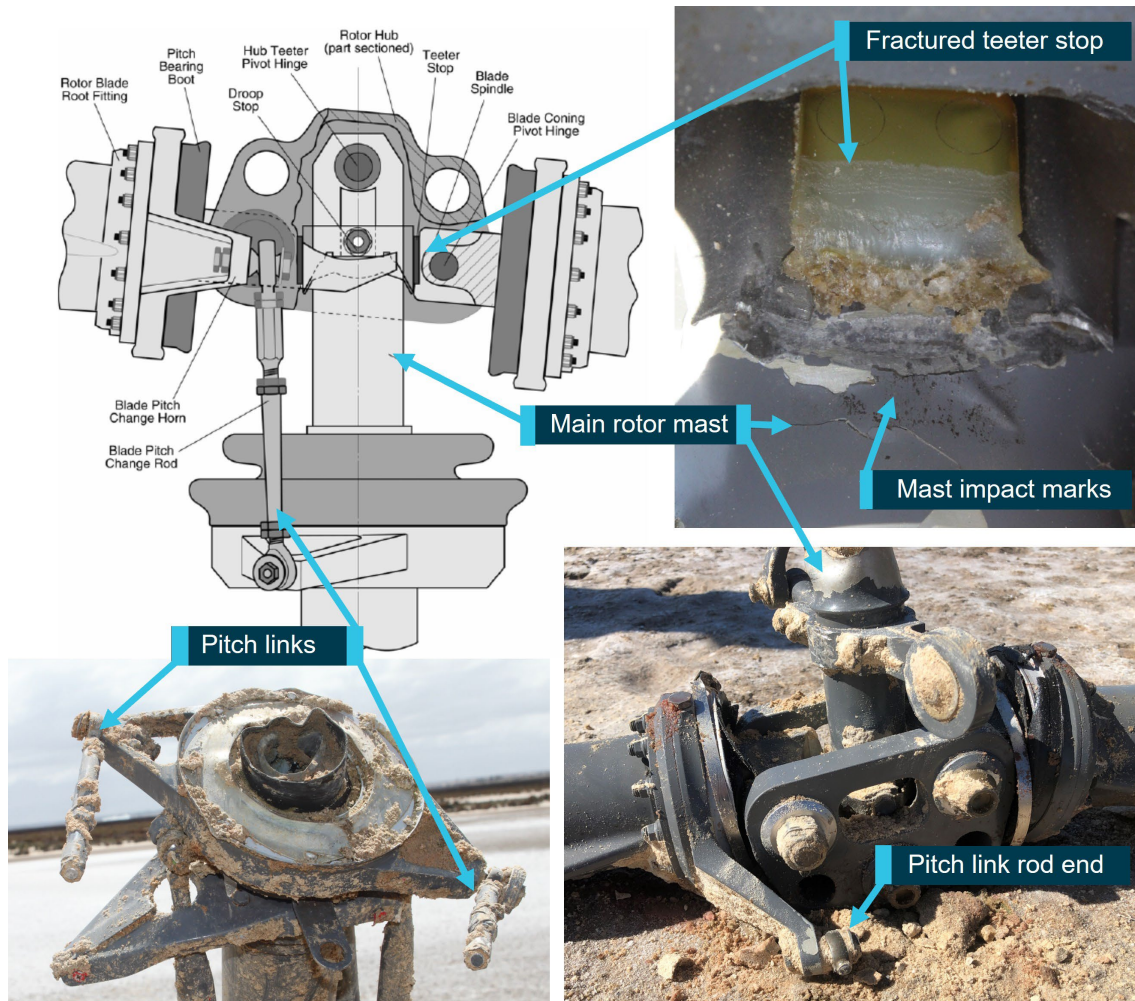
**Figure 8: Main rotor head and mast damage**

Damage to the main rotor head components (refer Figure 8 for main rotor head components detail) included:

- both main rotor pitch change links had fractured, in overstress, at the upper rod end thread
- both spindle tusks had fractured and the tusks were not recovered
- the teeter stops had fractured in the centre due to severe impact forces from the spindles, the lower halves had been liberated and impact damage was visible on the mast.

The mast had fractured near the swashplate, with no evidence of pre-existing fatigue. The fracture location was coincident with impact from a pitch horn that was free to rotate down and impact the mast, following pitch link failure. The fractured main rotor blade exhibited red paint transfer and damage consistent with it striking the forward fuselage with low energy and wrapping under the cabin.

*Note: Diagram of typical R22 main rotor head showing VH-RAS fractured pitch links and corresponding rod end, teeter stop split in half and impact damage from mast bumping.*
