# Near collision involving Piper PA-28-161, VH-ENL, and Bombardier DHC-8-315, VH-TQH

Mildura Airport, Victoria, on 6 June 2023

**ATSB Transport Safety Report**

AO-2023-025

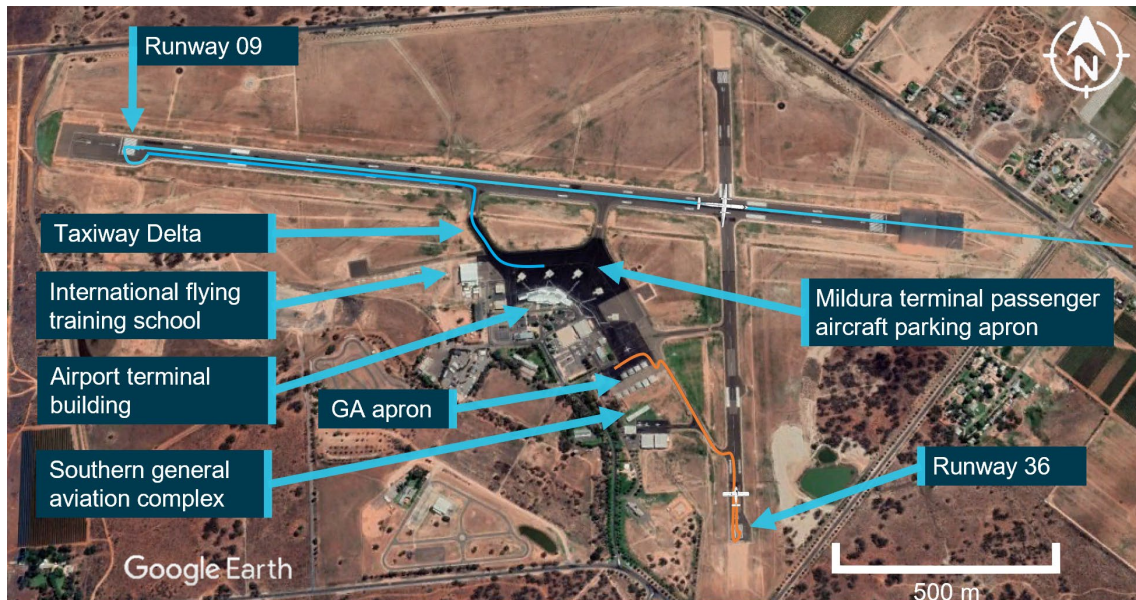
**Figure 1: VH-TQH (Dash 8) and VH-ENL (PA-28) ground tracks**

The Dash 8 had started its take off roll on runway 09 as the PA-28 gave a rolling call on runway 36 and commenced take-off. As the Dash 8 crossed the runway intersection of 09/36 at about 200 ft vertically, the PA-28 was rolling towards the intersection and about 600 m from the Dash 8 (Figure 1 aircraft positions).

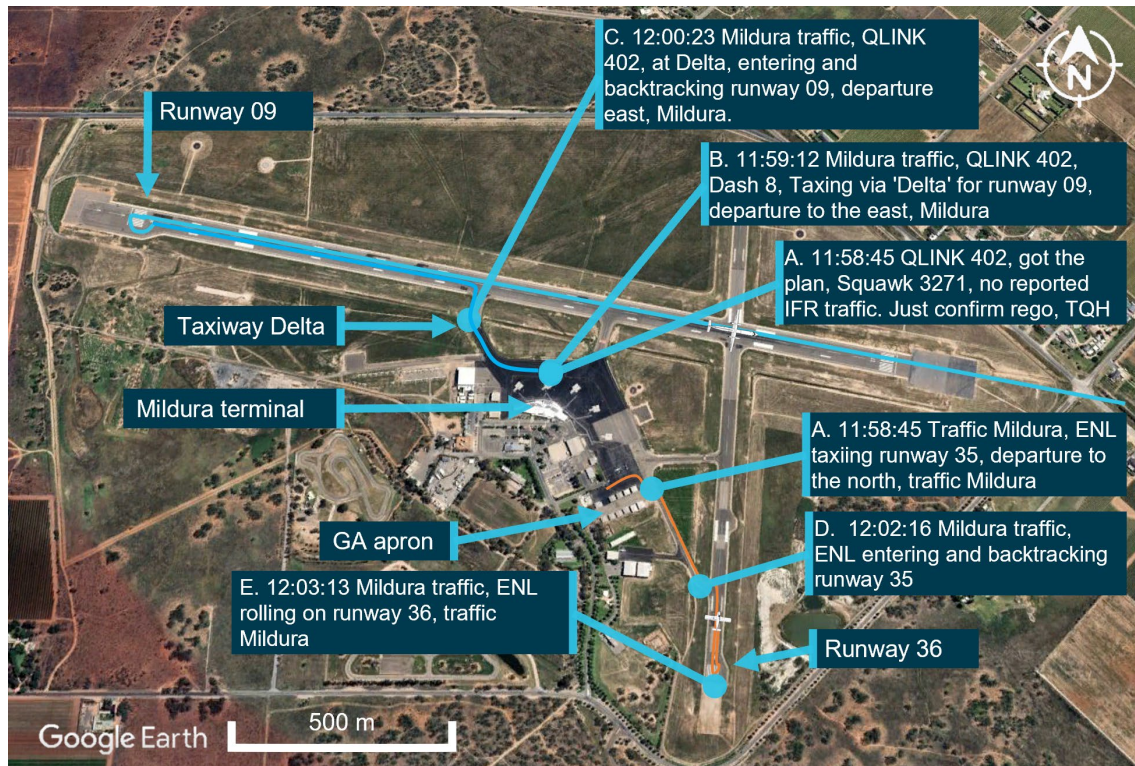
**Figure 4: Recorded data sequence**

Recorded data (Garmin watch of the pilot) on the taxi track of VH-ENL showed the PA-28 initial entry to runway 36 and backtrack occurred at 0202:18, and that initial power application occurred on the threshold of runway 36 at about 0203:22 (about 31 seconds after VH-TQH), accelerating VH-ENL along runway 36 until about abeam taxiway Bravo at 0203:38. At that time, the recorded data of VH-TQH shows the Dash 8 crossing the runway 09/36 intersection about 600 m ahead, and about 200 ft above the intersection of both runways (Figure 4).

The pilot of the PA-28, after identifying that the Dash 8 had departed on the crossing runway, continued their take-off roll. Recorded data further showed the PA-28 crossing the runway intersection about 18 seconds after the Dash 8, and at about 220 ft above the intersection.

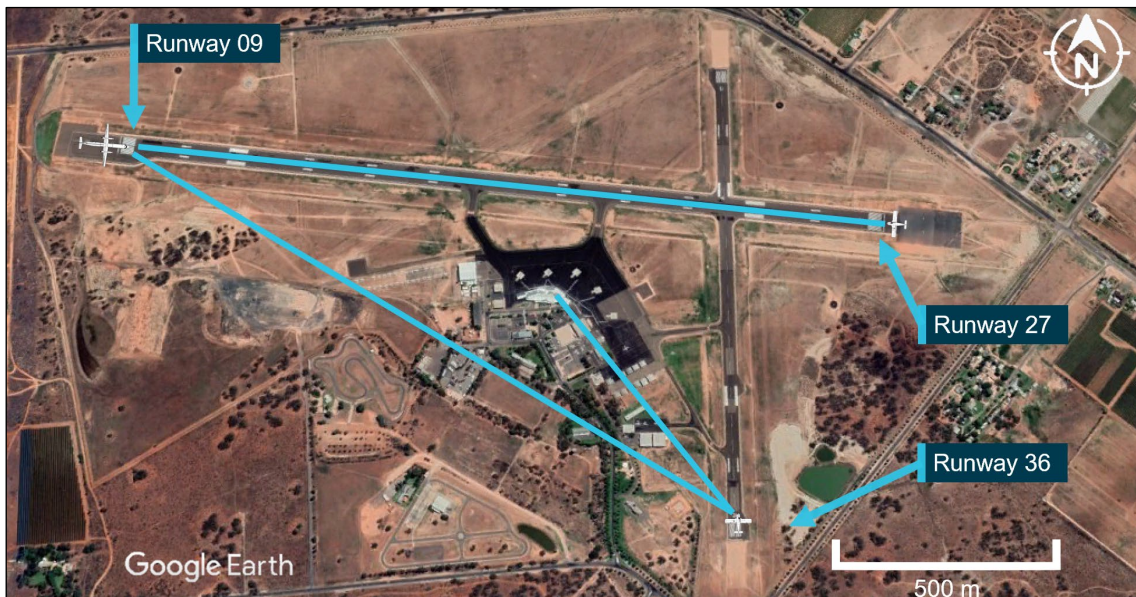
**Figure 5: Visual line of sight from runway 36/09/27**

The Dash 8 captain recalled that from the threshold of runway 09, the threshold of runway 36 was visually obscured by the terminal buildings, and the pilot of the PA-28 also recalled the buildings prevented pilots from seeing the threshold of runway 09 from the southern end of runway 36 (Figure 5).

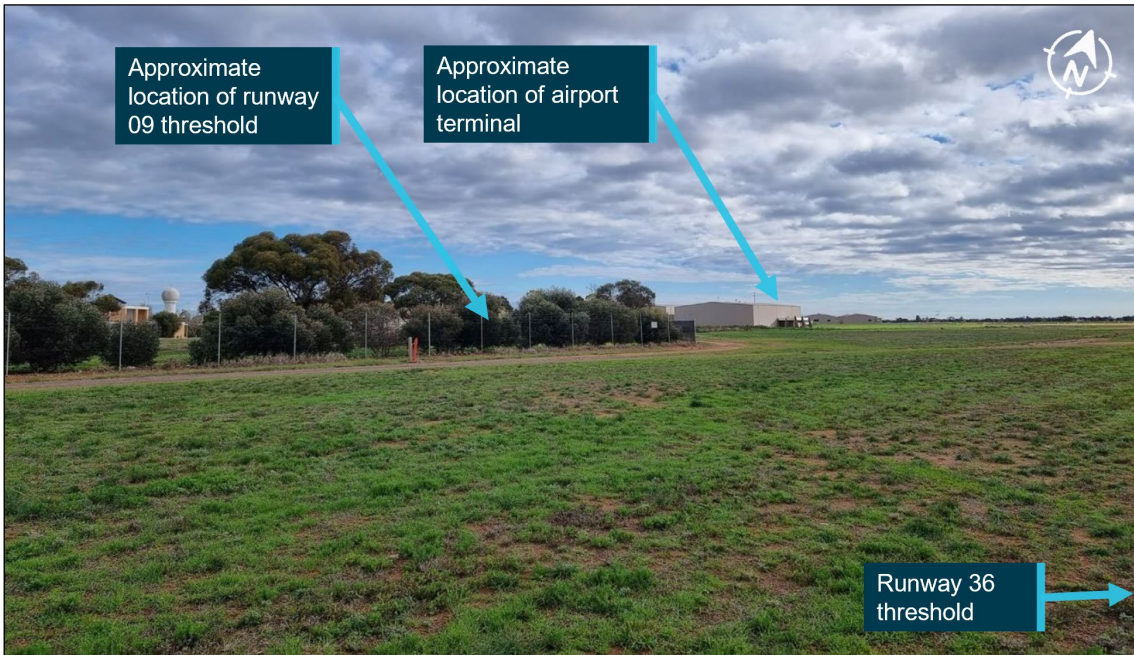
**Figure 6: View from threshold runway 36**

The operator's internal investigation report identified an obstructed visual line of sight from the threshold of runway 36 to 09 (Figure 6). The report identified that neither aircraft could visually identify each other 'due to local infrastructure and terrain that limits visibility between runway 09 and 36'.

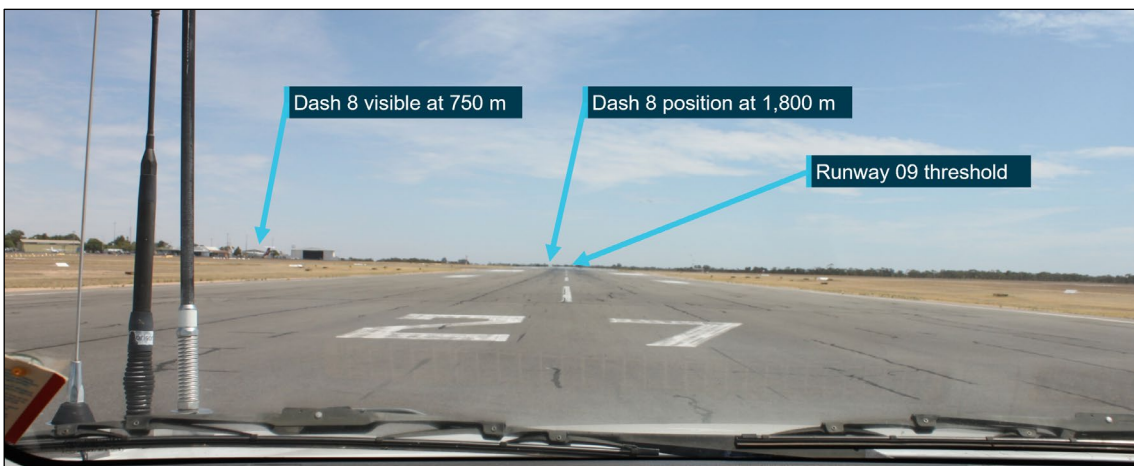
**Figure 7: View from threshold of runway 27**

ATSB on-site examination of the airport confirmed the obstruction noted in the operator’s report from the threshold of runway 36 to the threshold of runway 09, and in addition, from the threshold of runway 09 to the threshold of 36. In addition, the ATSB site inspection identified a lack of aircraft visibility also occurs from the thresholds of runway 09 and 27 (either end of the same physical runway). However, this was due to raised terrain along the runway between the two ends (Figure 7).
