Safe working incident involving MTM trains TD3148 and TD7255

Ferntree Gully, Victoria, on 25 February 2024

ATSB Transport Safety Report

RO-2024-001

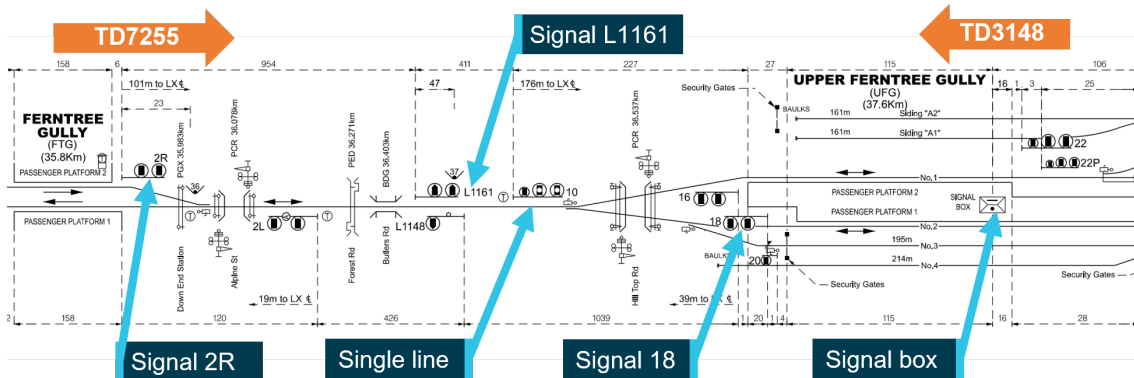
Figure 2: Signalling arrangement between Ferntree Gully and Upper Ferntree Gully

Trains TD7255 and TD3148 were travelling towards the single line section between Ferntree Gully and Upper Ferntree Gully (Figure 2).

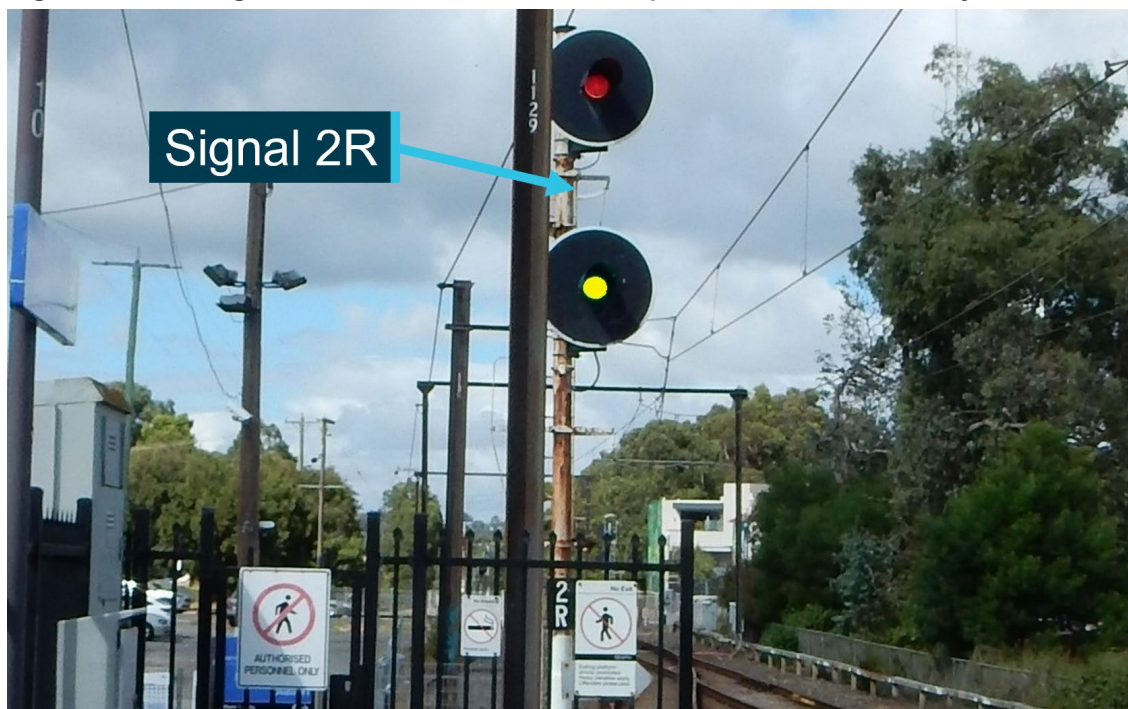
Figure 3: Home signal 2R located at the end of the platform at Ferntree Gully station

The driver of TD7255 reported that after passing through Boronia station, they proceeded at between 30 and 40 km/h through Ferntree Gully station on a departure home signal¹ (2R) that displayed a medium speed warning (Figure 3). A medium speed warning (red over yellow) indicated that the line ahead was clear, but the next signal was at stop. A train must not exceed 40 km/h after proceeding past a signal displaying a medium speed warning.

Signal 2R annotated to show a Medium Speed Warning indication

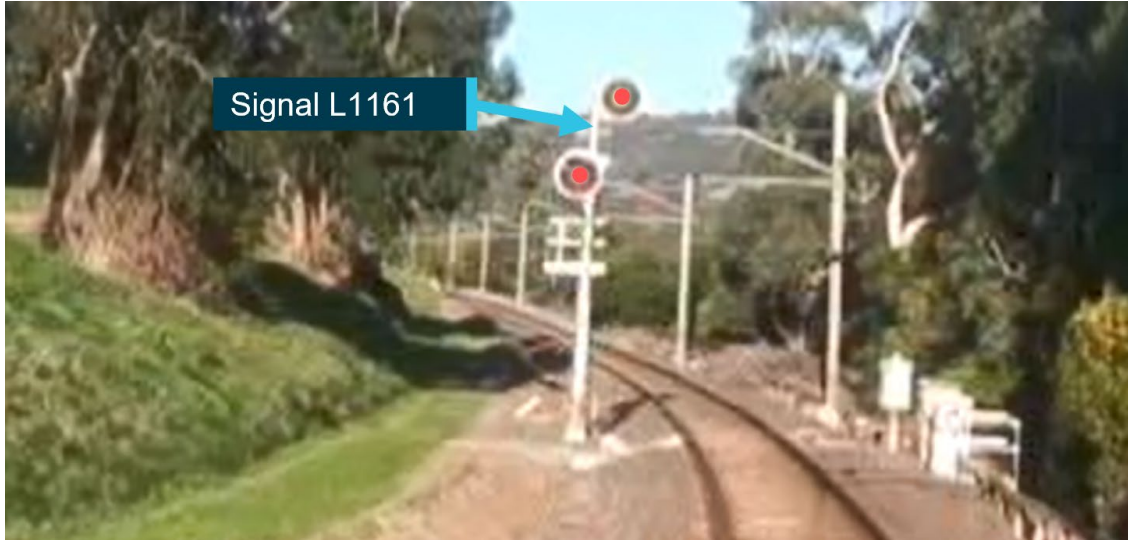
Figure 4: Signal L1161 on the approach from Ferntree Gully

Train TD7255 then entered the single bi-directional line between Ferntree Gully station and Upper Ferntree Gully station. The train arrived at signal L1161 at about 0947 and stopped at that signal as it displayed a stop indication (Figure 4). Train TD3109 that was travelling ahead of TD7255 was stopped on platform 2 at Upper Ferntree Gully awaiting the arrival of TD3148.

Signal L1161 annotated to show the signal aspect when at stop

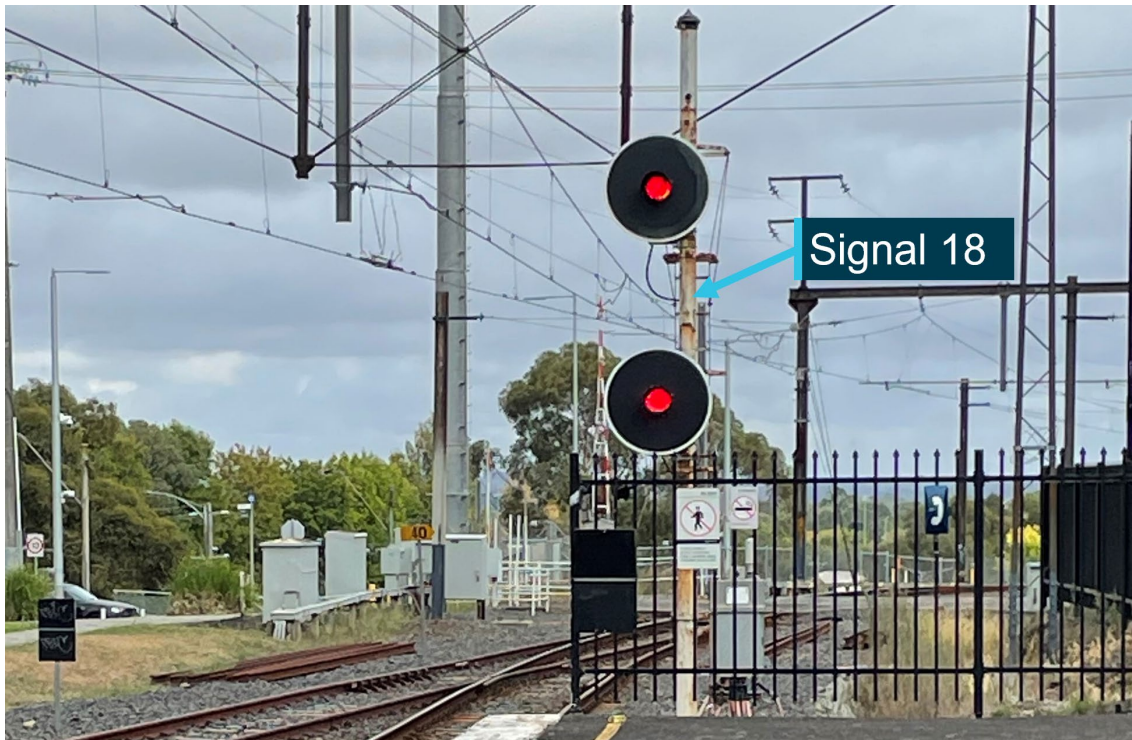
Figure 5: Departure home signal 18 at Upper Ferntree Gully station at stop

After departing Belgrave, train TD3148 had stopped at Tecoma and Upwey stations before arriving on platform 1 at Upper Ferntree Gully Railway Station at about 0951. TD3109 then departed the station towards Belgrave. TD3148 was to depart towards Ferntree Gully but was held at the platform by departure home signal 18 that displayed a stop indication (Figure 5).

The signaller based at Upper Ferntree Gully reported checking the signalling panel and train schedule and making an unsuccessful attempt to reset the signals. In the belief that the departure signal for TD3148 would not clear due to a recurring fault, the signaller contacted Metrol² and sought permission to issue a caution order³ to the driver of TD3148. This instrument would allow the driver to proceed at slow speed (no more than 25 km/h) towards Ferntree Gully. The Metrol train controller confirmed that a caution order could be issued.

The signaller issued a caution order for the train to proceed past signal 18 and the train departed at about 0958. The train tripped the automatic train stop⁴ for signal 18 and came to a stop a short distance past the signal. After the driver reset the train's systems, TD3148 proceeded into the single line section between Upper Ferntree Gully and Ferntree Gully stations.

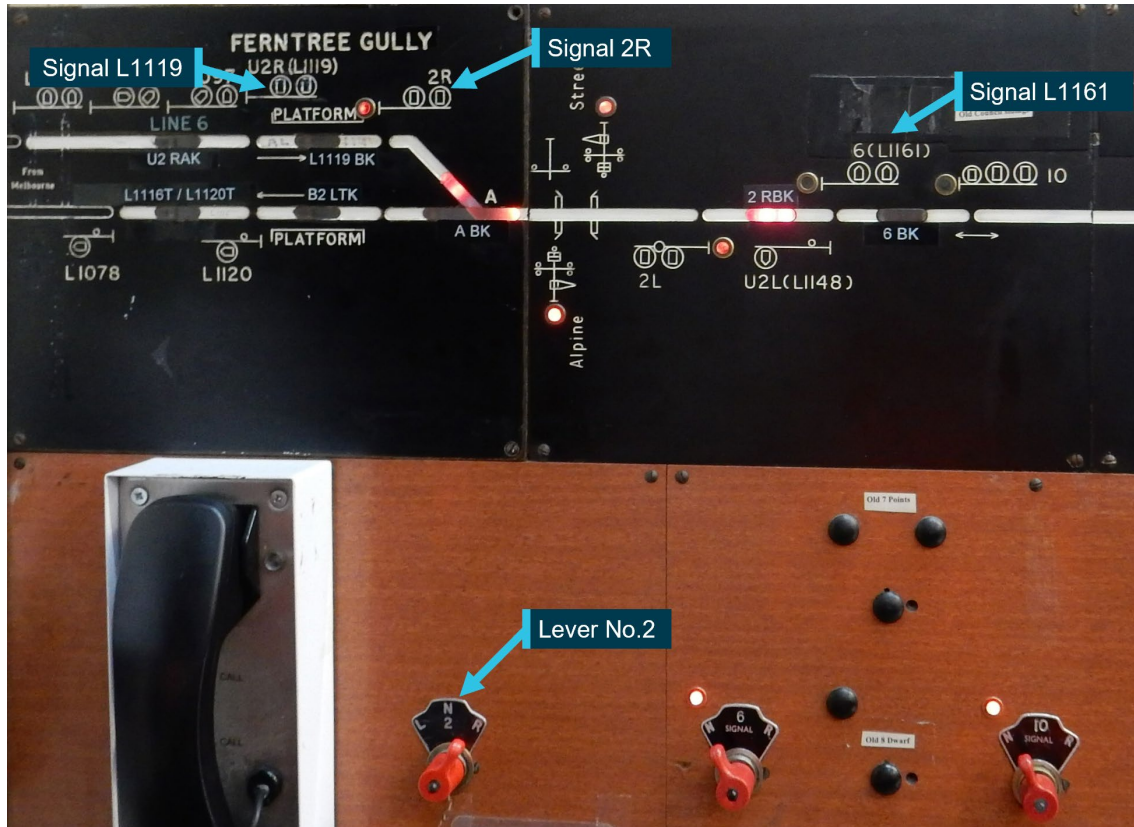
Figure 7: Part of signalling panel at Upper Ferntree Gully station

Signal and points between Ferntree Gully and Belgrave were controlled from Upper Ferntree Gully Railway Station which was fitted with a signal control panel (Figure 7). Installed in 1962, the control panel had incandescent indications. Signals L1119 and 2R were operated by lever no.2 and when it was placed to the 'R' position, signals L1119 and 2R displayed proceed aspects.
