Safety Advisory Notice

Number: AO-2022-049-SAN-001

On condition? Replacing O-ring seals before age catches up.

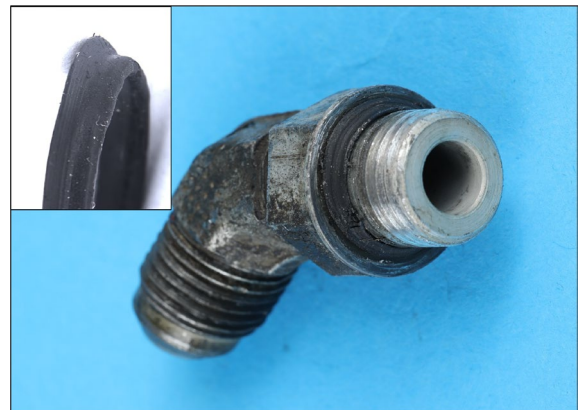
Age-affected O-ring seal of fluid carrying fitting with inset image displaying permanent deformation of the seal (Source: ATSB)

Following the accident, pressure testing of the engine driven fuel pump revealed a fluid leak from the pump outlet fitting that supplied the engine fuel control unit. The ATSB's analysis indicated that the condition of the O-ring sealing the fitting had deteriorated with age, with evidence of loss of pliability, permanent deformation and the presence of surface defects. Examination of aircraft records revealed that the pump had been in service for just over 29 years, and had likely remained undisturbed for maintenance related purposes throughout that period.

AO-2022-049-SAN-001: A proactive approach to replacing O-ring seals before they deteriorate to the point of failure, may avoid fluid leakage that on this occasion led to an in-flight, fuel-fed, engine compartment fire. The ATSB advises aircraft owners, registered operators and maintenance personnel to consider replacement of the O-ring seals of fluid carrying components, when examination of aircraft records identify components that have remained undisturbed for significant periods of time.
