# Collision with runway lighting involving Embraer ERJ-135, VH-JGB

Middlemount Airport, Queensland, 8 August 2017

**ATSB Transport Safety Report**  
Aviation Occurrence Investigation  
AO-2017-080  
Final – 5 December 2017

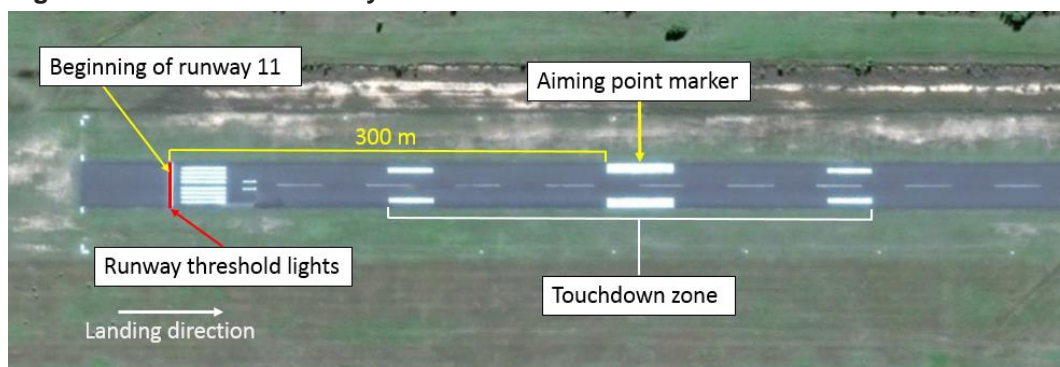
**Figure 1: Overview of runway 11 threshold**

A runway inspection was not carried out prior to the arrival of the second scheduled flight. The second flight arrived without incident, the ARO noted that the touchdown point for this flight appeared to be in the normal touchdown zone (Figure 1).

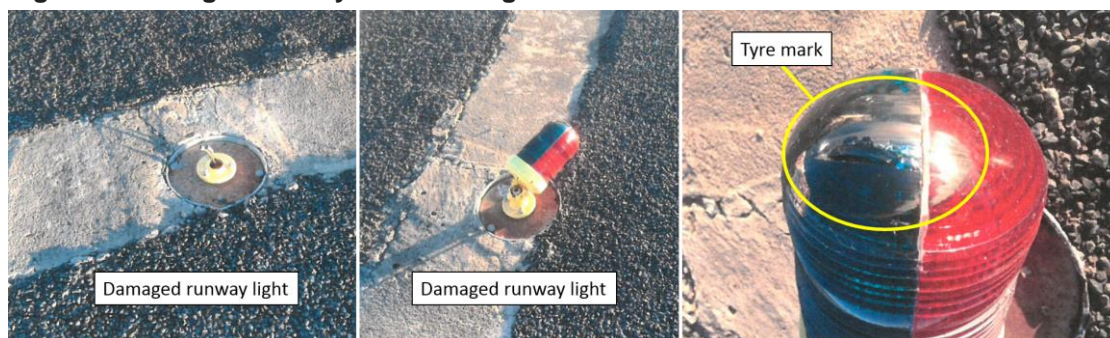
**Figure 2: Damaged runway threshold lights**

At about 1840, the ARO conducted an inspection of the runway prior to the departure of the two aircraft. During the inspection, the ARO identified two damaged runway threshold lights (Figure 2) and fresh tyre marks (Figure 3) about four meters further along the runway from the damaged lights. The ARO immediately proceeded to VH-JGB, and advised the flight crew that he believed they had damaged the runway threshold lights during their landing. The training captain inspected the aircraft tyres and landing gear, and determined that the aircraft had not sustained any damage.

Images shows the damage to the runway threshold lights (left and centre), and a tyre mark on a damaged light (right).  
Source: Airport operator, annotated by ATSB

During final approach the aircraft descended below the final approach path, and the aircraft landed prior to the selected aim point. Prior to landing, the main landing gear tyres collided with two runway threshold lights.

- Landings at Middelmount will be made by captains only.
- Line training flights will not operate to Middelmount.
- Training for operations without approach slope guidance will be conducted as standalone training following a period of consolidation of line flying after the completion line training.

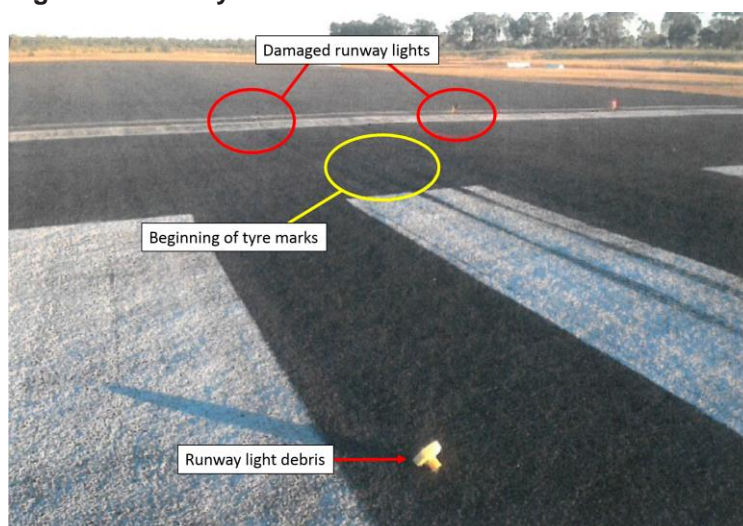
**Figure 3: Runway 11 threshold**

Image shows the damaged runway lights, touchdown tyre marks and runway light debris.  
Source: Airport operator, annotated by ATSB

The recorded touchdown point of the aircraft was consistent with the fresh tyre marks observed by the ARO.

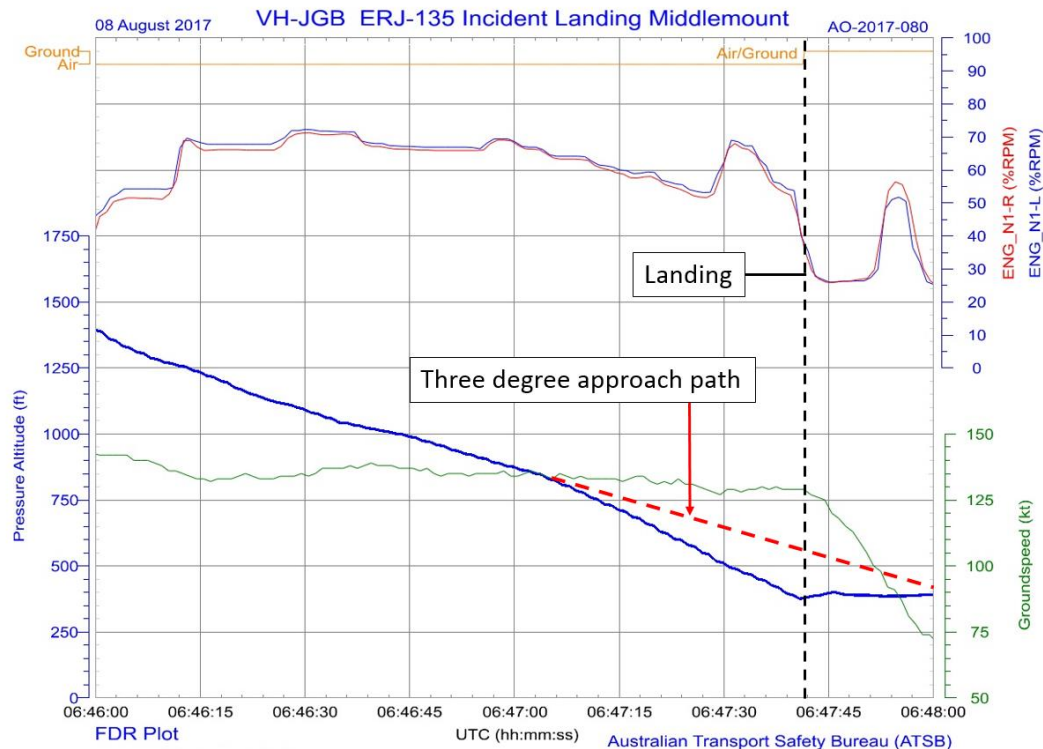
**Figure 4: Graphical representation of recorded flight data**

The flight data shows (Figure 4) that at 16:47:10, the aircraft was positioned on about a three degree approach path. At this time, the descent angle increased until the aircraft flared for landing.
