Aircraft preparation and foreign object damage event involving Saab 340B, VH-VEQ

Canberra Airport, Australian Capital Territory, on 10 November 2022

AO-2022-055

Final – 9 May 2024

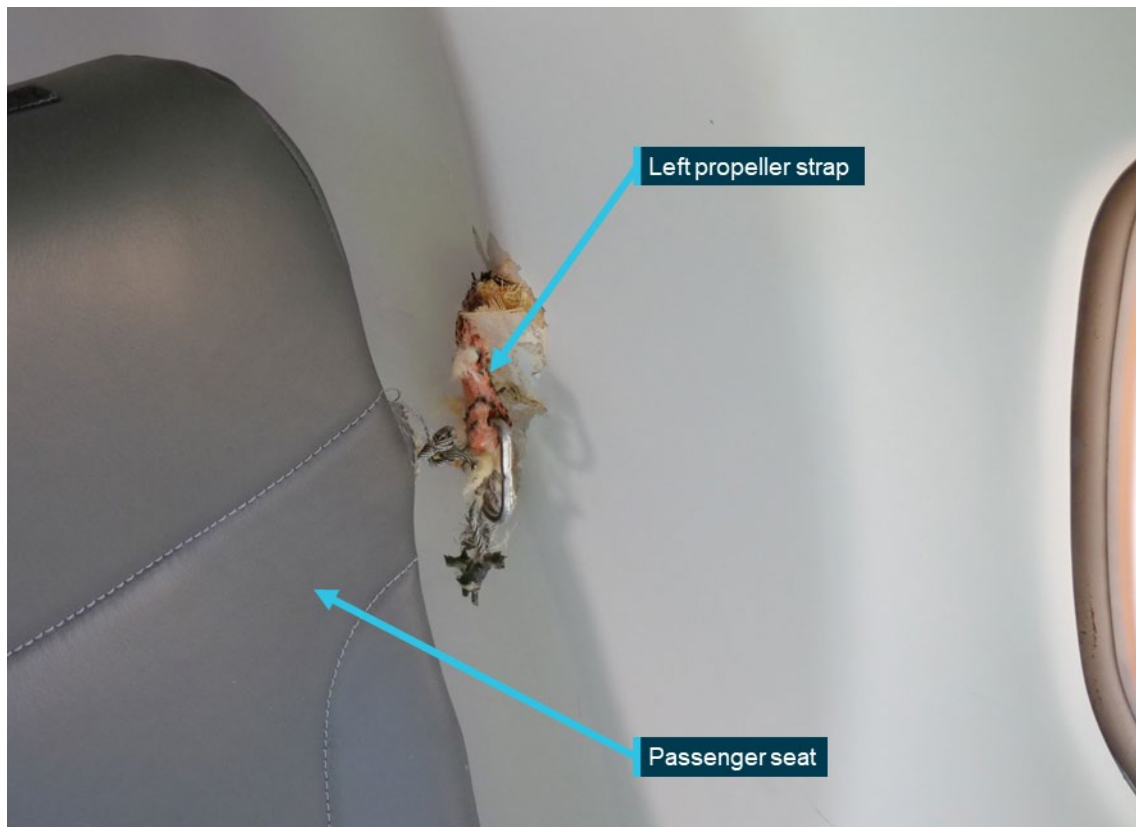
During the take-off, about the time the aircraft became airborne (according to the CM's recollection), the propeller strap was thrown free of the blade and into the fuselage (Figure 1). The strap itself became embedded in the fuselage, but the two failed cowling pins that were attached to the strap broke free and entered the cabin. One fragment struck the leg of the passenger in seat 2A, resulting in a minor injury (bruising).

Figure 1: Part of the left propeller strap that entered the fuselage adjacent to seat 2A

The aircraft was quarantined in Canberra pending the ATSB's attendance. A remnant of the propeller strap was recovered from the fuselage (Figure 1) where it had caught on a stringer.⁷ The cowling pins were no longer attached to the strap. Sections of both cowling pins were still secured in the engine cowling following the occurrence (Figure 2). Other parts breached the fuselage and were recovered from the cabin floor (Figure 3). A small section of one cowling pin was not located. The strap extension was still stowed on the flight deck.

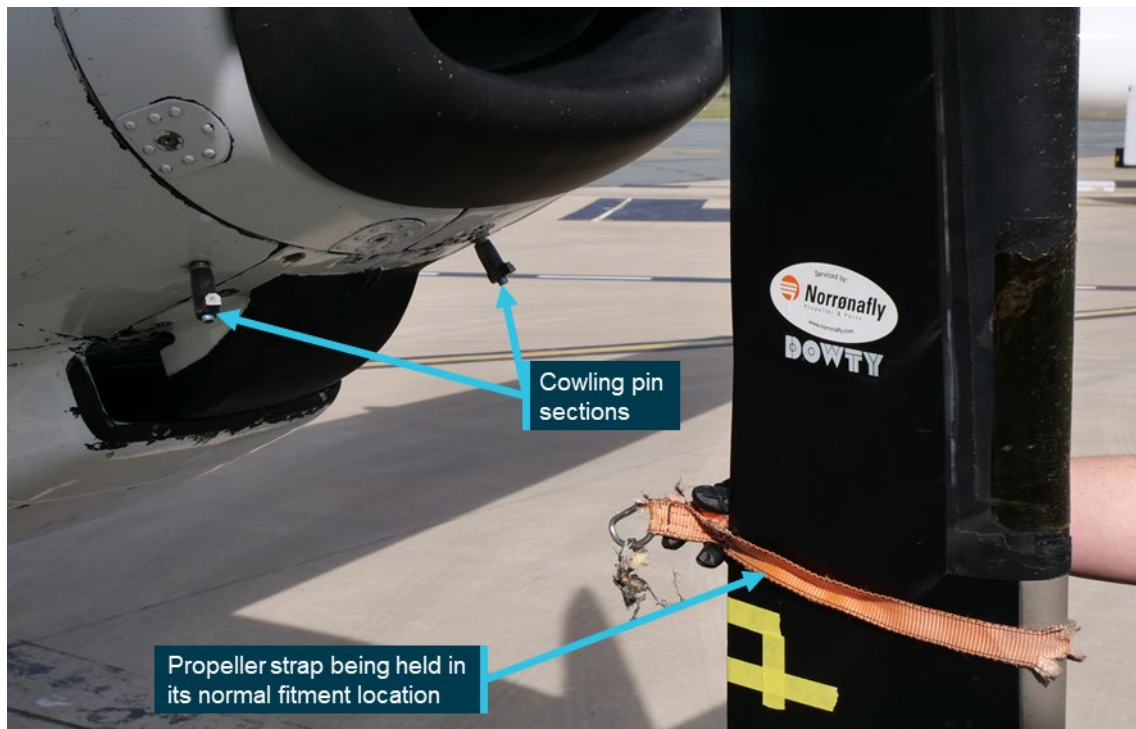
The engine continued to build torque with the propeller restrained, and 33 seconds after the initial movement the propeller began to turn. Subsequent investigation established that the propeller torque caused the pins securing the strap to the engine cowling to fail with the strap remaining secured to one of the blades.

Figure 2: Cowling pin sections that remained secured in the engine cowling, and the damaged propeller strap shown in the normal fitment location after being recovered from the fuselage

The aircraft was released for flight with the propeller strap still attached to the left propeller. Rotational torque during the engine start broke the 2 pins securing the strap to the engine cowling, leaving the strap webbing (with broken fragments of the pins still connected) attached to the propeller blade. The partial strap assembly was flung off the propeller during the take-off, penetrating the fuselage and injuring one passenger.

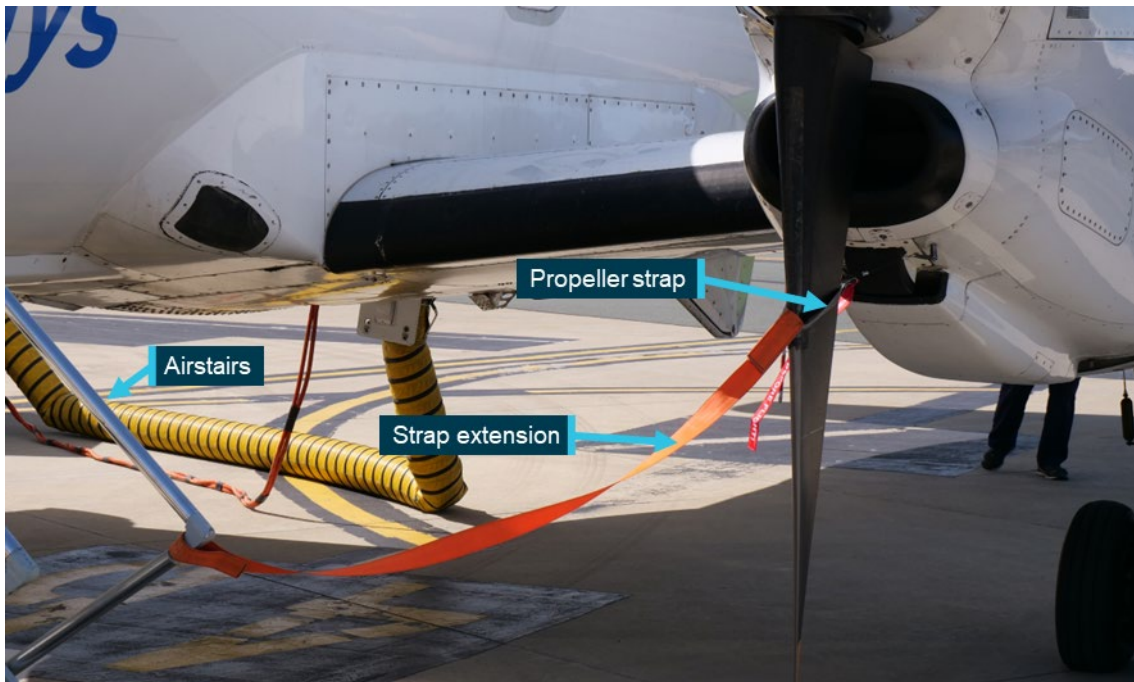
- The strap extension was not fitted. Because the cabin door could not be closed with the strap extension in place, its correct fitment would almost certainly have prevented the flight from proceeding with the propeller strap attached. A review of other departures out of Canberra found that some other flights were boarded without the strap extension being attached.
- The propeller strap did not have a visibility aid (streamer) fitted in accordance with the manufacturer's design. Link conducted an inspection of its Saab 340B fleet and found the condition of propeller straps to be significantly variable.
- Guidance provided by Link Airways for training of Swissport dispatchers did not explain the appearance, function and importance of the propeller straps.

Link also used a strap extension, made with fluorescent webbing and connecting between the handrail on the airstairs and the left propeller strap. The strap extension was not designed or supplied by the aircraft manufacturer, but a similar product was used by other Saab 340B operators. According to the Link *Flight crew operating manual* (FCOM), it was intended to 'provide a visual indication of a restricted area around the propeller' and a 'safety mechanism restricting the passenger door stairs from being closed without removing the extension and prop strap.' An example of the fitment of a strap extension in accordance with the FCOM is shown in Figure 5.

Figure 5: Exemplar strap extension fitted between airstairs and propeller strap

Link advised that it had updated the flight crew and cabin crew operating manuals to include additional preflight checks for the presence of the propeller strap and strap extension. Additional clarity was provided to cabin crew regarding contacting the flight deck during emergencies. Propeller strap discrepancies were rectified within Link's Saab 340B fleet, and regular inspections and maintenance were added to procedures.
