Australian Transport Safety Bureau

Data input error involving a Boeing 737, VH-XZI

near Adelaide Airport, South Australia on 12 October 2014

ATSB Transport Safety Report
Aviation Occurrence Investigation
AO-2014-171
Final – 27 August 2015

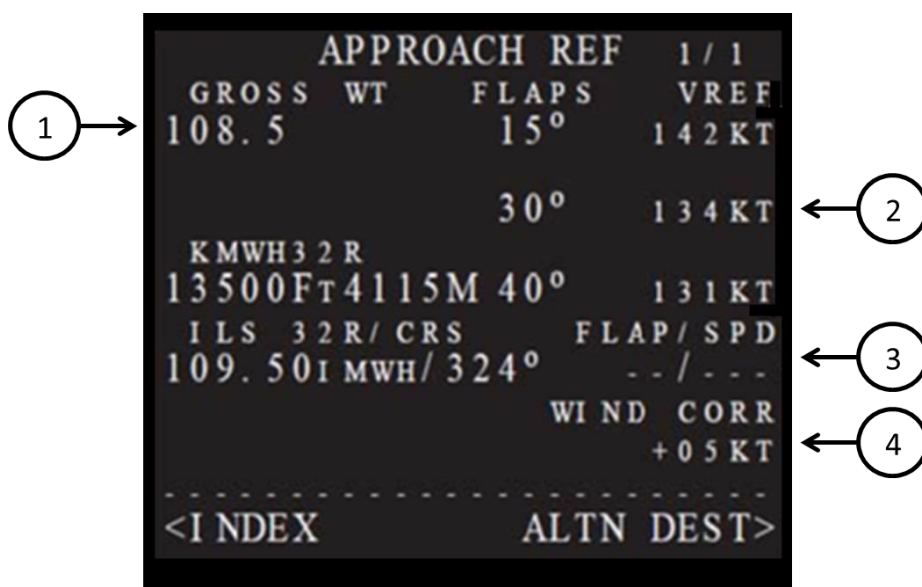
Figure 1: An example of a CDU Approach Reference page

During descent preparations, air traffic control (ATC) issued arrival instructions which the crew loaded into the flight management computer (FMC)¹ via the control display unit (CDU)² (Figure 1). In accordance with company procedures, the PM calculated the expected landing weight. After obtaining confirmation from the PF that his calculations were valid, he entered this figure into the aircraft gross weight (Gross WT) section of the approach reference page, (Figure 1). However, according to the post-flight data obtained from the quick access recorder (QAR), a figure of 52 tonne (T) had been inadvertently entered instead of the predicted landing weight of 62 T.

To complete the manual selections, the PM stated he verbalised, and then selected the flap 30 field on the CDU (Table 1).

As noted in Table 1 – note 1, once the crew left the approach reference page on the CDU and then returned to it, the page defaulted back to the FMC calculated (higher) GW and (higher) Vref for Flap 30. This realisation prompted the PM to say that the 'speed's wrong' to the captain. When

As a result of this incident, the operator intends to revise the flight crew operations manual (FCOM) descent procedures. The procedures will include an item requiring the PM to compare the landing weight entered into the Approach Reference page during descent preparation, with the load sheet estimated landing weight.

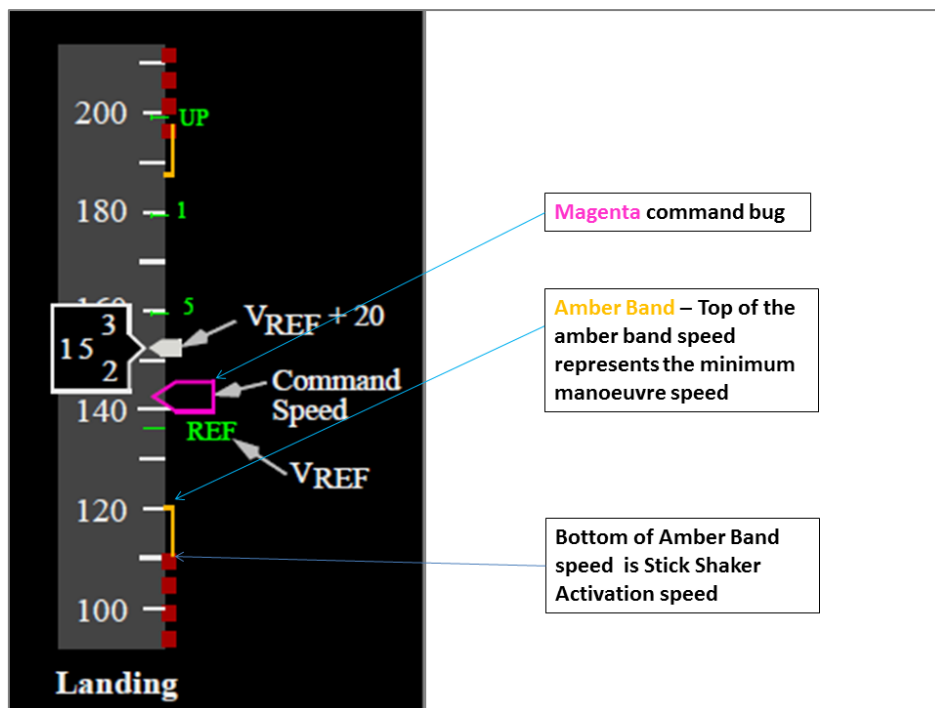
Figure 2: Sample B737 primary flight display airspeed indicator

Following the inadvertent landing weight data entry error, the FMC calculated the flap speed schedule and the landing reference speed (Vref), based on this lower weight. With each stage of flap selection, the magenta bug³ moved and pointed to the new command speed on the airspeed indicator. With the selection of flap 30, the command speed became Vref plus any wind correction factor entered by the crew⁴ (Figure 2).

At a height of about 200 ft, the PM reported he called "speed" when he noticed the magenta speed bug on the primary flight display (PFD) airspeed indicator (ASI) reduce to within close proximity of the top of the amber band (Figure 2); however the PF reported not hearing this call.

When the PM noted that the magenta bug was closer than normal to the manoeuvring margin amber band on the PFD airspeed indicator, he thought the 'moving' amber band may have reached a higher airspeed due to the increased g loading in the gusty conditions, until he also noted the discrepancy on the CDU from the flaps 30 Vref calculated earlier during the preparation for descent phase.
