Mid-air collision involving SIAI-Marchetti S-211s, VH-DZJ and VH-DQJ

25 km west of Tyabb Airport, Victoria on 19 November 2023

ATSB Transport Safety Report

AO-2023-057

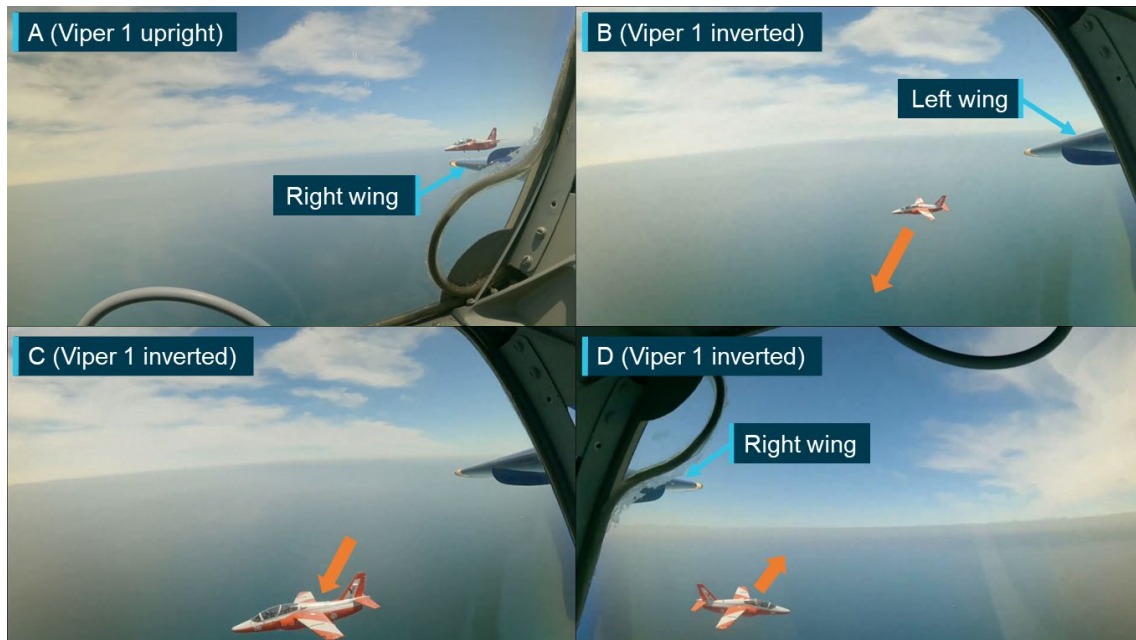
Figure 3: Recorded images from Viper 1 of second manoeuvre

Viper 2 rejoined the formation in the right echelon position (panel A in Figure 3) and shortly after, Viper 1 rolled inverted for a second attempt (panel B in Figure 3). On this occasion, instead of moving toward the line abreast and level position as planned, the pilot of Viper 2 manoeuvred to pass below (panel C in Figure 3) and across to the left of Viper 1 (panel D in Figure 3).

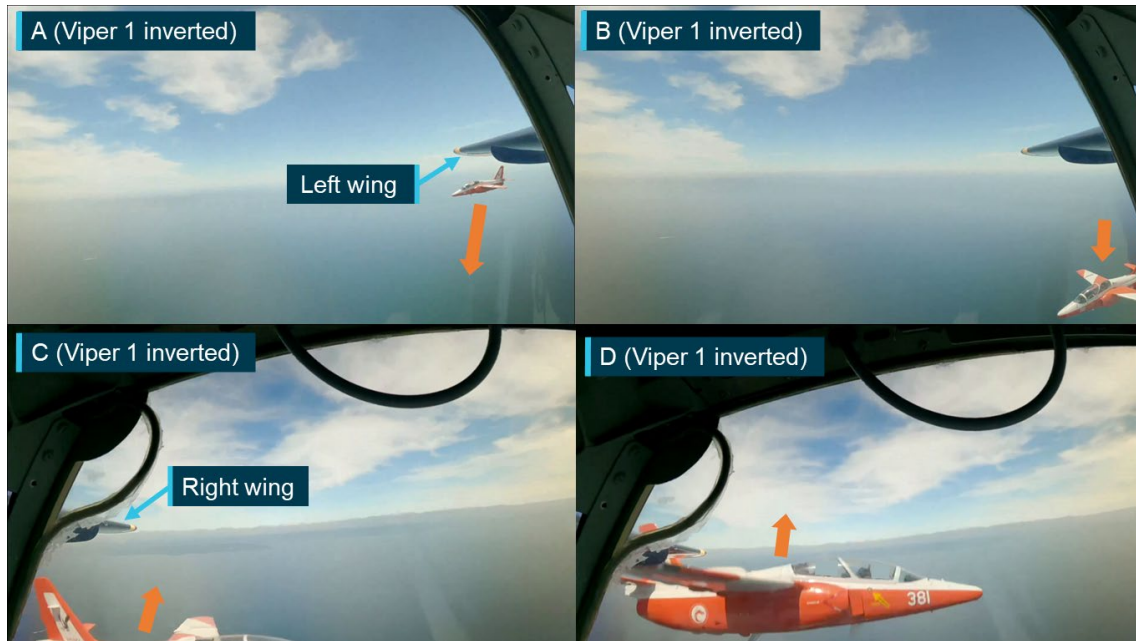
Figure 4: Recorded images from Viper 1 of third manoeuvre and collision

As with the previous attempt, Viper 2 moved rearward to allow Viper 1 to roll inverted. Before Viper 1 stabilised in the inverted attitude (panel A in Figure 4), Viper 2 began manoeuvring to pass beneath Viper 1 (panel B in Figure 4) and the safety pilot noted that Viper 2 moved in and underneath ‘quite quickly’. Viper 1 then stabilised in the inverted attitude and as Viper 2 approached, the vertical separation between the 2 aircraft reduced. Viper 2 passed beneath and began to pitch up and bank left, away from Viper 1 (panel C in Figure 4). At 1333, as Viper 2 climbed and banked left, the right wings of each aircraft collided (panel D in Figure 4).

The safety pilot observed Viper 2 pass underneath and begin climbing toward Viper 1, but the collision occurred before the safety pilot could recognise the collision risk and take any avoiding action.

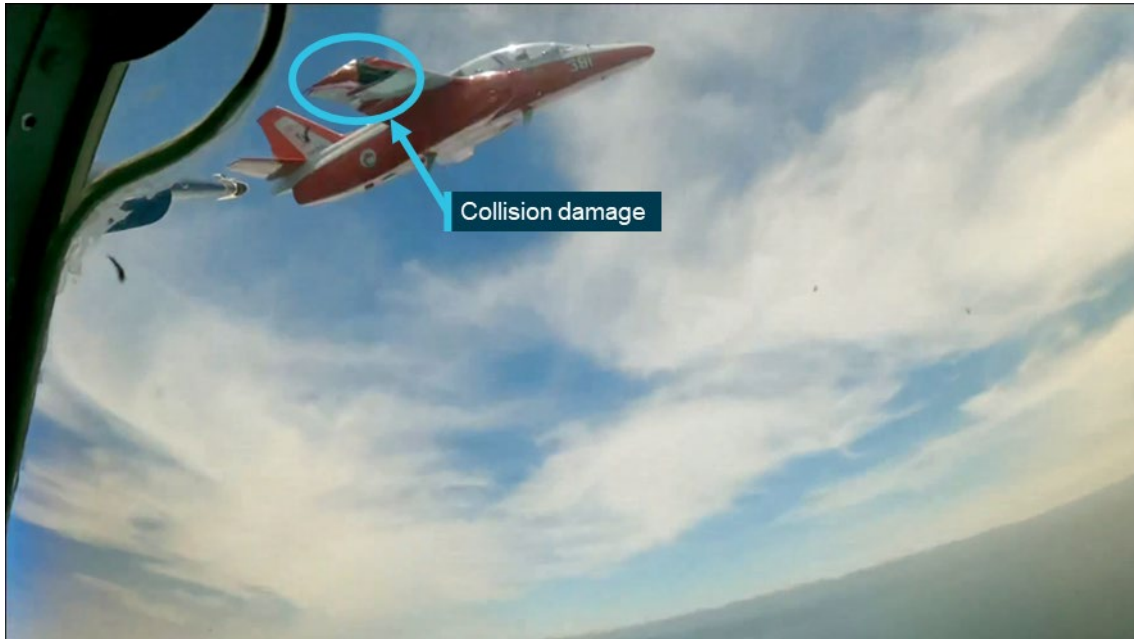
Figure 5: Recorded image from Viper 1 showing the collision damage to Viper 2

After the collision, and with the right wing severely damaged (Figure 5), Viper 2 continued to climb and began rolling right, passing above and behind Viper 1. Viper 2 rolled to an inverted attitude and quickly assumed a near-vertical, nose-down flight path toward the water and commenced a slow right roll until impacting the water at high speed. Both occupants were fatally injured.

The damage to Viper 2 was substantial, created a significant amount of drag, and reduced both lift and aircraft controllability. The video showed that immediately after the impact, control of Viper 2 was lost and soon after, it collided with water, fatally injuring the pilot and camera operator.

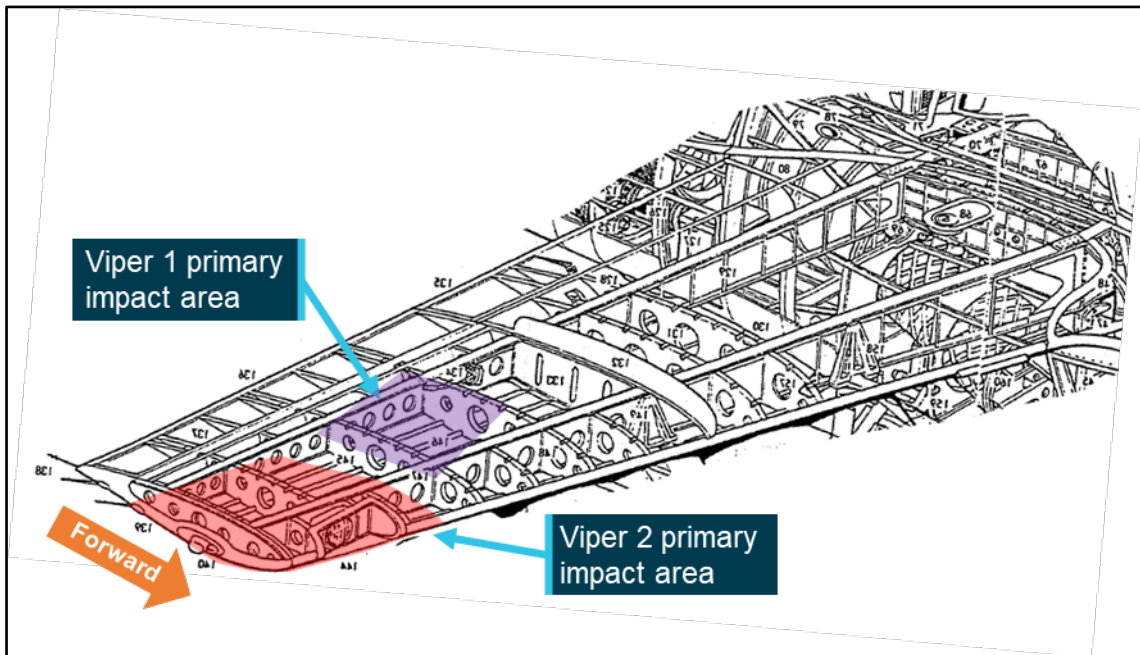
Figure 10: Cutaway drawing of the S-211 right wing structures in the primary impact areas

At the time of the collision, Viper 2 was pitched slightly nose up, in a left bank, rolling left and had slightly higher speed than Viper 1. The first contact during the collision occurred when the forward right wingtip of Viper 2 impacted the right wing of Viper 1. The impact to the wing of Viper 1 was distributed across both the front and rear spars and 2 main outboard wing ribs. The impact to the wing of Viper 2 occurred in the relatively weaker area of the front spar and 2 of the outermost wing ribs (Figure 10).

The impact loading on Viper 1 occurred further in-board on the wing, to relatively stiffer and heavier structures, and with impact loads distributed more evenly across the front and rear spar (the primary load carrying structure). In addition, once the structure on Viper 2 started to fail, it redistributed the load over the wing of Viper 1, lessening the local impact effects. As a result, Viper 1 was not significantly damaged and landed safely at Essendon.

Conversely, the primary impact loading on Viper 2 was further outboard near the wingtip to relatively weaker structure, with the loads primarily absorbed by the front spar, resulting in failure of the spar and substantial deformation to the outboard wing section.

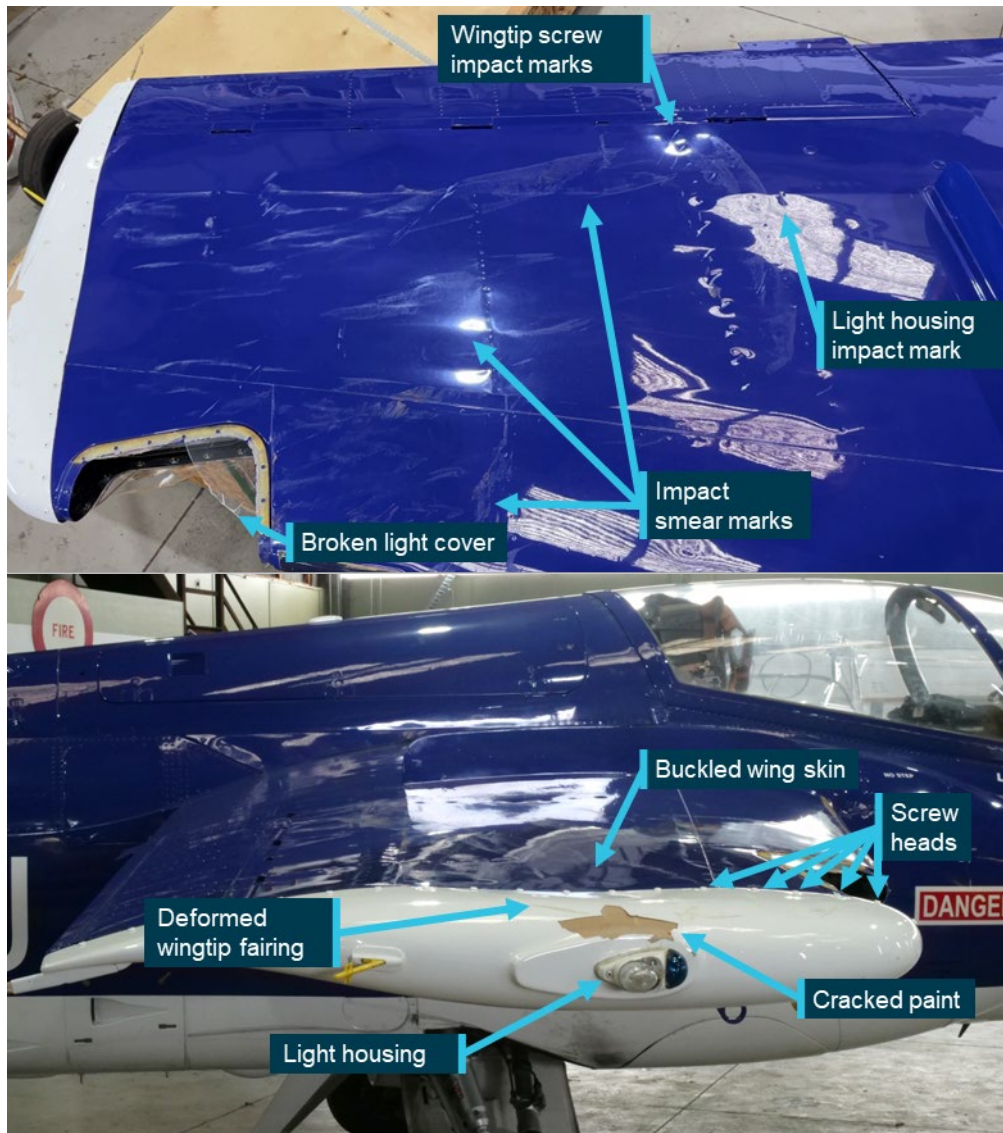
Figure 11: Viper 1 collision damage

Following the accident, Viper 1 was examined by the ATSB at Essendon Airport. Impact marks, including marks consistent with the wingtip fairing screws and wingtip light housing from Viper 2, along with paint transfers, were visible on the upper surface of the right wing. The upper wing skin was deformed, and the landing light cover broken (Figure 11).

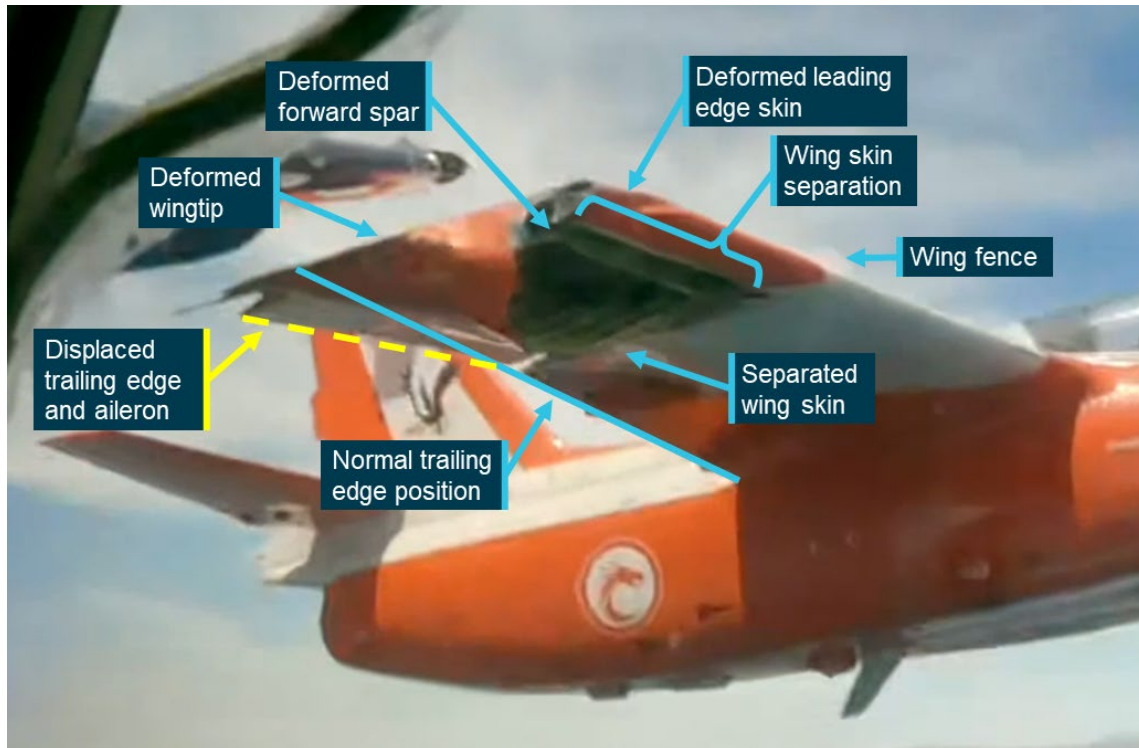
Figure 12: Right wing of Viper 2 immediately after the collision

The recorded video showed that upon impact, the outboard section of the right wing of Viper 2 bent downward and the lower wing skin separated from the wingtip toward the wing fence⁷ along a rivet line immediately aft of the leading edge (Figure 12). The wing tip, leading edge skin and forward wing spar were all deformed by the impact. Once the wing structure of Viper 2 started to fail, it redistributed the load across the wing of Viper 1, lessening the local effects and reducing the overall loads to that aircraft. The right aileron of Viper 2 was also deflected downward in both the normal plane of movement and also the spanwise direction, likely due to the outboard wing section and rear wing spar also being deformed downward.
