# Collision with terrain involving a Oficinas Gerais de Material Aeronautico DHC-1 MK 22 Chipmunk, VH-POR

Jandakot Airport, Western Australia on 26 April 2024

AO-2024-013

Preliminary – 4 July 2024

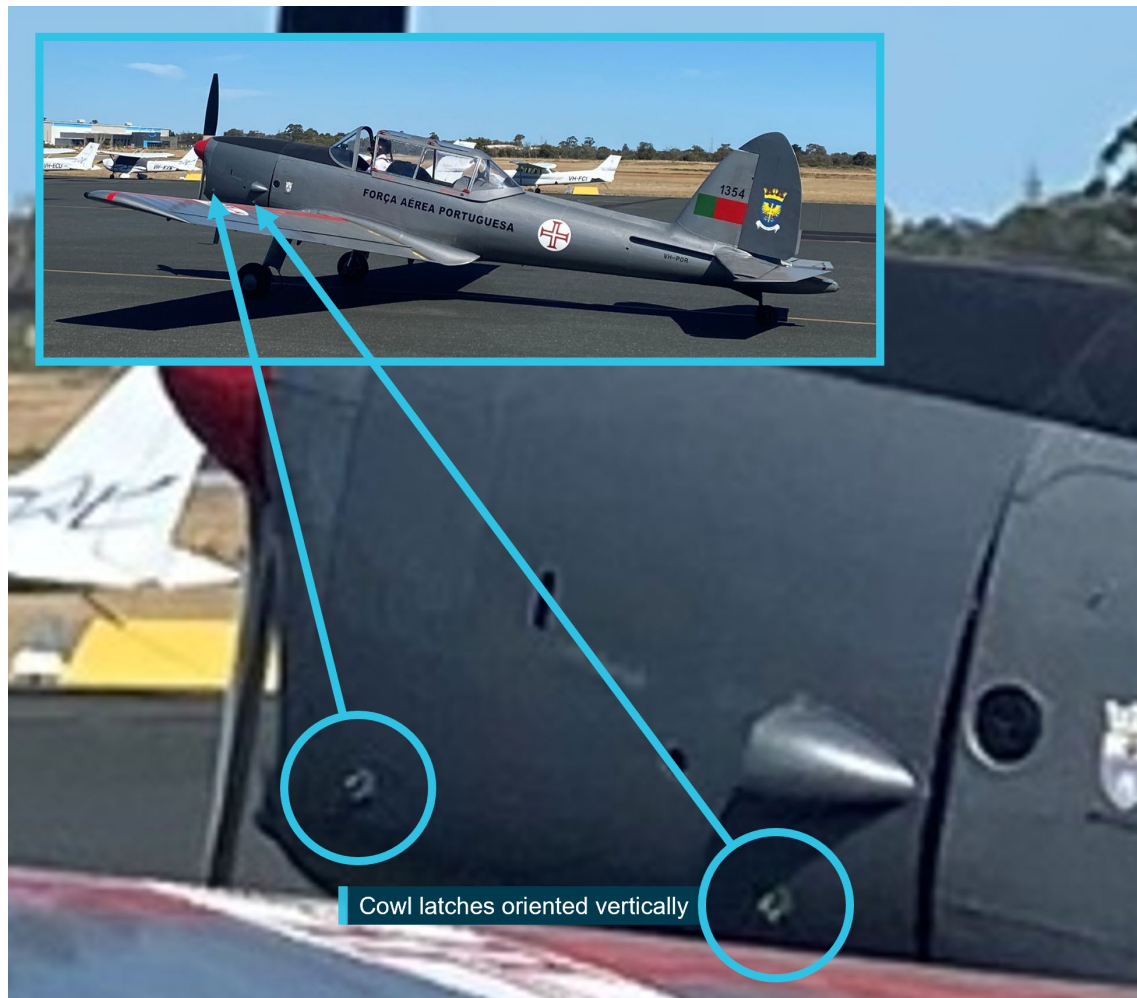
**Figure 1: VH-POR taxiing for take-off**

A witness on the southern apron took photographs of the aircraft taxiing past, which show the engine cowl latches on the left side were oriented vertically<sup>1</sup> (Figure 1).

The gap at the rear edge of the cowl is normally present when the cowl is closed fully.  
Image source: Witness, annotated by the ATSB.

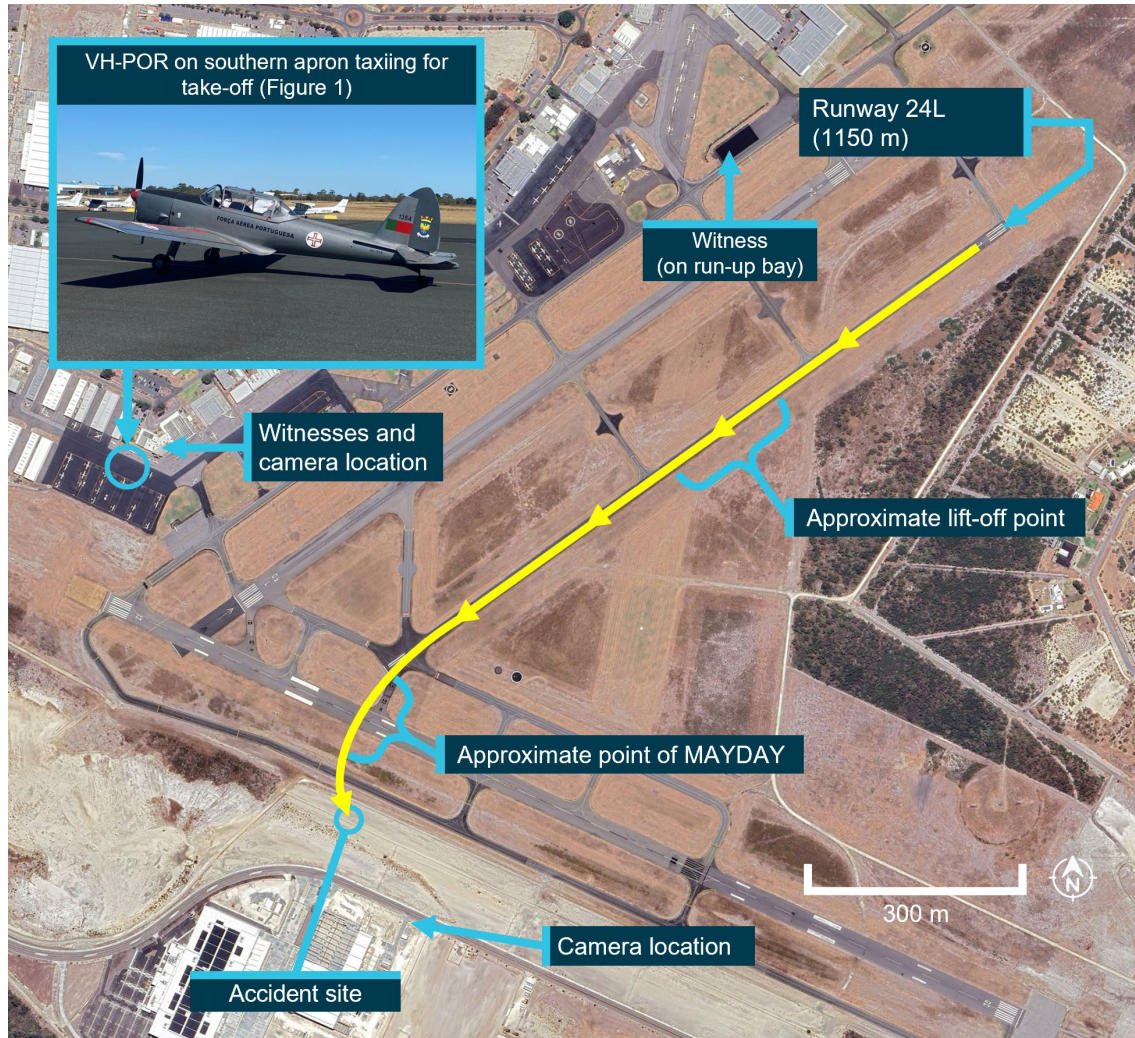
**Figure 2: Approximate flight path**

The pilot continued to taxi to the end of runway 24L and at 1313 was given clearance to take off. Camera footage recorded the aircraft commencing its take-off roll and becoming airborne about halfway along the runway's length (Figure 2).

One witness, located at the run-up bay, recalled seeing something 'flapping' on the aircraft during the take-off. This witness, and witnesses in a nearby building looking through a window, observed the aircraft roll to the left at low height near the end of runway 24L. There were no reports of an abnormal engine sound. At 1314:24, the pilot made a radio call stating 'papa oscar romeo papa oscar romeo MAYDAY MAYDAY MAYDAY'.<sup>2</sup>

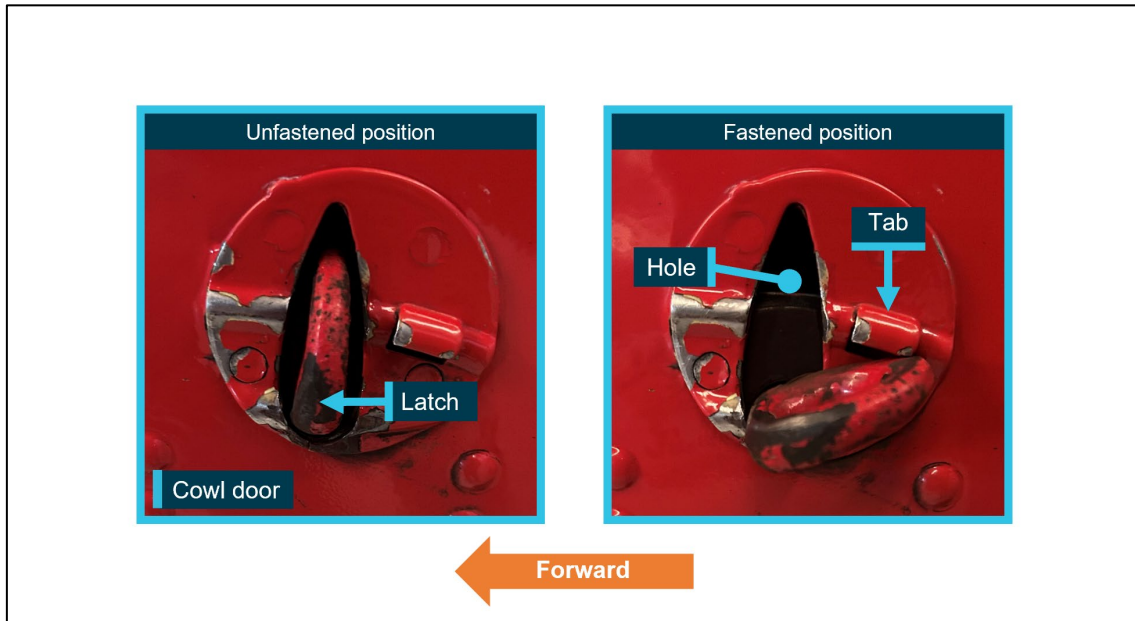
**Figure 4: DHC-1 Chipmunk cowl latch detail (exemplar aircraft)**

Access to the engine is via a cowl door on either side. The cowl doors are hinged at the top and fastened by 2 latches at the bottom of each cowl. The latches are attached to the lower engine cowl and when in the vertical position pass through holes on the cowling doors (Figure 4, left). To fasten the cowl, the latches are pulled outboard, further compressing a pre-compressed spring, and turned clockwise (1/4 turn) to the horizontal position. Releasing the latch fastens the cowl and the latches are held in place by the spring and prevented from turning counterclockwise by a tab (Figure 4, right).
