# Collision with terrain involving Robinson R44, VH-OCL

8.1 km north-north-west of Kumarina Roadhouse Airport, Western Australia, on  
3 November 2022

## **ATSB Transport Safety Report**

AO-2022-053

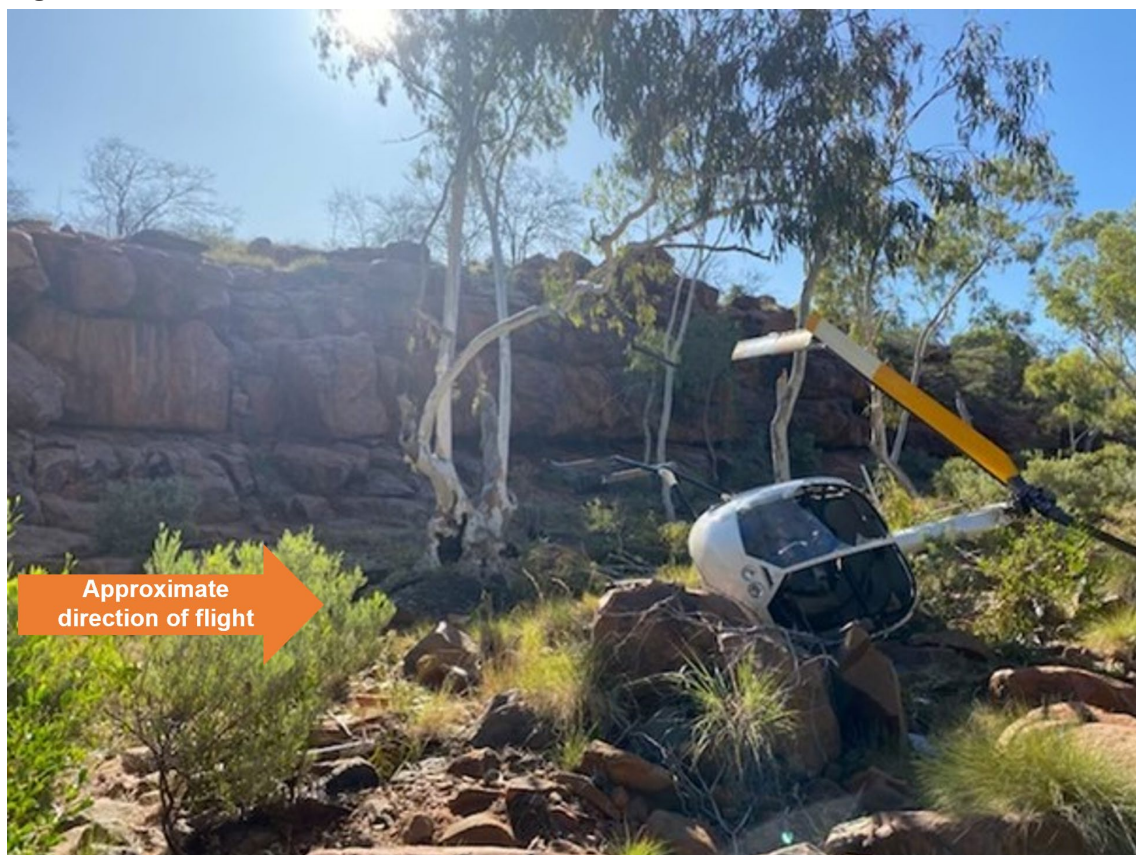
**Figure 2: VH-OCL**

The pilot was not able to arrest the descent and the helicopter collided with terrain and rolled onto its left side (Figure 2) about 150–200 m from its take-off point. The pilot received minor injuries but was able to exit the helicopter and assist the 2 rear seat passengers' exit. The 2 rear seat passengers received minor injuries. The passenger in the front left seat was seriously injured and not able to exit the helicopter unassisted. The remaining 4 survey team members arrived at the helicopter and assisted the pilot to retrieve the trapped passenger. The helicopter was substantially damaged.

*The helicopter approached the gorge from the left of the picture prior to the collision with terrain.*  
Source: Operator, annotated by the ATSB

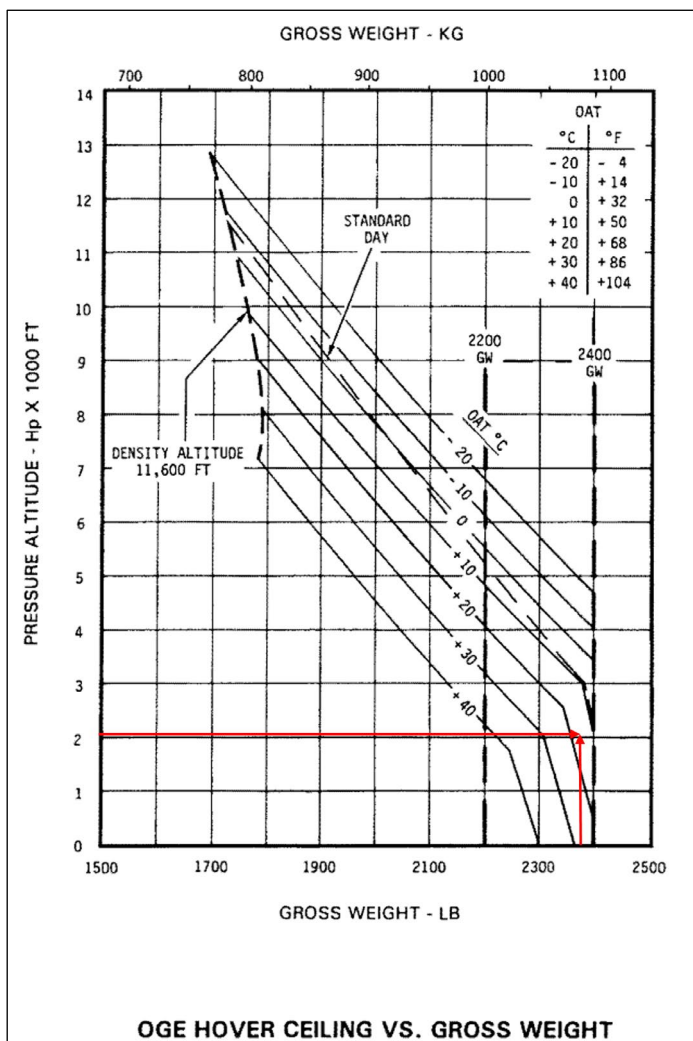
**Figure 3: R44 out of ground effect hover ceiling**

The ATSB calculated that the helicopter could hover IGE up to its maximum take-off weight at a temperature of 29 °C and a pressure altitude of 2,050 ft. However, the performance charts indicated that the helicopter would not be able to hover OGE (Figure 3). At the take-off weight estimated by the pilot of 2,378 lb (1,079 kg), the maximum temperature for an OGE hover was calculated at 17 °C. At 29 °C, the maximum hover weight to conduct an OGE hover was 2,315 lb (1,052 kg).

The OGE hover ceiling vs. gross weight chart is overlaid with red lines representing the pressure altitude of 2,050 ft and planned worst case gross weight of 2,378 lb, intersecting at a temperature of approximately 17 °C.

Note: as the ATSB estimated weight of the accident flight was above the maximum gross take-off weight, it is not represented on the chart.
