Loss of control and collision with terrain involving Beechcraft E55, VH-OMD

Cowra Airport, New South Wales on 11 April 2024

ATSB Transport Safety Report

AO-2024-011

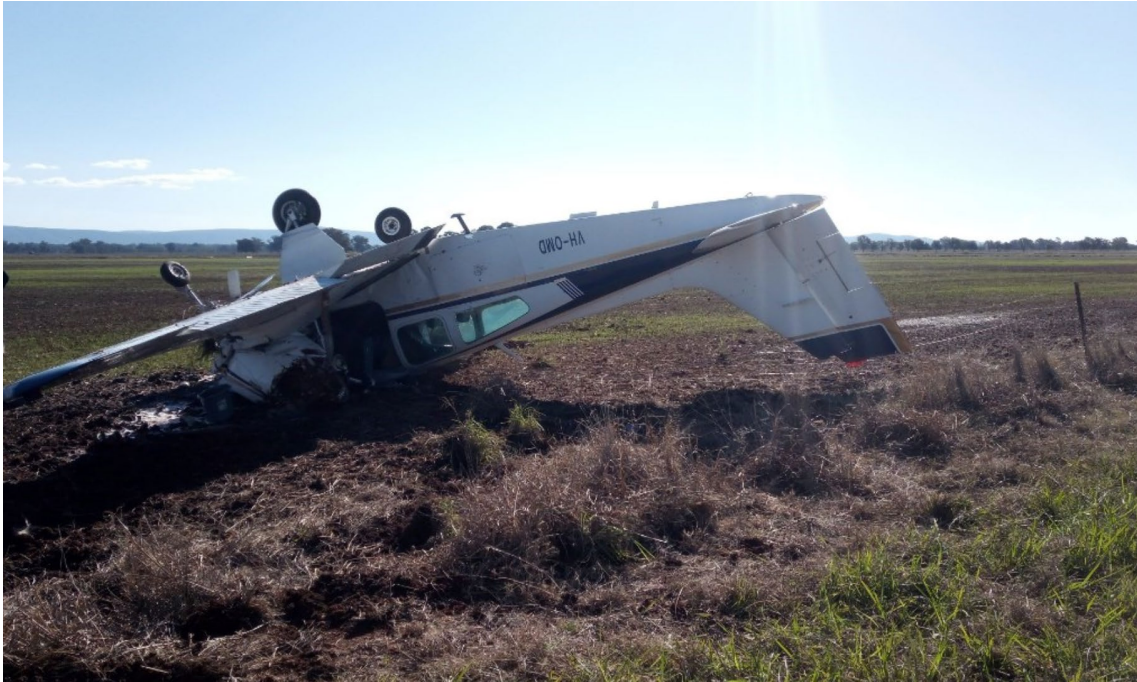
Figure 4: VH-OMD accident site

The aircraft collided with the ground in a nearly vertical nose-down attitude and came to rest inverted (Figure 4). The student and instructor sustained minor injuries and it is possible that their recollection of events may have been affected by trauma associated with the collision. The aircraft was substantially damaged.

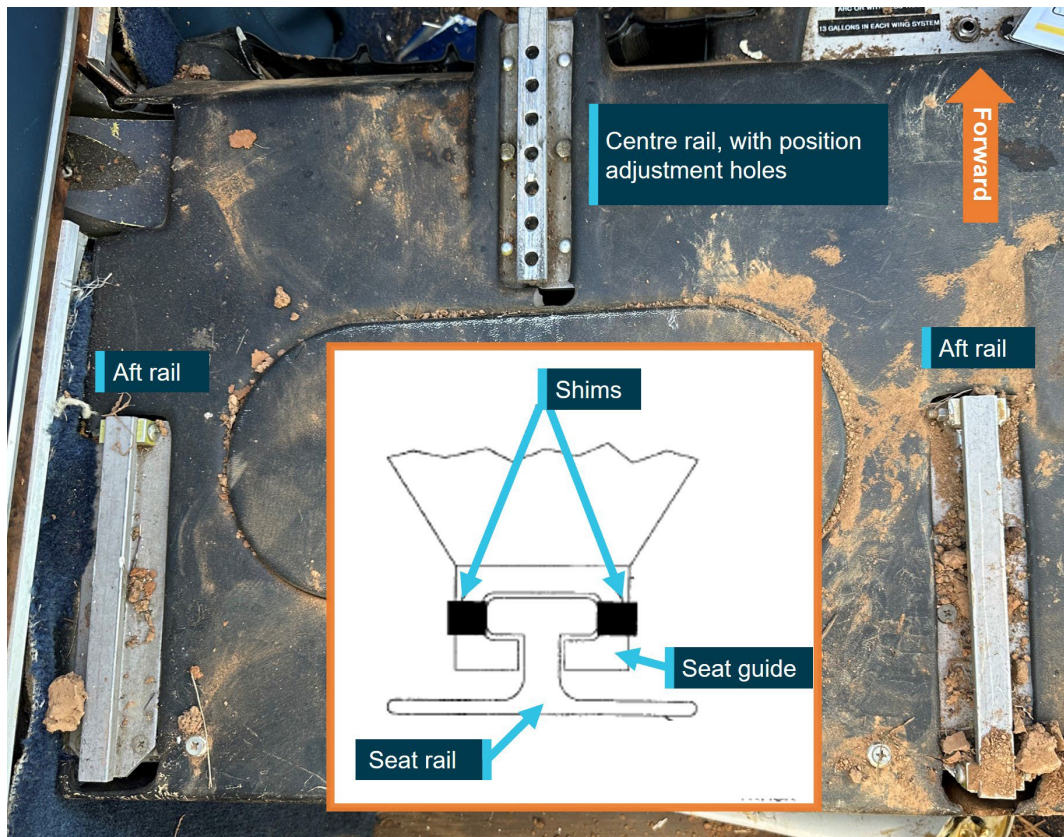
Figure 5: Seat rails

The front seats were fitted with 4-point restraints, each consisting of 2 lap straps connected to the seat frame and 2 shoulder harness straps connected via a Y belt to an inertia reel attached to the upper cabin structure. The inertia reel was designed with a locking device that would secure the shoulder straps in the event of sudden forward movement or impact. The seats could be adjusted forward or aft, with the seat guides sliding along 3 seat rails: 2 main (aft) and 1 centre (forward) (Figure 5). The seat is retained at the desired adjustment by a spring-loaded locking pin engaging in one of the forward centre rail holes. Shims could be added to the inside of the guide to ensure locking pin alignment.

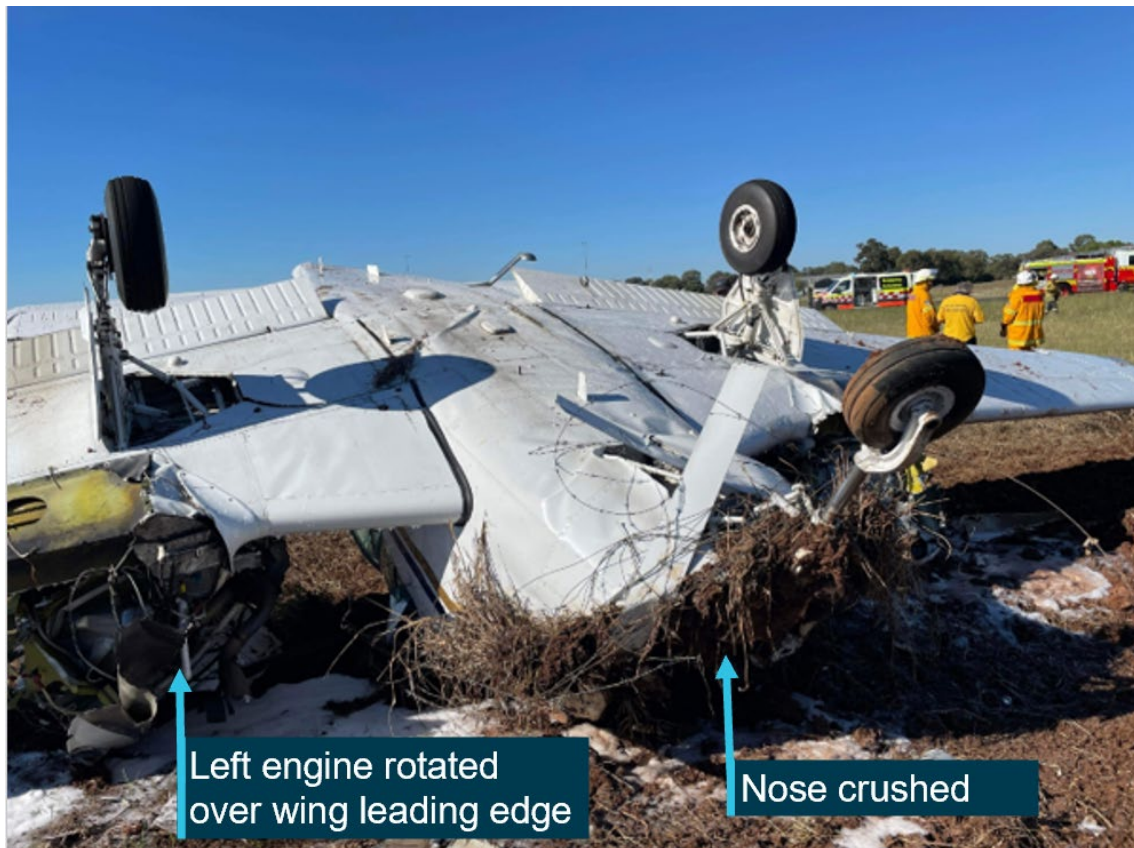
Figure 7: Impact damage to VH-OMD

Both engines had folded backwards around the wing leading edge, which pulled the engine control cables such that the engine control levers were no longer representative of the pre-impact positions. Damage to the wing leading edge resulted in fuel leaking, but there was no post-impact fire. The aircraft departed with full fuel, and had approximately 400 L of fuel remaining on board at impact. Both fuel selectors were set to ON. Flight control continuity was established.

The left propeller flange fractured resulting in the propeller assembly detaching from the engine crankshaft and coming to rest spinner-down embedded in the dirt. The propeller manufacturer advised that the damage to the blades was consistent with the propeller either windmilling or not rotating at impact. The left spinner was indented with the counterweight, showing that the propeller was in fine pitch and not feathered.

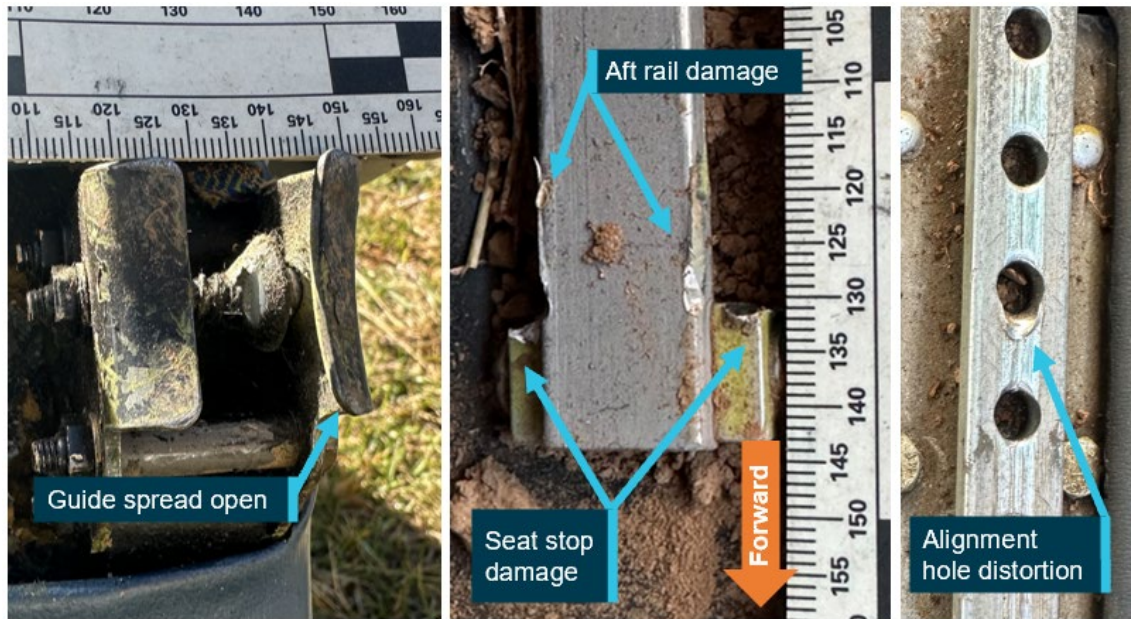
Figure 8: Spreading of one seat guide (left) and associated damage to the rails (right)

Damage and distortion to the seat rails and seat guides was consistent with forward and right forces sustained during the impact sequence. Both seats' centre rails exhibited distortion and smearing on the forward edge from the locking pins being forced from their rail holes. The left seat

locking pin was bent rearward, and the right seat alignment pin had sheared. Figure 8 shows spreading of one of the seat guides and the associated damage to the seat rails.

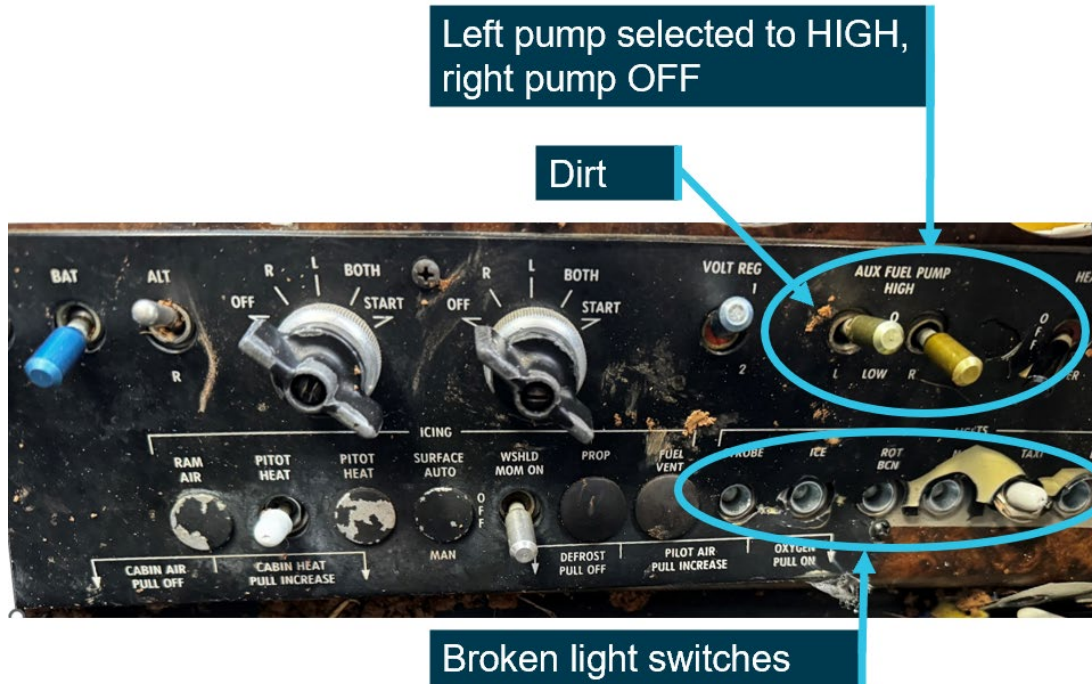
Figure 9: Panel showing post-impact switch positions and disruption

A post-impact photograph showed the left engine auxiliary pump in the high position (Figure 9). However, as the entire panel had come adrift, there was dirt adjacent to the switch, and most of the switches in the row beneath it had broken off, its post-impact position was not considered reliable evidence of its position at the time of the accident. The switch panel location was also consistent with injury to the student's knee. Additionally, the student reported that the pump had been used only for priming prior to engine start then confirmed to be off and not used again during the flight. The metal fuel pump switches were also by design unlikely to be confused with the smaller plastic light switches in the row below and inadvertently selected. It was therefore unlikely to have been on prior to the accident.

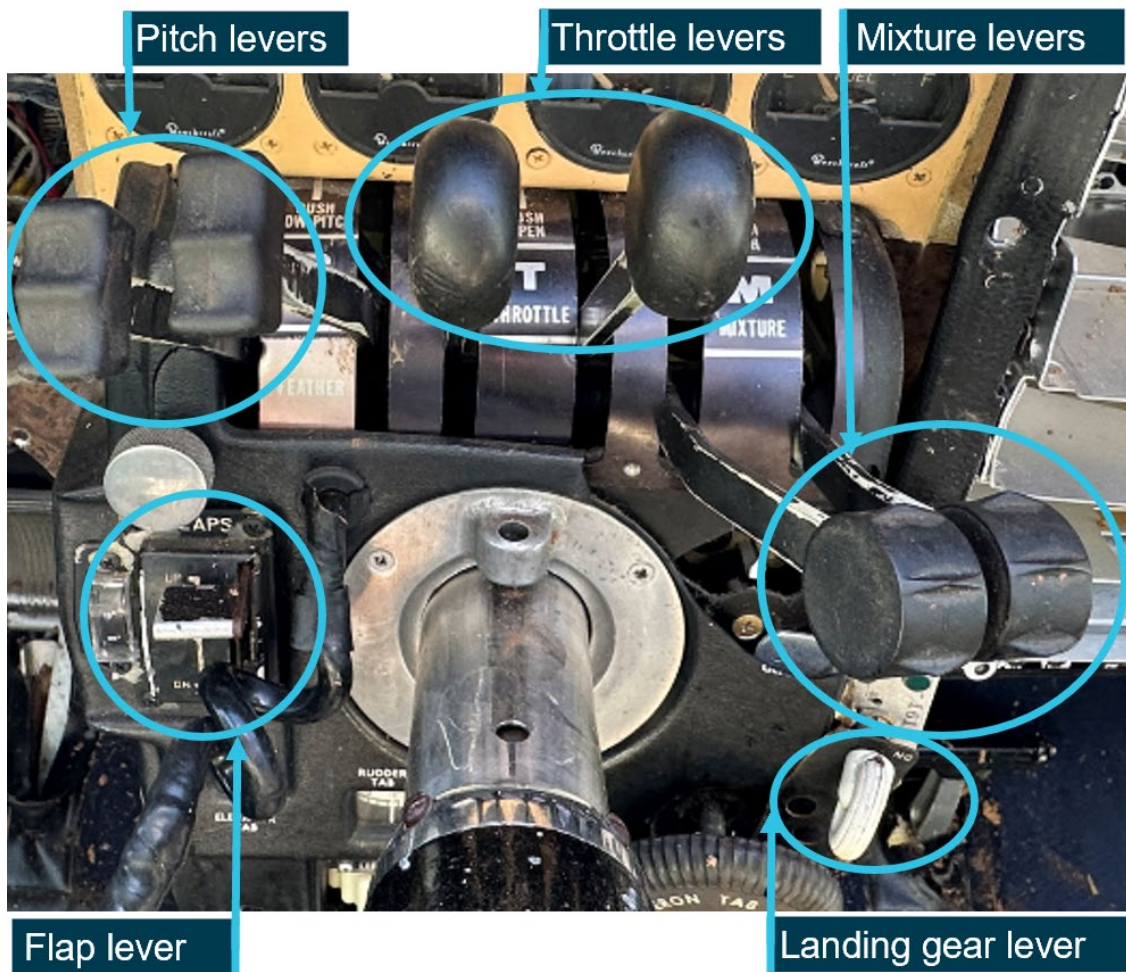
Figure 11: VH-OMD engine control levers

In this case, as the instructor primarily flew VH-OMD, and it was the only twin engine aeroplane the student had flown (other than a simulator), habit interference was unlikely. However, the lack of colour differentiation in the levers, and particularly not having red mixture control levers, may have reduced the opportunity for rapid visual identification of the mixture lever position.
