Fuel starvation involving Cessna T210M, VH-MYW

4 km north-west of Bankstown Airport, New South Wales on 26 May 2024

ATSB Transport Safety Report

AO-2024-033

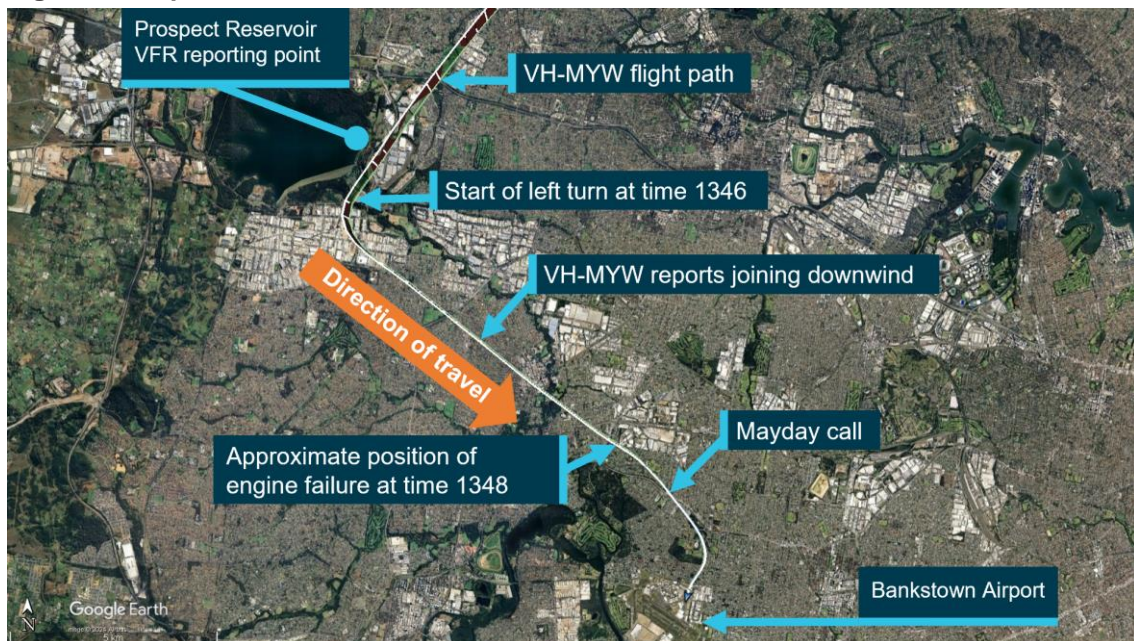
Figure 1: Sequence of events

The aircraft arrived overhead Prospect Reservoir at 1346 (Figure 1) and the aerodrome controller (ADC) instructed VH-MYW to maintain 1,500 ft and join the downwind leg of the circuit for runway 29R. An approximate 25° angle of bank turn was conducted to track toward a downwind join for runway 29R.

The pilot recalled that, at about the time of that radio transmission, with the aircraft about 4.5 km north-west of Bankstown Airport, the propeller RPM increased and they felt a braking sensation. They recalled that, in response they attempted to reduce drag on the propeller, changed fuel tank selection and briefly selected the electric fuel boost pump to ON. They then aimed to maintain glide speed while looking for a place to land.

At 1348, the pilot transmitted a MAYDAY call on the Bankstown Tower radio frequency stating they were having engine problems. The ADC advised that all runways were available, and they could track as required. The ADC continued to coordinate traffic to assist VH-MYW.

At 1350, a helicopter operating in the area, reported that the aircraft had landed at the intersection of taxiway November 1 and taxiway Lima.

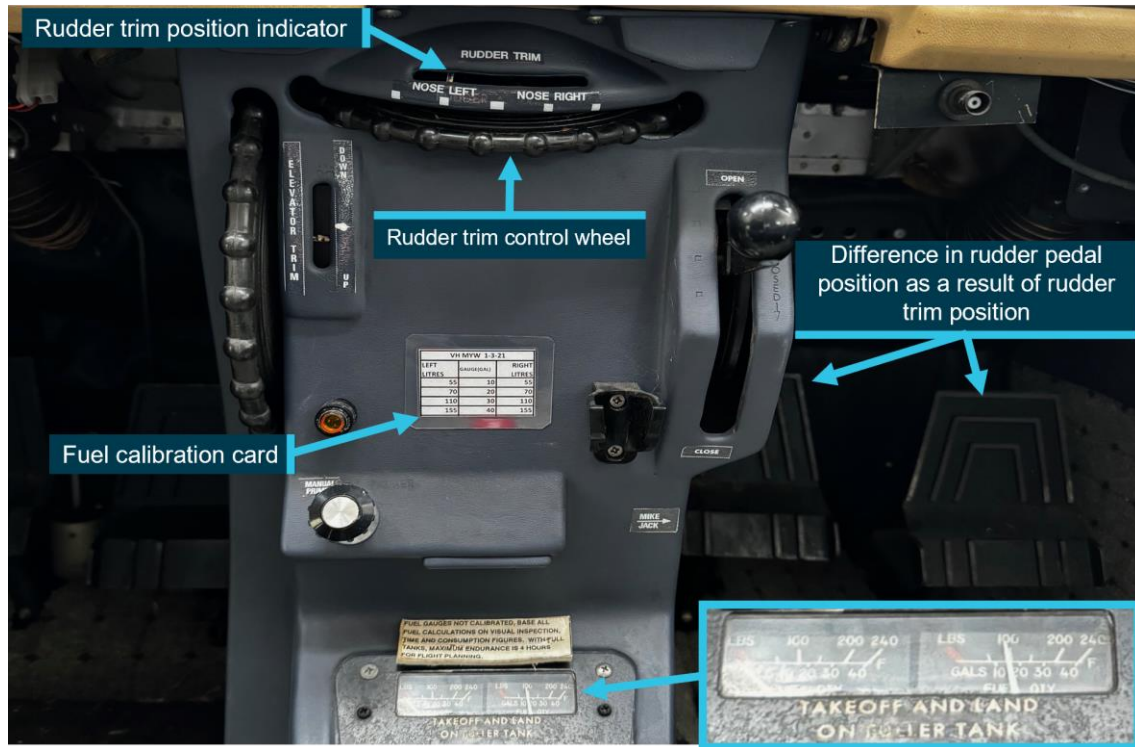
Figure 2: Aircraft control pedestal post-incident.

The aircraft was fitted with elevator and rudder trim. Rudder trimming was accomplished via a wheel mounted in the cockpit (Figure 2). Setting the rudder trim left of centre would result in the aircraft maintaining the nose left of the flight path and remaining in that position until the wheel was manipulated, or the rudder pedals were manipulated. To maintain the desired track with that trim configuration, the aircraft would need to be flown in an uncoordinated state with the right wing low.

The pilot stated the rudder trim had been set left of centre since the aircraft was re-assembled in Australia and that the trim wheel was not manipulated in flight.

The aircraft had undergone a fuel calibration and the placard above the fuel gauges was no longer relevant however, it was not removed (Figure 2). The placard was not considered to have contributed to the incident as the fuel on board was likely less than the 4 hours stated on the placard. The onboard fuel dipstick used was labelled C210 dipstick and was marked with the aircraft's previous registration, ZS-MYV.

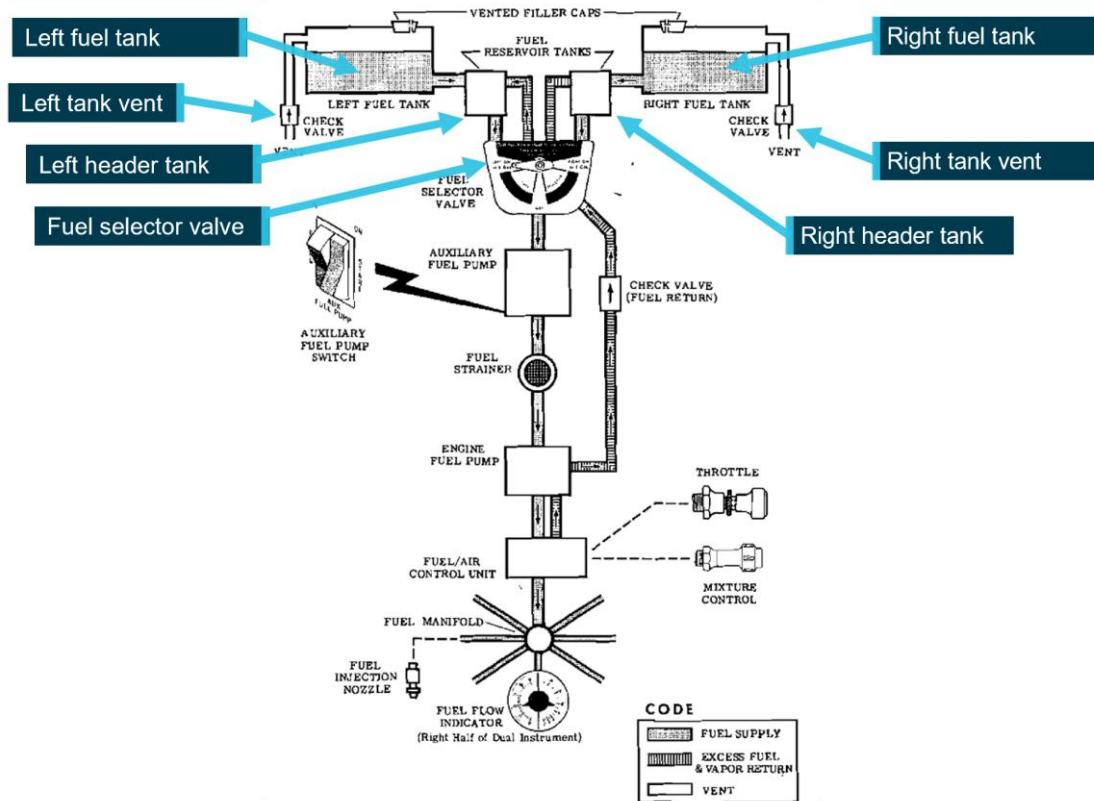
Figure 3: Cessna 210M fuel schematic

The Cessna 210 fuel system consists of a main fuel tank located in each wing. Each tank capacity is 171 L, of which 169 L is usable fuel. Each tank gravity fed a smaller fuel reservoir tank of approximately 1.9 L through fuel collector ports, which were located at the forward and aft inboard side of the main fuel tank (Figure 3 and Figure 4).

The fuel selector valve had 3 positions – left, right, and off – and so fuel could only be drawn from either the left or right tank. Cessna advised that at a low cruise power setting, if no fuel was being fed to the smaller fuel reservoir tank, it could supply fuel to the engine for between 1.5–3.5 minutes. The pilot advised that, at the time of the power loss the fuel selector was selected to the right fuel tank.

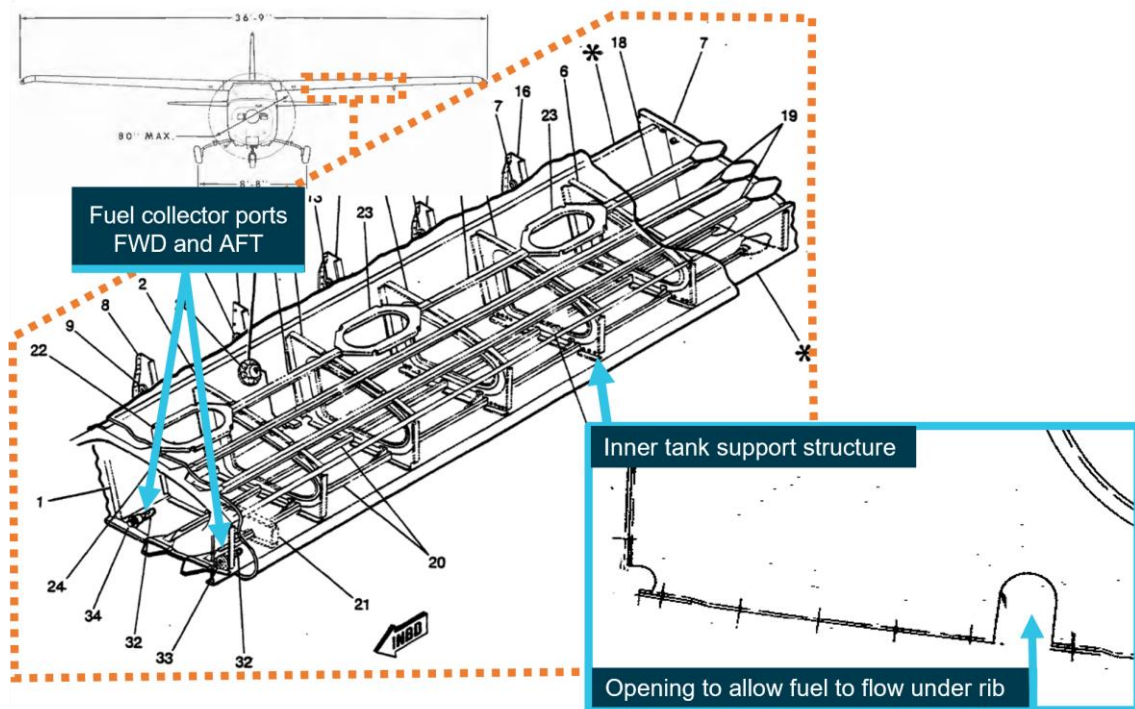
Figure 4: Fuel tank design

The fuel tank design included an internal rib support structure (Figure 4). Each rib had an enlarged centre opening for fuel to freely flow through the tank, with small openings at the base of each rib, ensuring useable fuel could not become trapped. Cessna stated, ‘The small, if any, amount of fuel caught behind any structure would be part of the unusable fuel level determined during certification.’

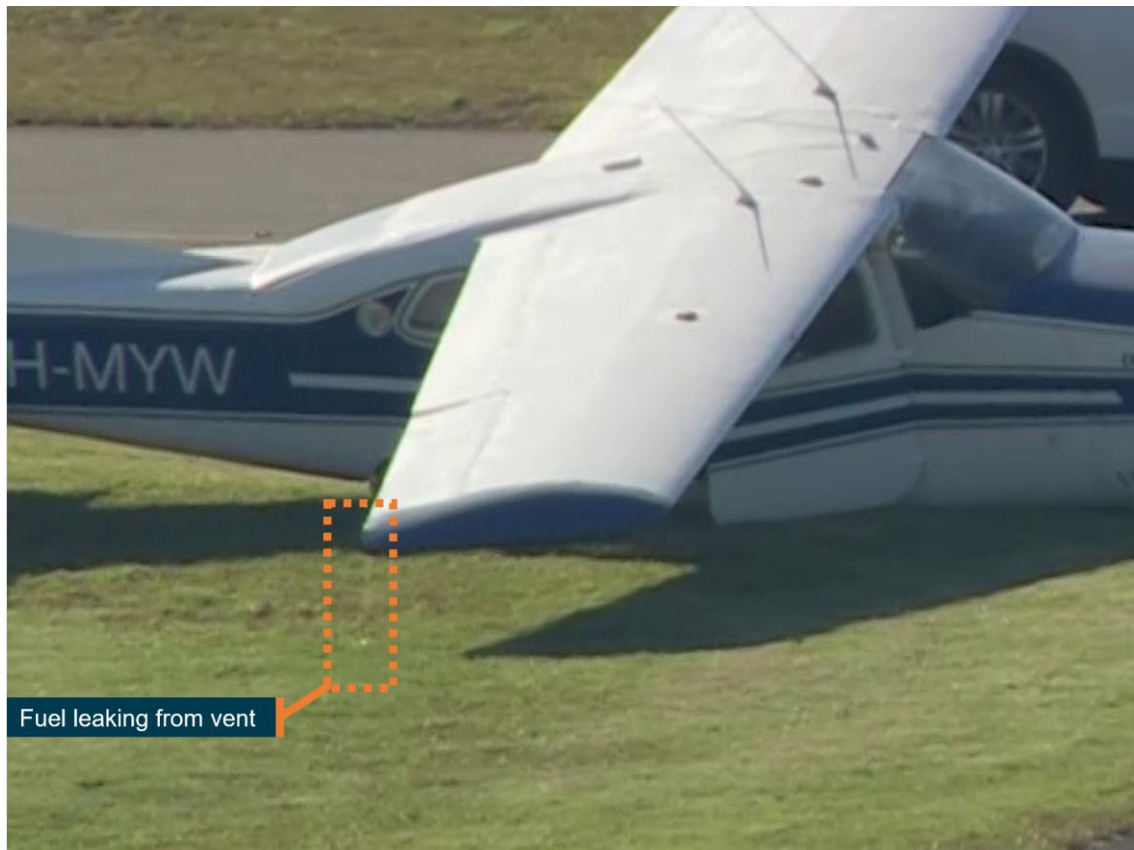
Figure 5: Fuel leak from right tank vent

The ATSB did not attend the site. A video of the aircraft, provided by 9News Australia showed fuel leaking from the right fuel tank vent. The aerodrome operator who attended the incident site stated that the fuel which leaked from the vent was no more than 2–4 litres, of which most was funnelled into a jerrycan. While the ATSB could not verify how long the fuel was leaking, based on the observations of the aerodrome operator, it was unlikely to have significantly affected the amount of fuel in the tank. There was no evidence of fuel leaking from the left tank.

The post-incident inspection revealed between 40–50 L remaining (which equated to approximately 1/4 full tank) in the right tank, with about 2–4 L reportedly leaking after the landing. The pilot operating handbook (POH) stated that if there was less than 1/4 fuel in the tank and the aircraft was in uncoordinated flight, the fuel pick-ups could uncover, and fuel starvation could occur.
