Mid-air collision involving Jabiru UL 450, 19-4079, and Cessna 182, VH-APN

2.7 km west of The Oaks, New South Wales, on 26 October 2024

ATSB Transport Safety Report
Aviation Occurrence Investigation
AO-2024-054
Preliminary – 20 December 2024

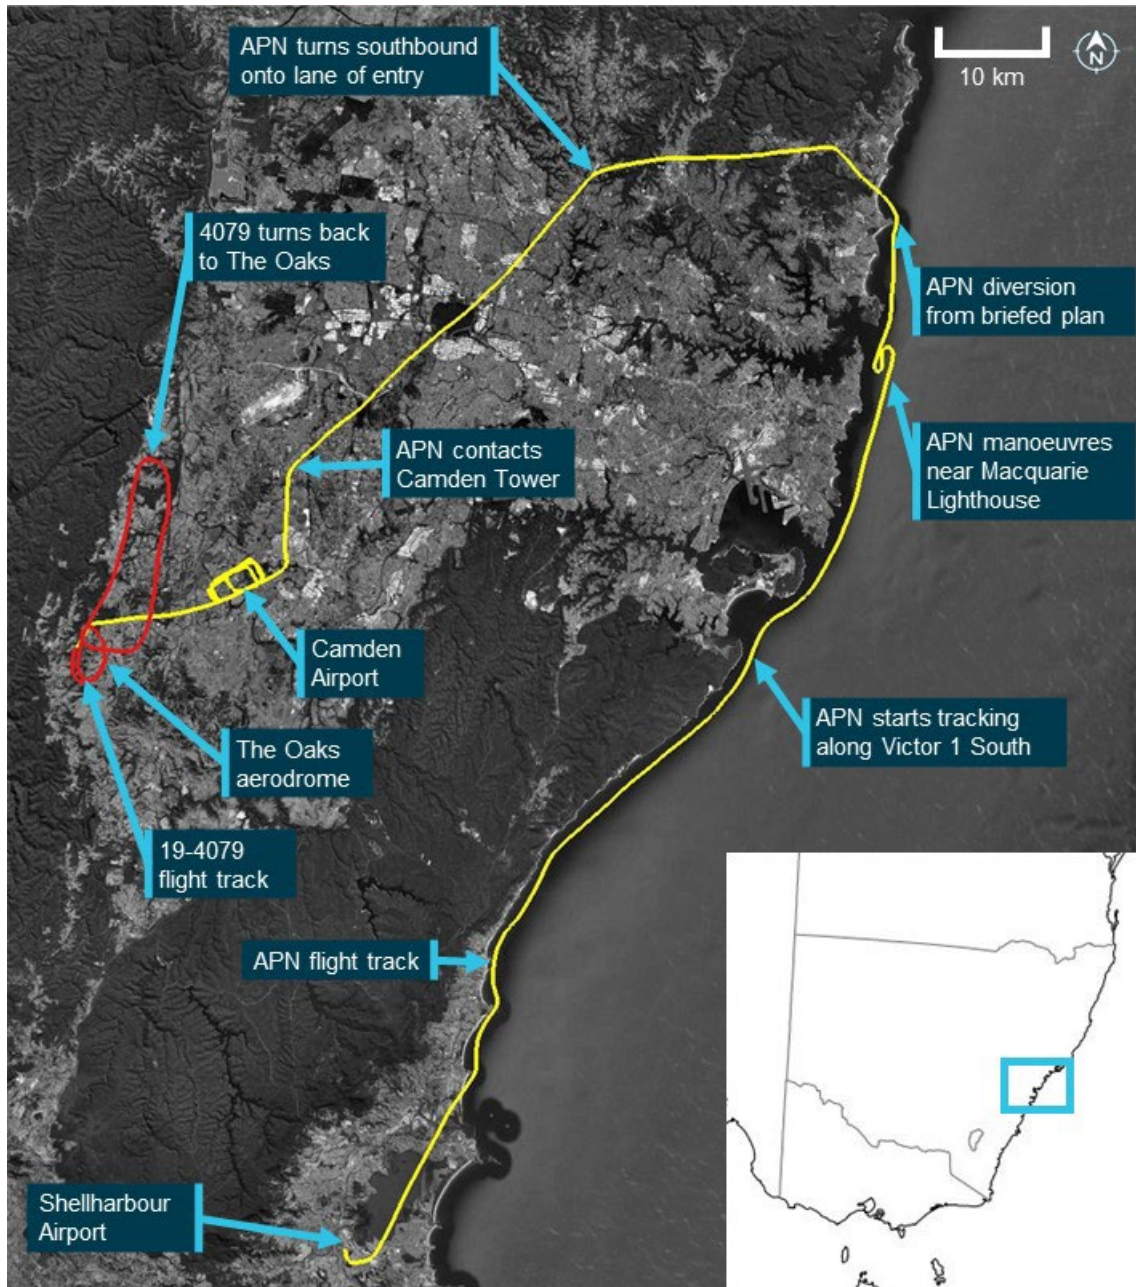
Figure 1: Flight paths of VH-APN, 19-4079 and accident location

level.⁴ At 1036, a radio call recorded on the CTAF stated that APN was departing crosswind and tracking north-east toward the sea cliff bridge, with the flight proceeding in this direction (Figure 1).

APN continued tracking in a south-westerly direction toward Bringelly township, an inbound reporting point for Camden Airport (Figure 1). At 1124, APN contacted Camden Tower air traffic control (ATC), requesting clearance for a touch-and-go and to conduct some circuits. ATC gave instructions to maintain 1,800 ft, join final for runway 24 and report when APN was 3 NM (5.6 km) from the runway threshold, with the aircraft starting to track toward this position. At 1128, APN reported being 2 NM (3.7 km) from runway 24 at about 1,700 ft, with Camden Tower ATC clearing APN for a visual approach. Shortly after, APN called the tower again requesting to remain at 1,800 ft for a practice glide approach to runway 24, which was approved.

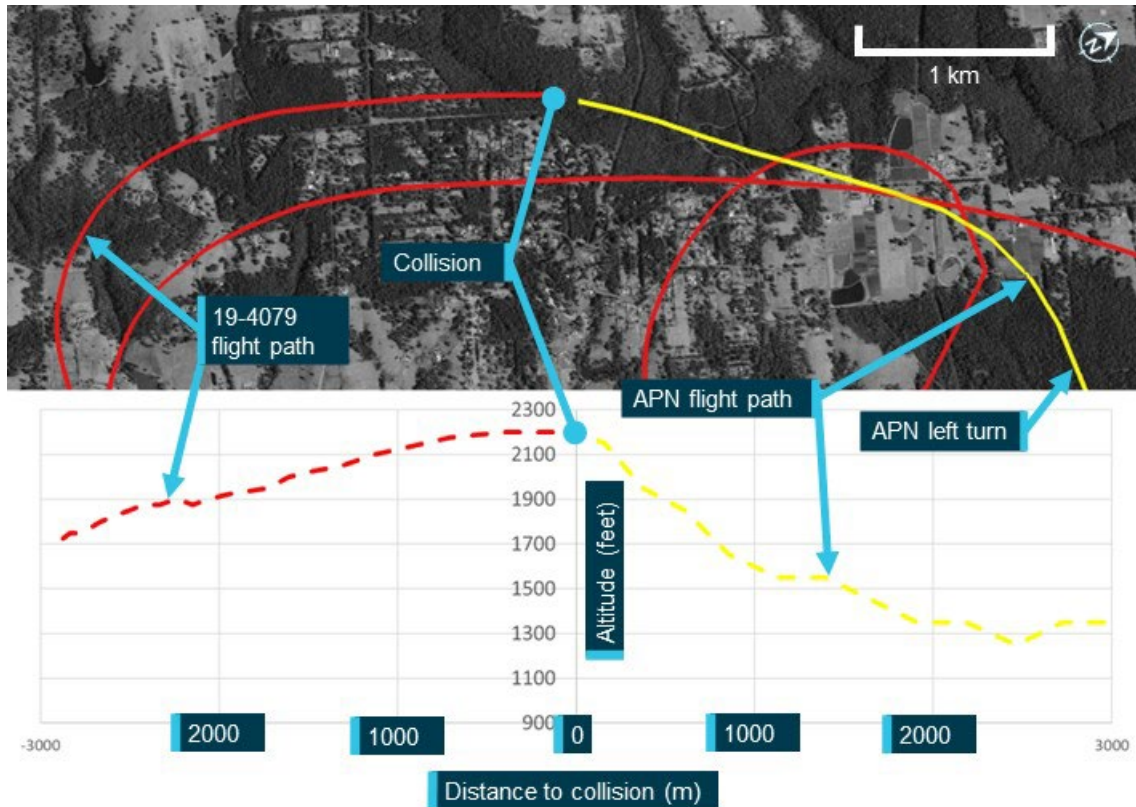
Figure 2: Flight paths and vertical profiles of VH-APN and 19-4079 prior to the accident

At about 1143:30, shortly after APN departed the Camden Airport control zone, the onboard video and 4079 flight data indicated that the pilot of 4079 conducted a go-around from runway 18L at The Oaks. The onboard video showed that the pilot of 4079 was transmitting a radio communication on The Oaks radio frequency. The Sonex pilot reported that they heard the pilot of 4079 transmit that they were going around and observed 4079 from their position in the run-up bay for runway 36. Around this time, APN tracking data showed that this aircraft turned slightly right onto a track of 263°T while continuing to maintain about 1,200–1,300 ft (Figure 2).

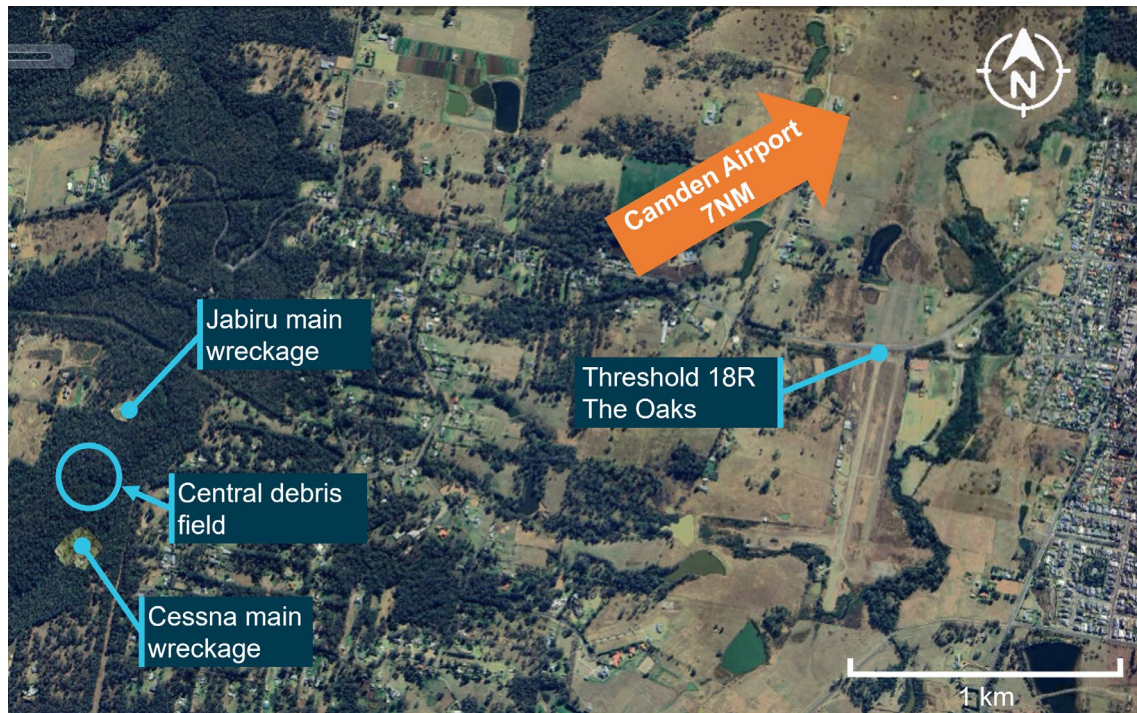
Figure 3: Accident site location in relation to The Oaks

The accident site was located about 2.7 km west of The Oaks aerodrome in heavily treed terrain. The 2 primary wreckage locations were approximately 520 m apart, with 4079 north of APN (018° True) (Figure 3). A debris field was located about halfway between the 2 main wreckage locations. Most wreckage items found in the central area were from the left wing of 4079, with a small number of components from APN. Most of the central wreckage was found within a radius of about 50 m.
