Australian Transport Safety Bureau

Safety Advisory Notice

Number: AO-2024-013-SAN-01

DHC-1 Chipmunks may have incorrect rivets fitted

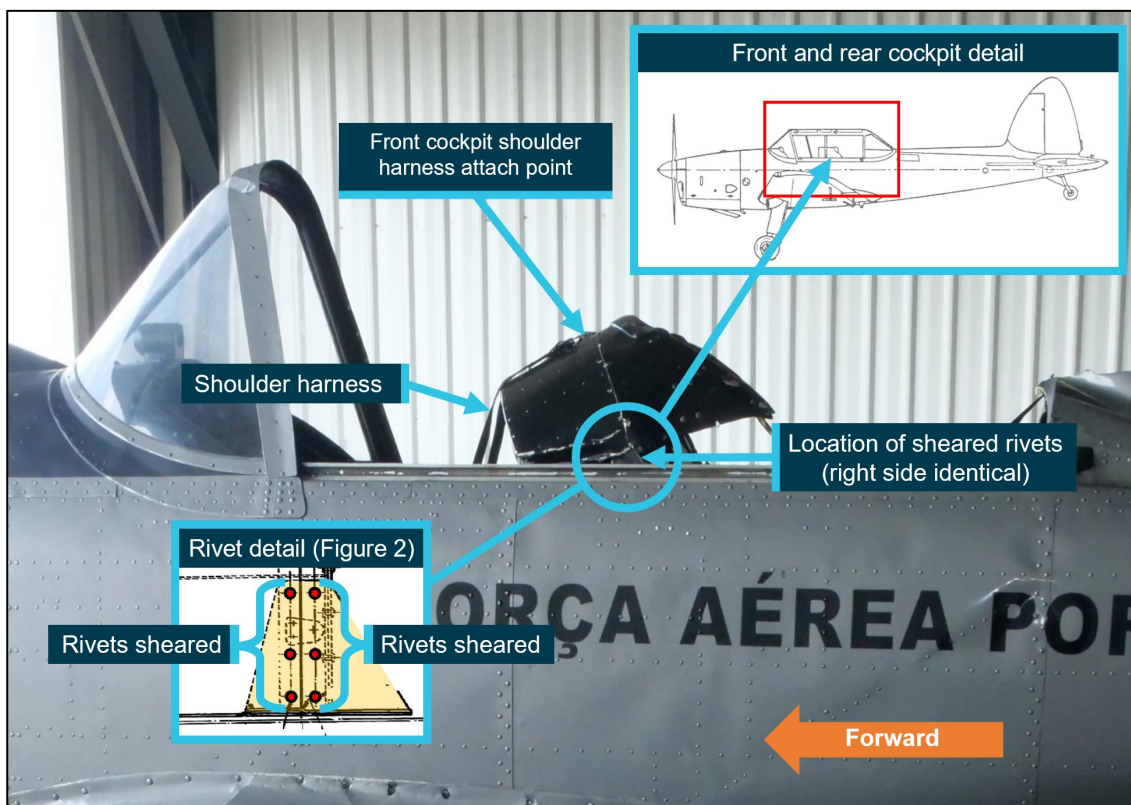
The ATSB found that on impact the upper structure between the front and rear cockpits, corresponding to the attach point for the front cockpit shoulder harness, was torn away from its mountings. Most noteworthy, all 12 rivets (6 per side) that attached the structure to the mountings had sheared (Figure 1).

Figure 1: Location of sheared rivets

The presence of the non-conforming rivets significantly reduced the integrity of the structure retaining the front cockpit restraint, and thereby compromised the crashworthiness of the aircraft. This non-conforming modification may be present in other Chipmunk aircraft, in which case it would likely affect survivability in an accident.

AO-2024-013-SAN-01: The ATSB advises DHC-1 Chipmunk maintainers and owners to be aware that fitment of incorrect specification rivets where the upper structure between the front and rear cockpits attaches to the gussets on either side could significantly compromise the crashworthiness of the aircraft.

Those conducting work on aircraft must ensure modifications are carried out to the required specification, or during maintenance returned to that specification.

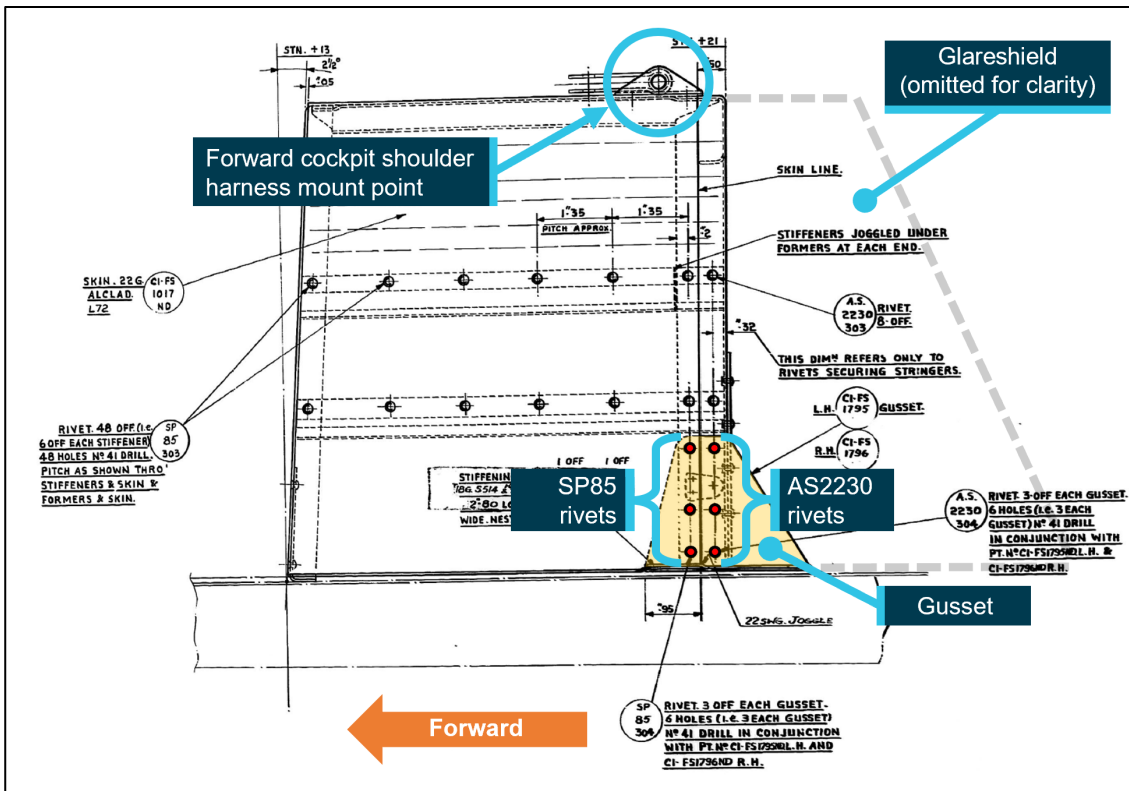
The 2 mountings, called gussets, were installed as modification H.268. This modification was issued by Hawker Siddeley in 1966 to replace the original aluminium alloy gussets with high-tensile steel. The modification required the forward row of rivets attaching the structure to the gussets to be part number SP85 mushroom head rivets, and the rear row to be part number AS2230 countersunk rivets (Figure 2).

Figure 2: Rivet detail

Both part number SP85 and AS2230 rivets were required to be manufactured to British standard L.86, which was an aluminium alloy that included copper and magnesium (with international equivalences of Alloy Designation 2117, US specification AMS7222, and European specification ENAW-AICu2.5Mg). The standard also specified that the rivets were to be anodised (a surface treatment) and coloured violet.

- The rear row of countersunk rivets appeared to be pure or near-pure aluminium and therefore the incorrect specification. Testing indicated a significant reduction in strength (estimated to be about one-third of the specification strength).
- The forward row of mushroom head rivets appeared to be an alloy consistent with L.86. The rivets were coated with a gold-coloured chromate conversion coating instead of violet anodising. ATSB testing indicated that the strength of the rivets met or exceeded literature values for L.86 alloy.
