# Hydraulics system failure involving Fairchild SA227-DC, VH-WAJ

Perth Airport, Western Australia, on 12 August 2024

## **ATSB Transport Safety Report**

AO-2024-047

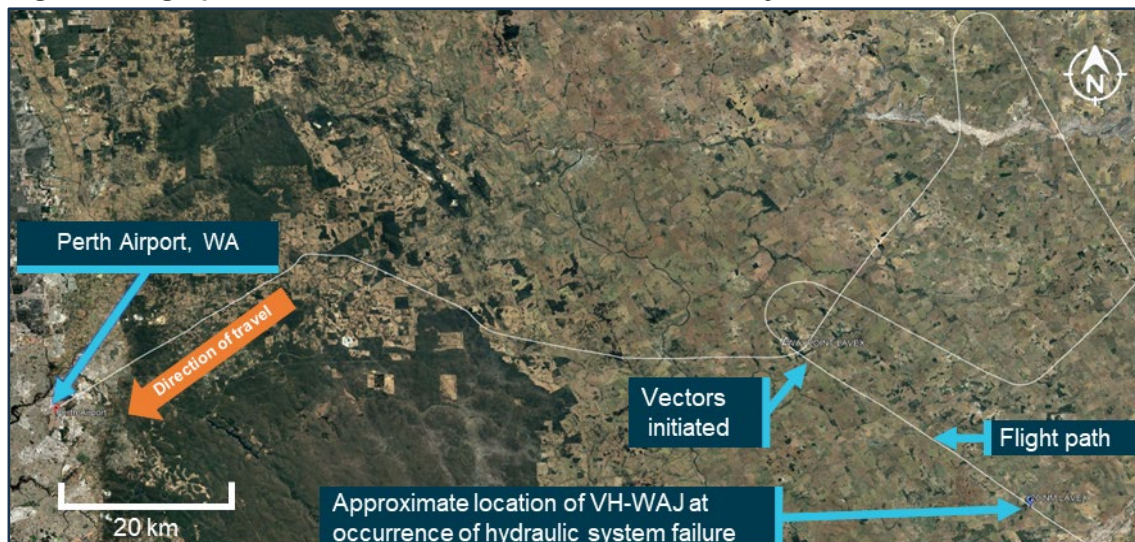
**Figure 1: Flightpath and location of VH-WAJ at the time of hydraulic failure**

At about 1000, the aircraft was close to the top of descent into Perth (Figure 1), when the right hydraulic system low-pressure annunciator light flickered and then subsequently remained solid, which indicated a system failure.

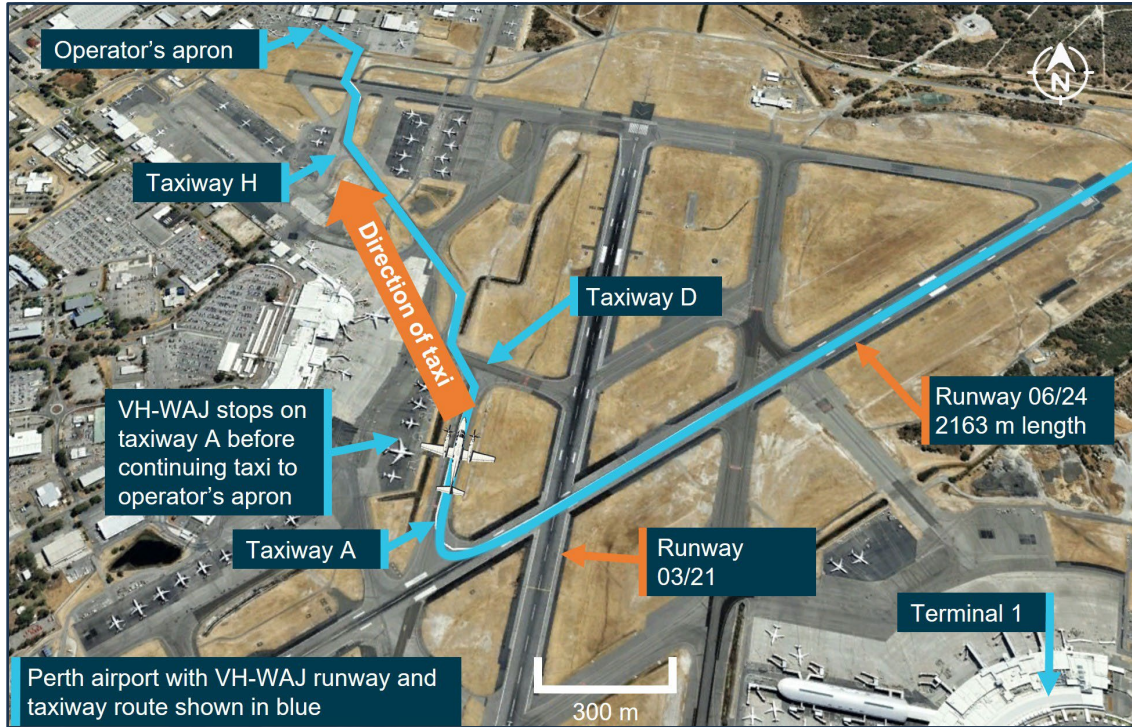
**Figure 3: Aerial view of Perth Airport showing the route used by VH-WAJ after landing**

A system of interconnected taxiways connects runways with terminals, aircraft aprons and hangars. The captain reported using asymmetric power to taxi (as nose wheel steering was not functional due to the hydraulics failure) at walking pace via taxiways D and H to the operator's apron.
