# Collision with terrain involving Oficinas Gerais de Material Aeronautico DHC-1 MK 22 Chipmunk, VH-POR

Jandakot Airport, Western Australia on 26 April 2024

## **ATSB Transport Safety Report**

AO-2024-013

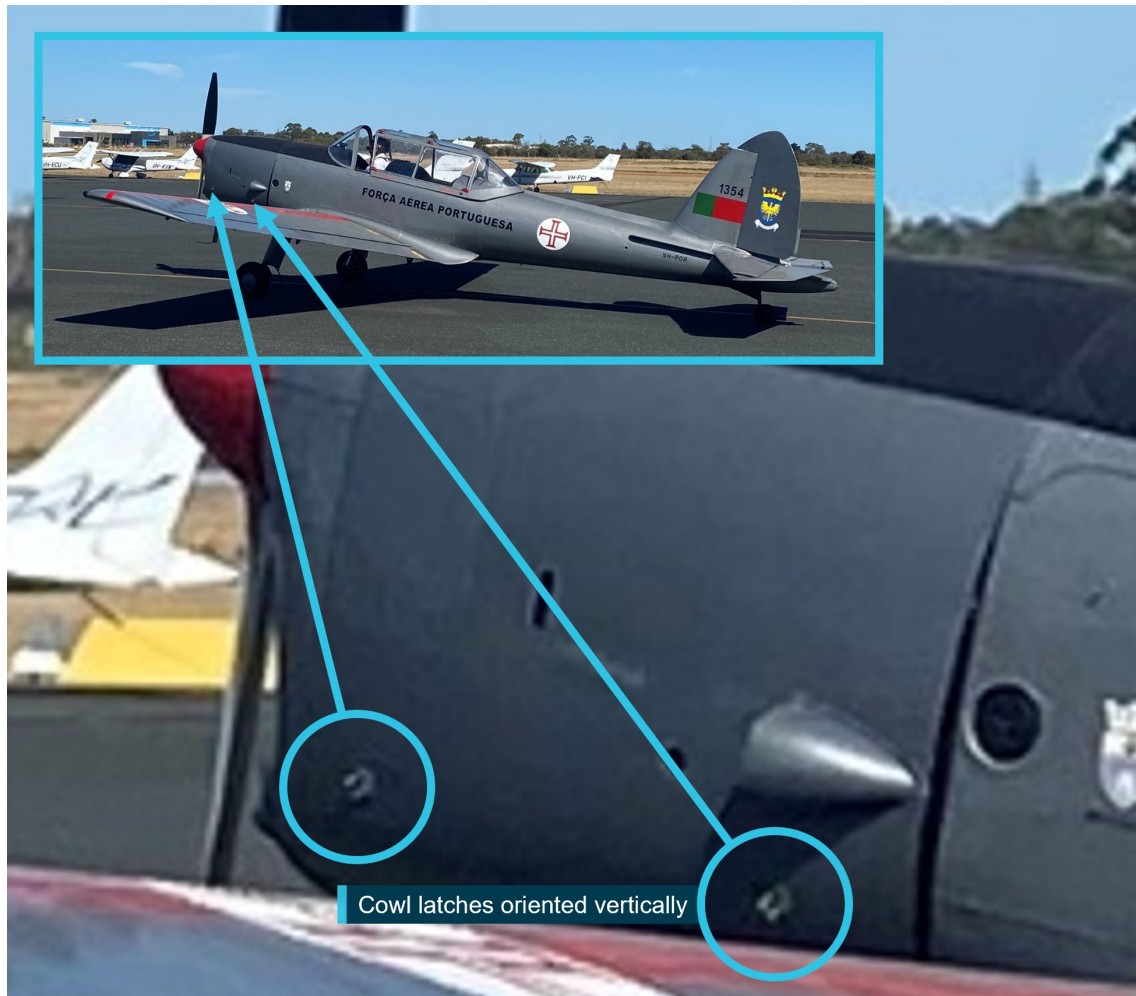
**Figure 1: VH-POR taxiing for take-off**

A witness on the southern apron took photographs of the aircraft taxiing past, which show the engine cowl latches on the left side were oriented vertically<sup>1</sup> (Figure 1).

*The gap at the rear edge of the cowl is normally present when the cowl is closed fully.*  
Image source: Witness, annotated by the ATSB

Damage to the engine cowl latches was indicative of the latches being correctly fastened on the right side but unfastened on the left at the time of impact. The engine cowls and latches were otherwise undamaged.

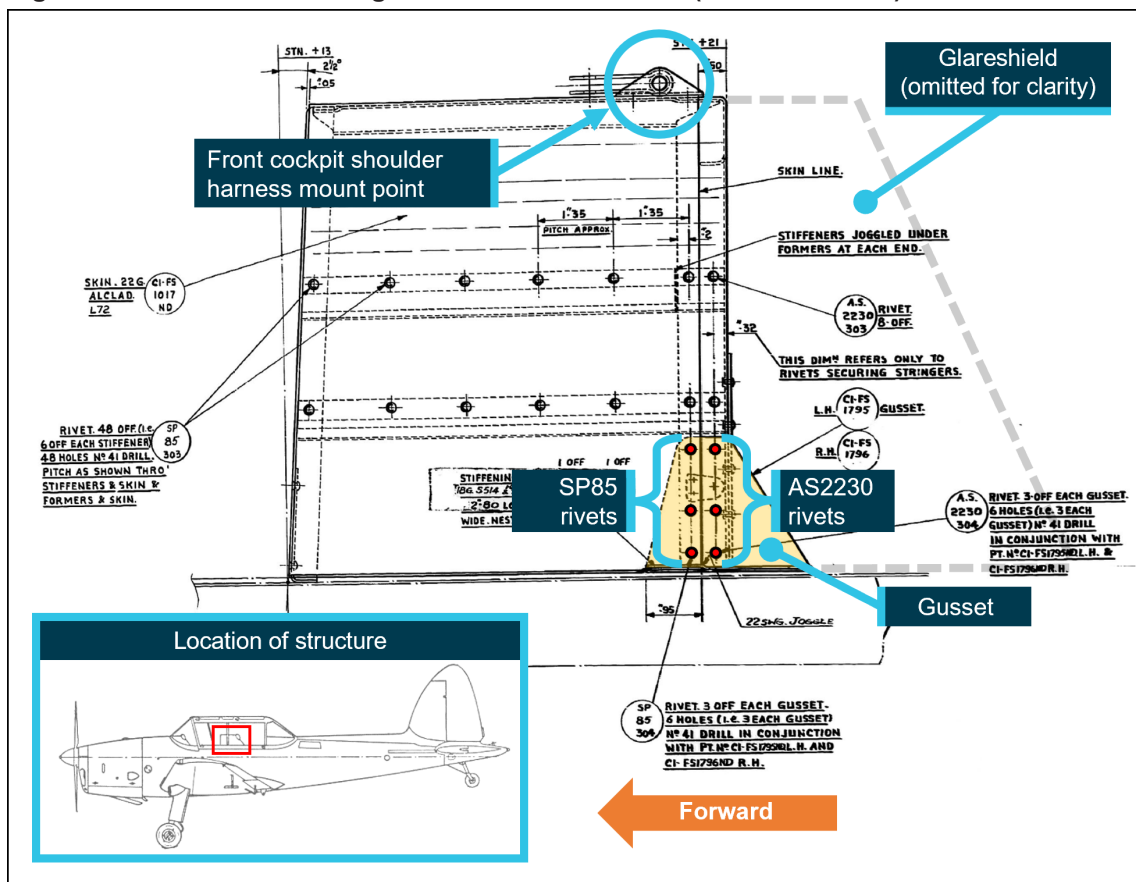
**Figure 6: Modification H.268 gusset and rivet location (left side shown)**

In October 1966, modification H.268 was issued<sup>6</sup> to strengthen this structure. The modification was classified as ‘desirable’, and was applicable to DHC-1 Chipmunk marks 20 (which included Portuguese-manufactured aircraft), 21, 22, 22A and 23. The modification replaced the original aluminium alloy gussets with high-tensile steel. The modification required the forward row of rivets attaching the structure to the gussets to be part number SP85 mushroom head rivets, and the rear row to be part number AS2230 countersunk rivets. Later testing by the manufacturer subjected the front cockpit shoulder harness of a modified aircraft to a 22 G load, with no failures.

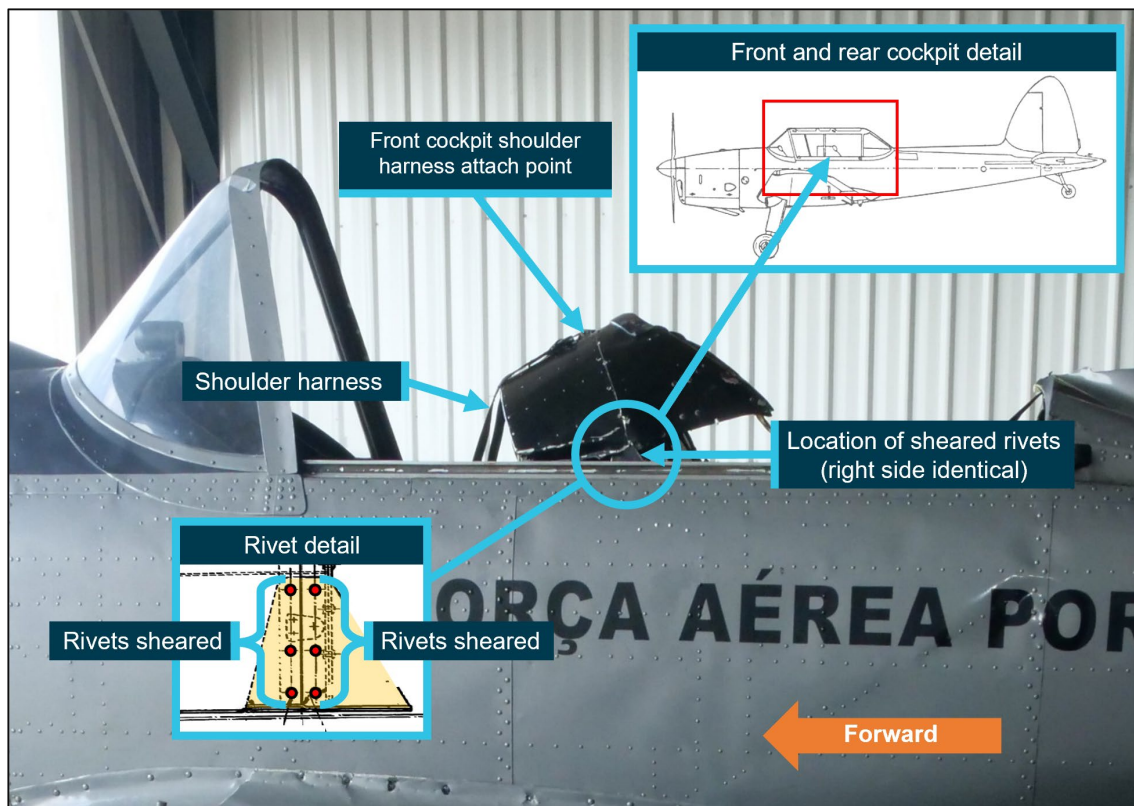
**Figure 7: Detached upper structure showing harness attach point and location of sheared rivets**

The ATSB found that on impact the upper structure between the front and rear cockpits, corresponding to the attach point for the front cockpit shoulder harness, was torn away from its mountings (Figure 7). All 12 rivets (6 per side) that attached the structure to the mountings had sheared.

Upper structure has been placed in position for the photograph and is representative of its position immediately post-accident. Image source: ATSB, de Havilland Support Ltd (detail), annotated by the ATSB

The gussets fitted to VH-POR were steel, rather than aluminium alloy, which indicated that modification H.268 had been embodied. This modification also required the use of part number SP85 and AS2230 rivets. Both types were required to be manufactured to British standard L.86, which was an aluminium alloy that included copper and magnesium.<sup>10</sup> The standard also specified that the rivets were to be anodised (a surface treatment) and coloured violet.

- The material composition of the rear row of rivets (countersunk) was consistent with pure or near-pure aluminium<sup>11</sup> and therefore a non-conforming specification. Testing indicated a significant reduction in strength, estimated to be about one-third of the strength of the specification rivets.
- The material composition of the forward row of rivets (mushroom head) was consistent with an alloy consistent with L.86. The rivets were coated with a gold-coloured chromate conversion coating instead of violet anodising. ATSB testing indicated that the strength of the rivets met or exceeded literature values for L.86 alloy.

The presence of the non-conforming rivets significantly reduced the integrity of the structure retaining the front cockpit restraint, and thereby compromised the crashworthiness of the aircraft. This non-conforming modification may be present in other Chipmunk aircraft, in which case it would likely affect survivability in an accident.

To advise DHC-1 Chipmunk maintainers and owners of the importance of carrying out this modification to the required specification, the ATSB issued a safety advisory notice ([AO-2024-013-SAN-01](#)) on 11 September 2024.

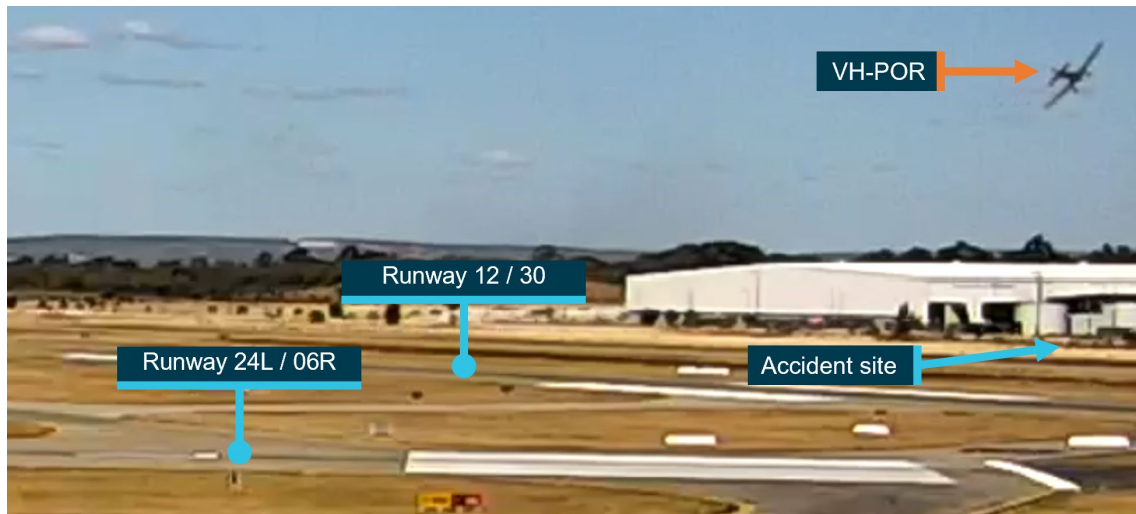
**Figure 8: VH-POR angle of bank during left turn after take-off**

The aerodynamic stall<sup>13</sup> speed of aircraft in a steady turn increases appreciably with an angle of bank greater than 30°, and at angles greater than 45° there is a rapid increase in stall speed. At 55° angle of bank, stall speed is increased by about 32%. The Chipmunk's stall speed in a 55° steady turn while maintaining level flight would have therefore been about 62 kt.
