Midair collision involving Eurocopter EC130 B4, VH-XH9, and Eurocopter EC130 B4, VH-XKQ

Main Beach, Gold Coast, Queensland, on 2 January 2023

ATSB Transport Safety Report

AO-2023-001

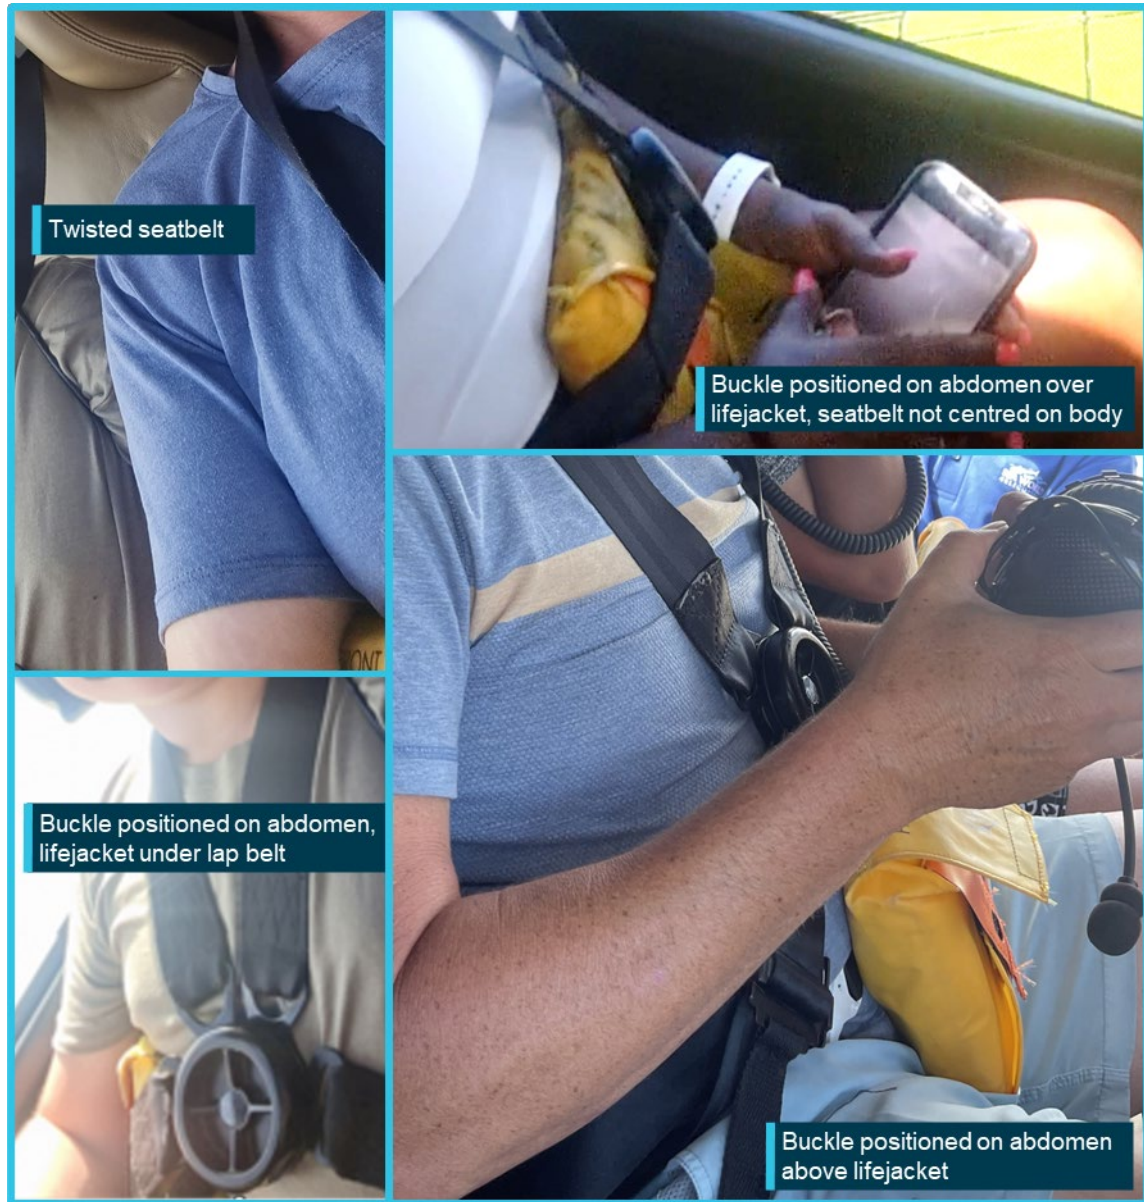
Figure 53: Examples of passenger incorrect seatbelt fitment

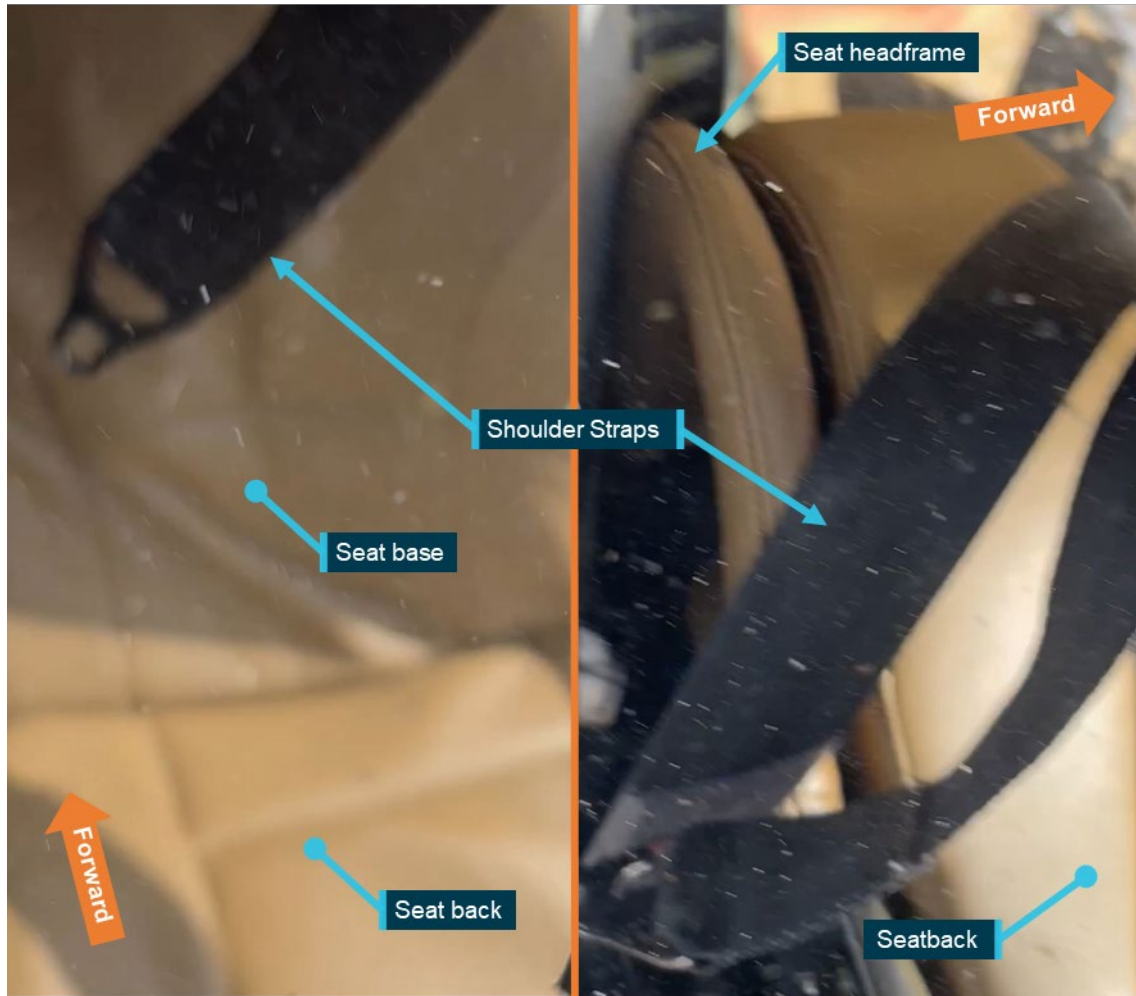
Figure B14: Front right seat shoulder harness disconnected during rollover
